This folder is for the 12 and 6 Month servicing of the Tasman Bridge

12 Monthly service April
2019- Inspections and
recommendations

Tasman Bridge Gantry Structural Capacity Assessment

6137698-MEM-0002-A Durability Assessment of Tasman Bridge Beams

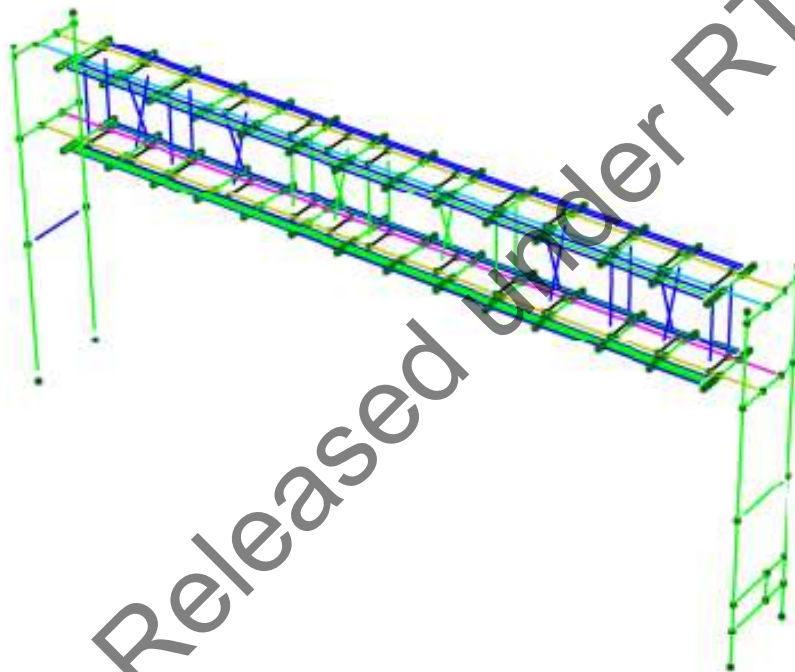
Viewpoint (-145,-33)

The top and bottom chords of the trusses of Gantry No 8 & 13 were determined to fail theoretically under ultimate load combinations. Therefore these members require additional strengthening or replacement in order for the gantries to adequately handle the load imposed on them.

- Strengthening of the truss chords of Gantry No 8 & 13 is recommended if additional loading is to be imposed on these gantries. A targeted inspection is recommended to check the likely corrosion and section loss within the top and the bottom chords of the truss.

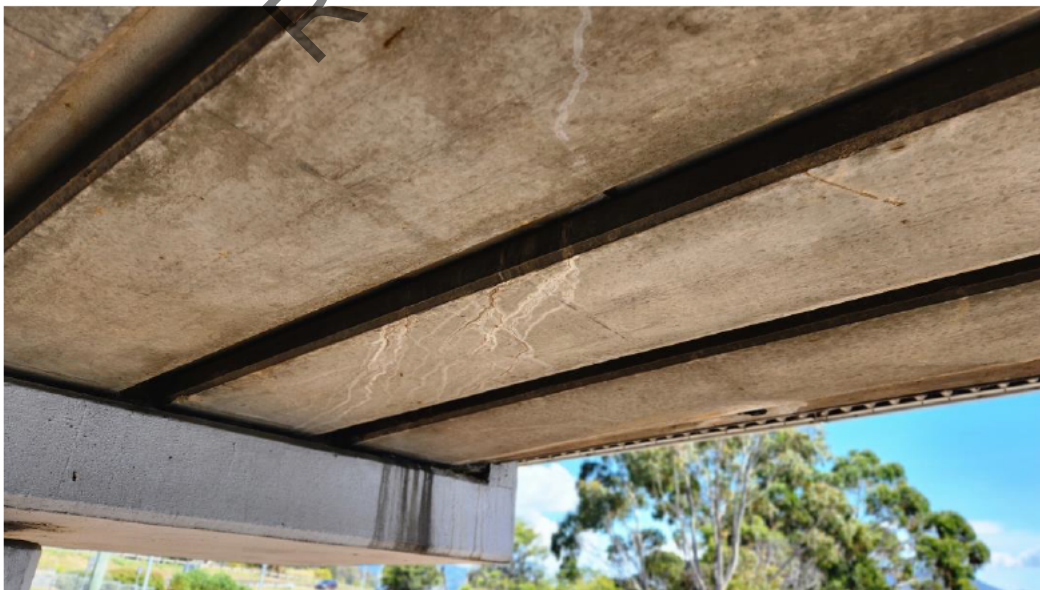
Initially, the underside of the superstructure was inspected between Piers D and E. No defects were noted in this location other than some minor surface cracking that was noted on the second most northern beam, towards Pier E, refer Figure 2. This cracking was likely to have been present for some time due to the calcite residue (autogenous healed) present along the crack. The EWP could not reach the crack to measure the crack width, however it was determined visually that the extent of the cracking at this location is likely to be minor.

Figure 2 Cracking at second beam from the north between Piers D and E

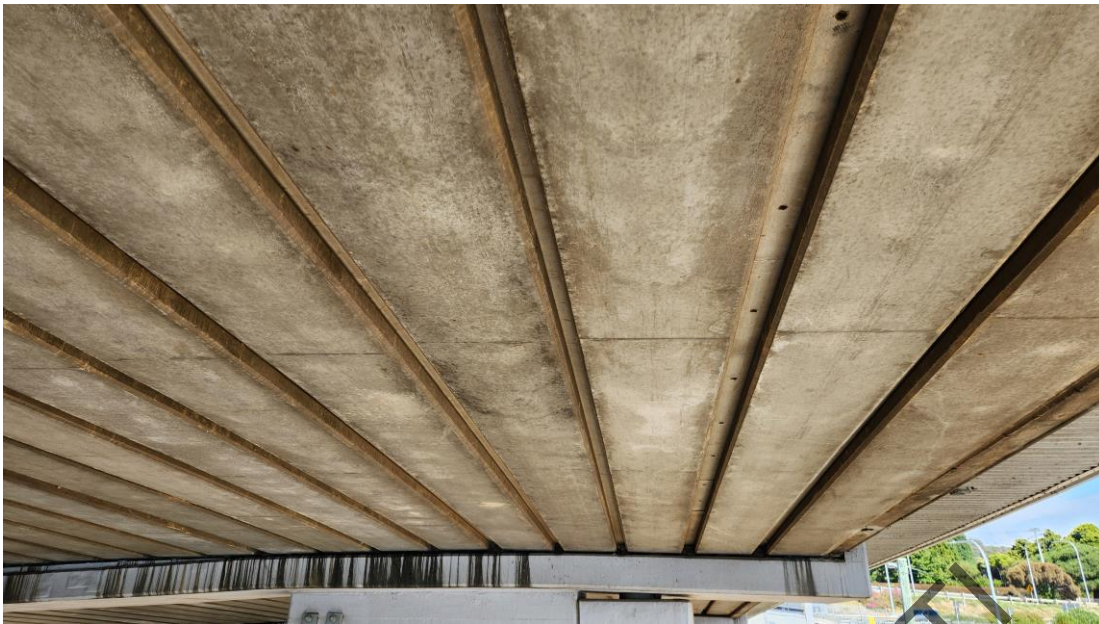
Figure 3 General view of the condition of the soffit of the bridge deck and girders between Piers D and E

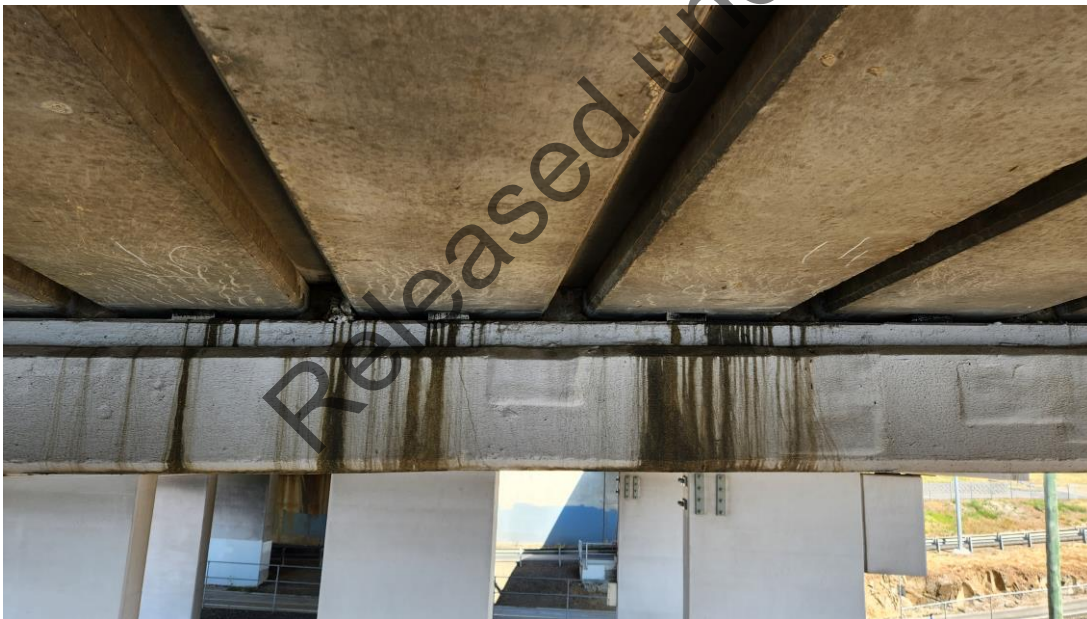
Runoff from the bridge was noted to have stained some sections of the Pier E headstock, refer Figure 4. Some of the staining visually appears similar to vertical cracking. However, it was confirmed during the inspection that there was no cracking on surface of the headstock. The staining suggests that the joint in the roadway is not completely sealed.

Figure 4 Staining on the eastern face of the headstock of Pier E

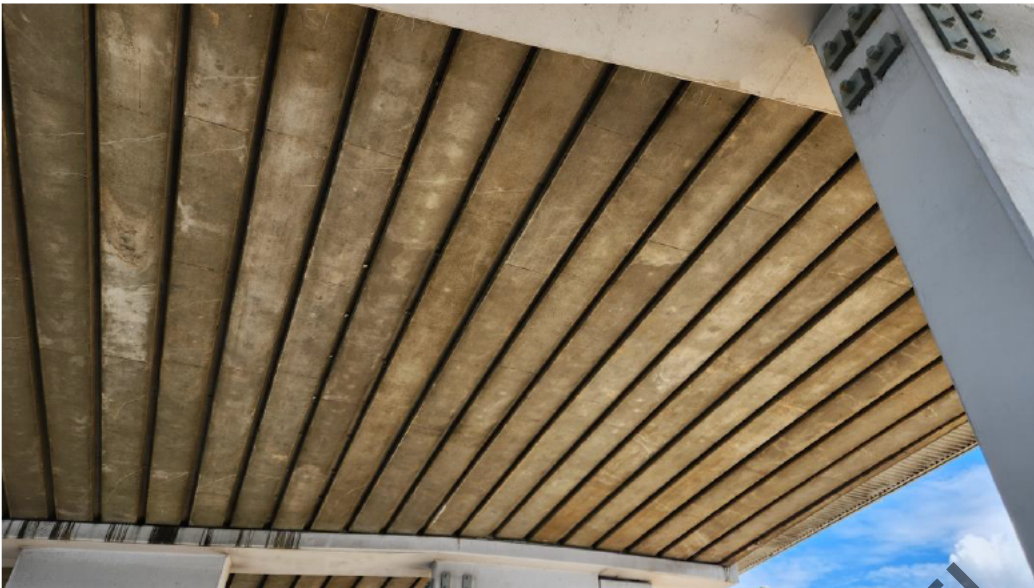
Figure 5 General view of the condition of the soffit of the bridge deck between Piers E and F

No defects were noted on this section of the bridge, refer Figure 5. A white runoff substance from the bridge surface was noted to have left marks on the underside of the beams. It was not possible to physically reach all of the stains, however, no cracking was noted at the locations that were accessible.

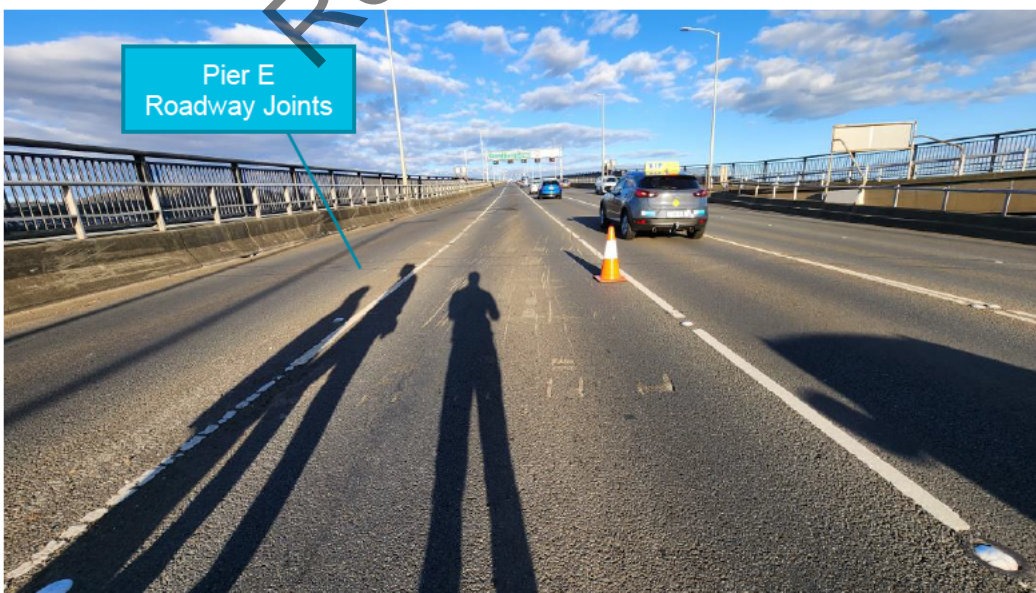
Figure 6 General view of the damage to the asphalt

The damage to the asphalt was limited to the three northern lanes of the bridge, with the majority of the damage being concentrated on the second lane from the north. The damage extended roughly from 1.5 m east of Pier F to Pier D, with majority of the damage located either side of Pier E. Pier locations were determined from the joints on the surface.

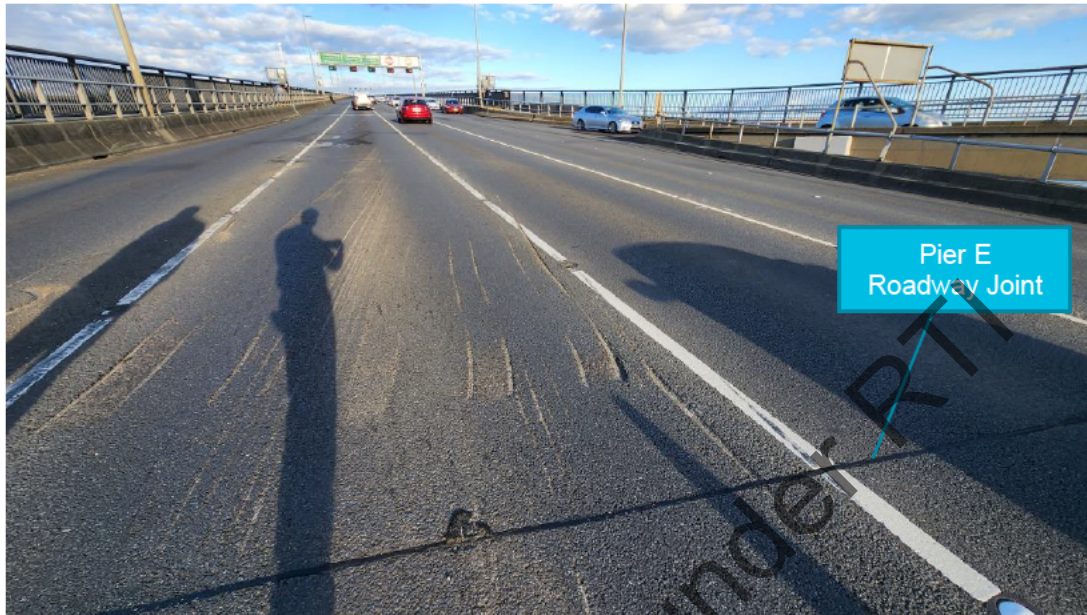
Figure 7 Gauges in the asphalt

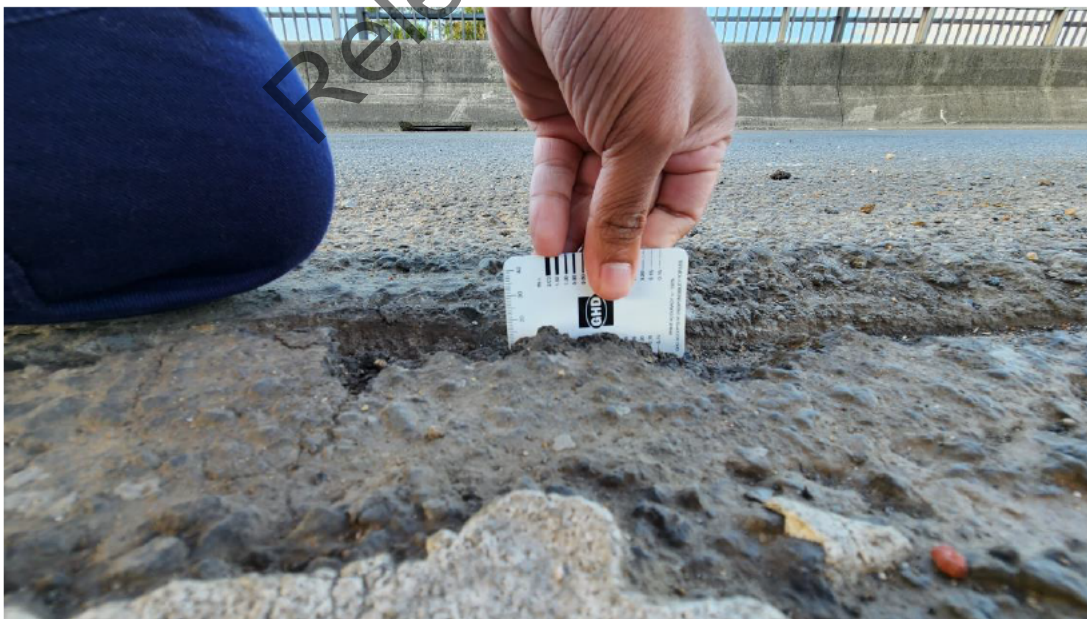
The gouges caused by the truck were found to have a maximum depth of roughly 15mm. This suggests that the damage is likely contained within the asphalt and has not reached the concrete deck. The damage appears to be superficial with no evidence indicating that the structural capacity of the bridge has been affected. It may be worth patching up the damage for aesthetic and functional purposes, however, from a structural perspective, no repairs are required.

Figure 8 Depth of the gouges in asphalt

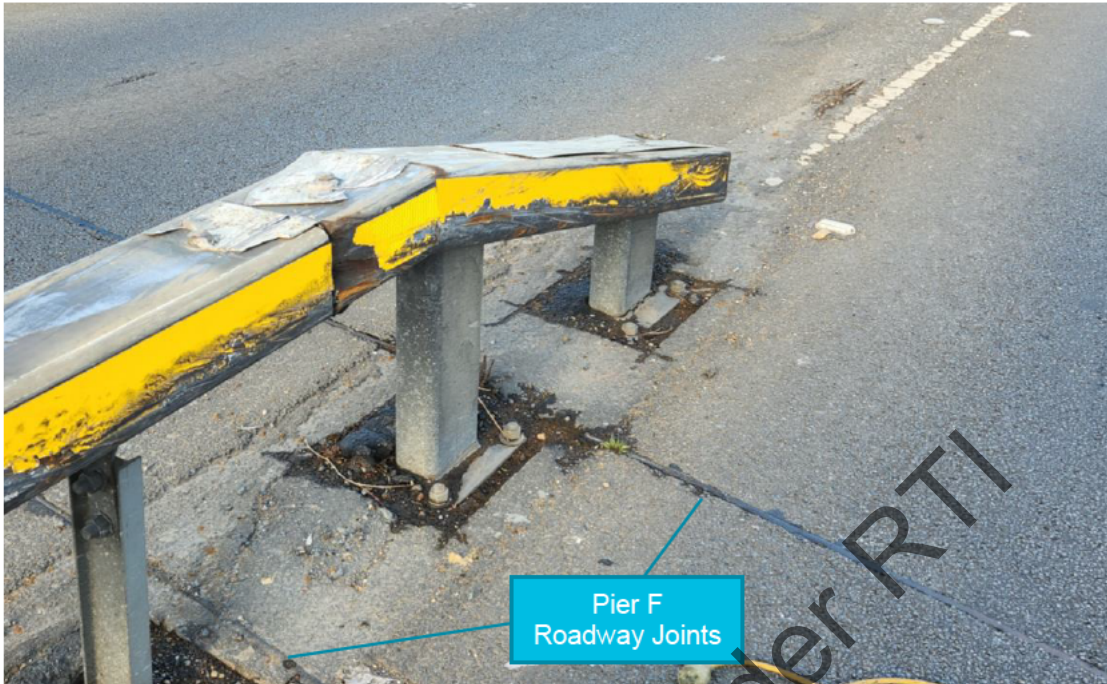
The impact from the truck was found to have cracked the base of the end post on the barrier. The hold down bolts for this post and the remainder of the barrier appeared to be in serviceable condition. Stornoway arranged for the cracking in the barrier post to be welded as part of the barrier repair.

Figure 9 Cracking at the base of the barrier post
