DEPARTMENT OF STATE GROWTH

JUNE 2020

HOBART CITY DEAL SOUTHERN PROJECTS SUB-PROJECT 2: MACQUARIE STREET AND DAVEY STREET BUS PRIORITY
CONCEPT STAGE - ROAD SAFETY AUDIT

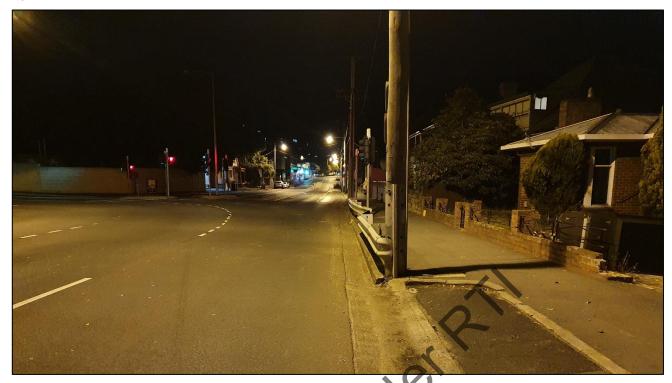
Item 2.1

2.1.	There is a power pole on the left-hand side at the intersection of the Southern Outlet and Macquarie Street which is located within the deflection zone of the safety barrier. This may intensify the outcomes of a crash in this location.	Consider providing a different crash barrier to protect the pole, or alternatively consider relocating the electricity services underground.	Occasional	Serious	High		Existing hazards within the clearzone are listed as a departure in the Design Report. Relocation/undergrounding of power poles is outside Scope of this project.DSG to confirm if this upgrade is to be included in this project.

Figure C.1 Power pole at the Macquarie Street and Southern Outlet intersection

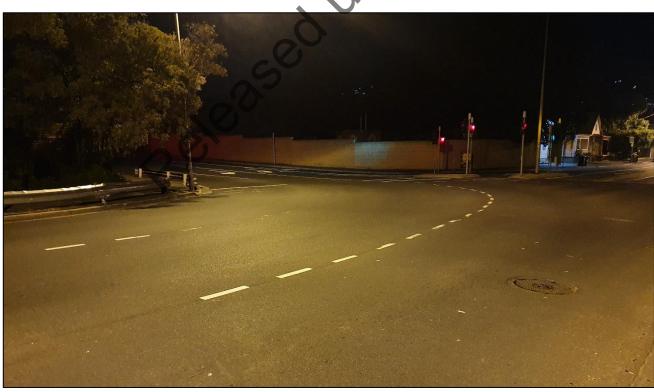
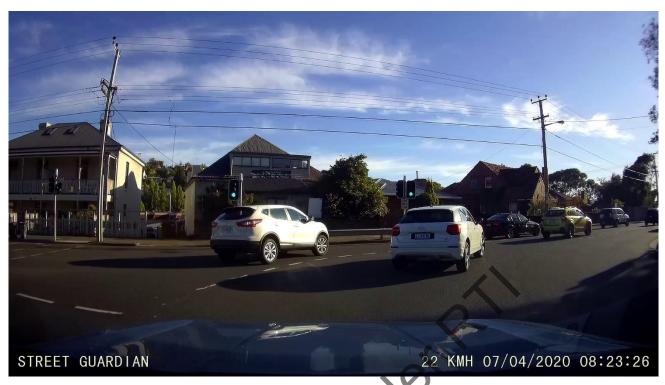
Item 2.2

2.2.	The line marking between the two right most lanes on the turn from the Southern Outlet to Macquarie Street has been worn. This may result in side swipe collisions due to the lack of lane definition.	It is recommended that the line marking be reinstated with long lasting thermoplastic line marking.		96	To Note		Agreed, note in concept design report / costing design advice.

Figure C.2 Worn Line Marking - Macquarie Street looking at right turn from Southern Outlet

Figure C.3 Worn Line Marking - Right turn from Southern Outlet onto Macquarie Street

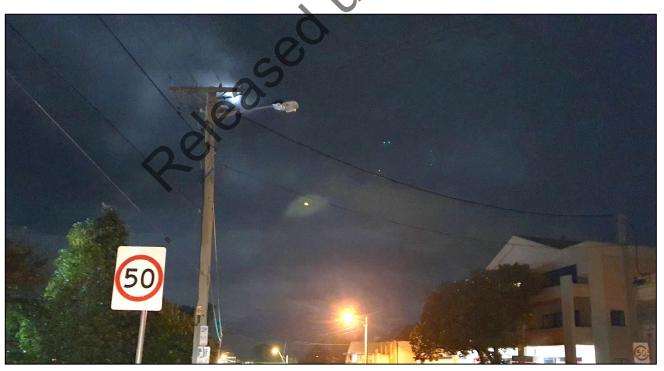
Item 2.3

2.3.	There is a streetlight luminaire which is not functioning just north of Gore Street.	It is recommended that the streetlight luminaire be replaced.	20.	-	To Note		Noted. To be resolved in future stages of design.

Figure C.4 Street Light

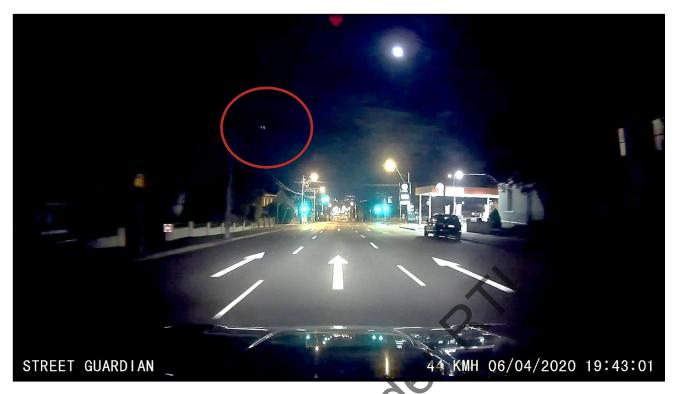
Item 2.4

2.4.	There is a streetlight luminaire which is not functioning just south of Ispahan Avenue	It is recommended that the streetlight luminaire be replaced.	-	-	To Note		Noted. To be resolved in future stages of design.

Figure C.5 Street Light

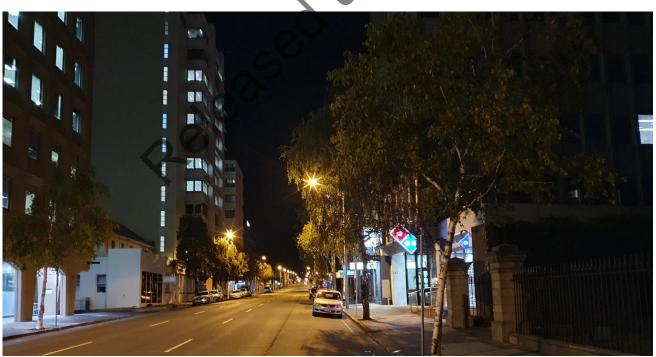
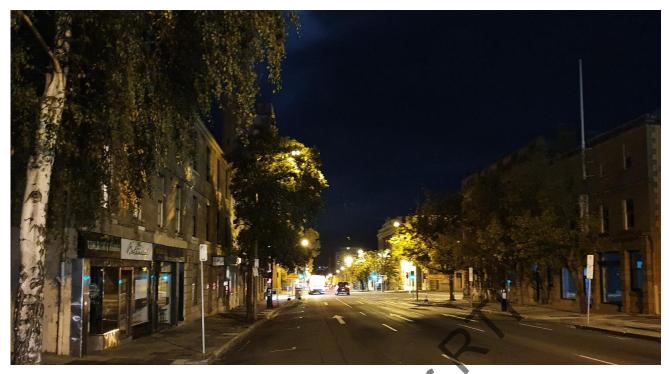
Item 2.5

2.5.	Trees obscure the street lighting between Harrington Street and Murray Street.	Consider truming or removing trees so that the street lighting is less obstructed.	-	-	To Note		Noted. To be resolved in future stages of design.

Figure C.6 Tree obscuring streetlight

Figure C.7 Tree obscuring streetlight

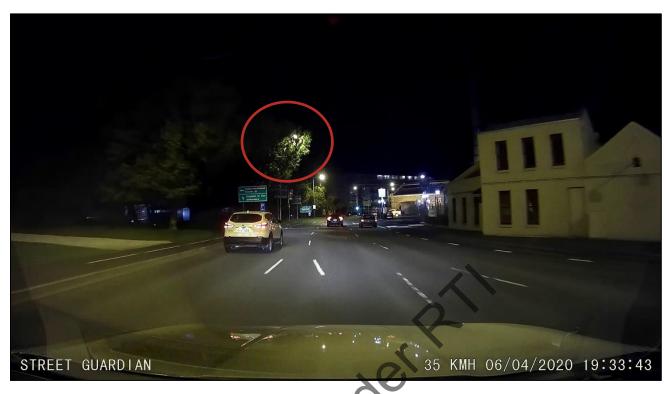
3.1.	Streetlight partially obscured by tree north of Evans Street. This may result in a driver having a collision with an object on the road due to poor illuminance.	Trees to be trimmed or removed so that the street lighting is less obstructed.	-	-	To Note		Noted. To be resolved in future stages of design.

Figure C.8 Tree obscuring streetlight

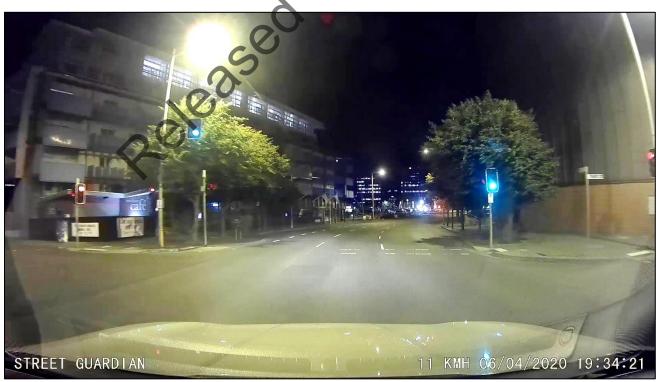
3.2.	Trees on both sides of the road south of Evans Street encroach into the lane which may result in a crash for large vehicles.	Trees to be trimmed or removed to reduce impacts between the trees and large vehicles.	-	S.	To Note		Noted. To be resolved in future stages of design.

Figure C.9 Trees encroaching traffic lanes

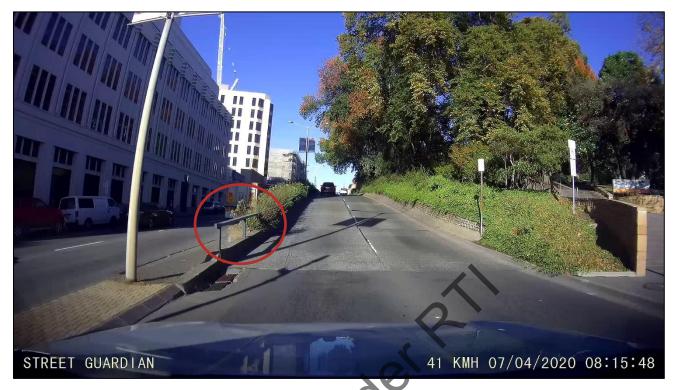
3.3.	The safety barrier in the median south of Elizabeth Street is considered a spearing hazard for errant vehicles as it has a horizontal rail.	Replace the safety barrier with a conventional safety barrier and provide the appropriate terminal.	Occasional	Serious	High		Outside of project area. Included note in concept design.

Figure C.10 Safety Barrier in median

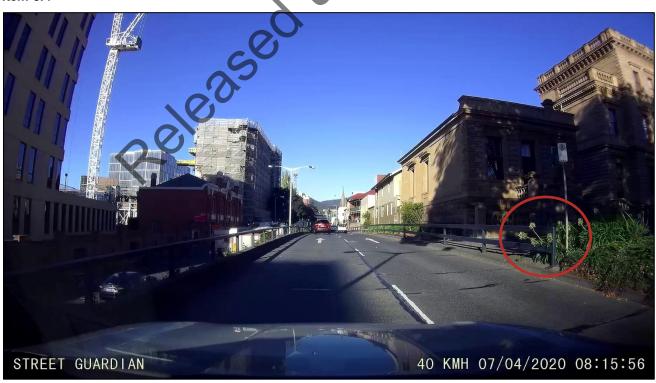
3.4.	The safety barrier on the right-hand side south of Elizabeth Street (where Davey Street is split level) is considered a spearing hazard for errant vehicles as it has a horizontal rail.	Replace the safety barrier with a conventional safety barrier and provide the appropriate terminal.	Occasional	Serious	High		Outside of project area. Included note in concept design.

Figure C.11 Safety Barrier on right hand side

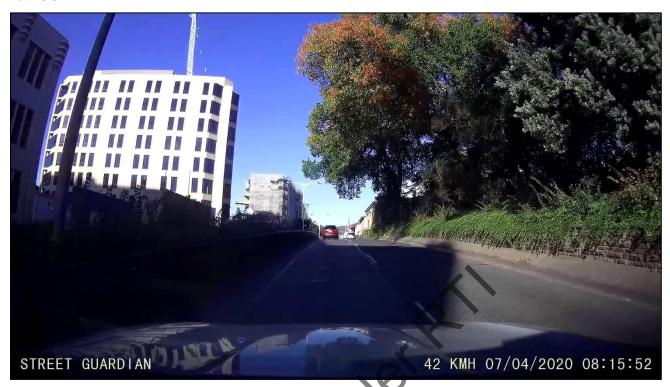
3.5.	The lane line between the two right hand lanes between Elizabeth Street and Murray Street where Davey Street is split level is in poor condition. This may result in a side swipe crash in poor light or weather.	It is recommended that the line marking be reinstated with long lasting thermoplastic line marking.	-	-	To Note		Outside of project area. Included note in concept design.

Figure C.12 Centre Linemarking

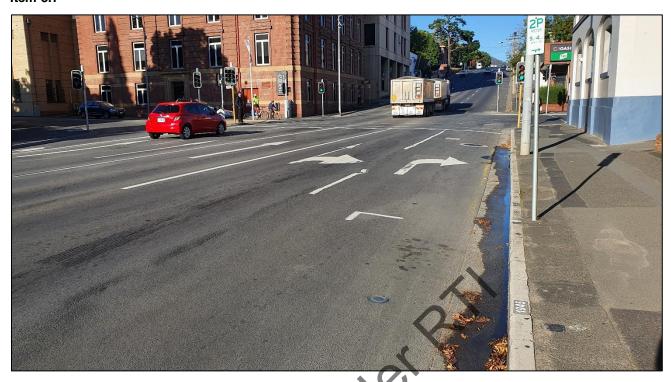
3.7.	The pavement in the vicinity of Sandy Bay Road is rutted and corrugated which may result in a vehicle losing control or a pedestrian tripping.	It is recommended that the pavement be reinstated as part of the proposed road modifications.	Occasional	Limited	Low		Agreed, include resurfacing in scope. Note in concept design report / costing design advice.

Figure C.14 Rutted Pavement

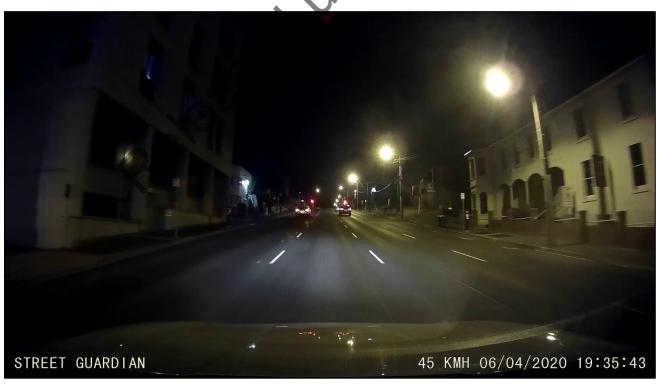
Figure C.15 Poor street lighting on left hand side

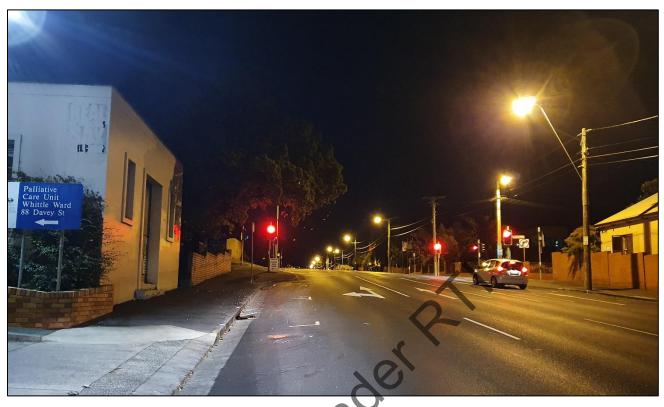
3.9.	Streetlight partially obscured by tree north of Barrack Street which may result in a driver having a collision with an object on the road due to poor illuminance.	Trees to be trimmed or removed so that the street lighting is less obstructed.	-	-	To Note		Noted. To be resolved in future stages of design.

Figure C.16 Tree obscuring streetlight

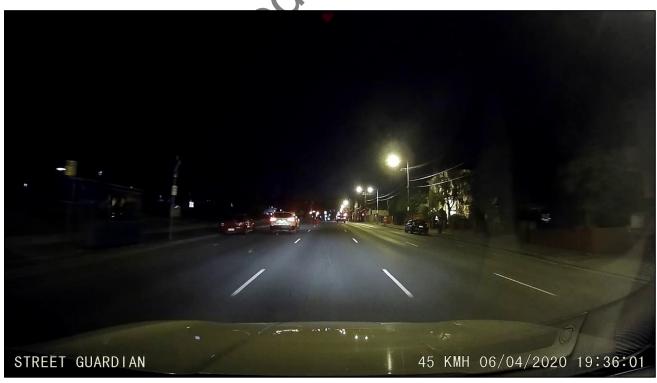
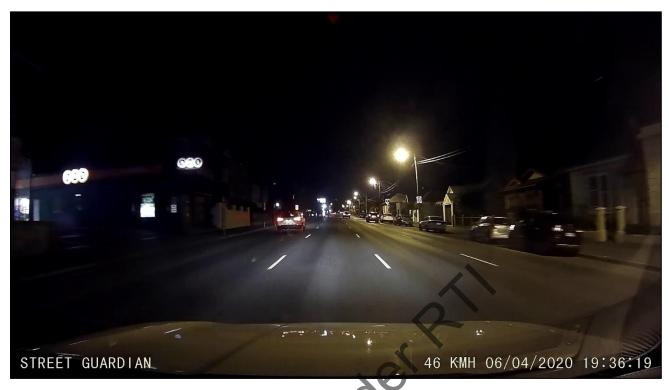
CLIENT RESPONSE
ITEM	AUDIT FINDINGS	AUDIT RECOMMENDATIONS	FREQUENCY	SEVERITY	RISK	ACCEPT YES/NO	REASONS/COMMENTS
3.11.	Street lighting is poor on the left-hand side between Molle Street and Antil Street. This may result in a driver having a collision with an object on the road and may also result in a pedestrian on the footpath tripping.	Consider undertaking a detailed street lighting investigation to determine if additional street lighting is required.	-	-	To Note		Note in concept design report

Figure C.17 Poor street lighting on left hand side

Figure C.18 Poor street lighting on left hand side

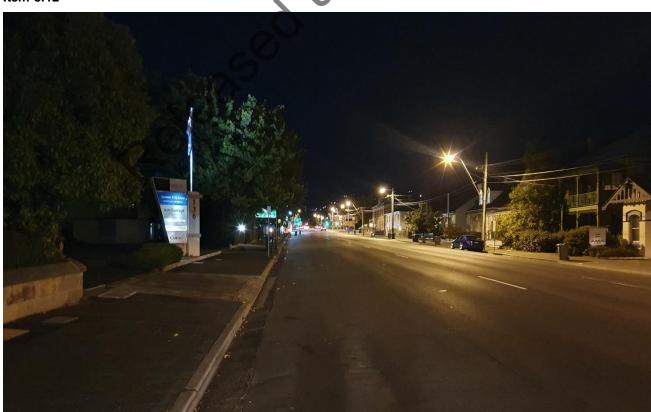
3.12.	The University of Tasmania advanced direction sign north of Antil Street is partially obscured by vegetation. This may result in sudden lane changes from drivers, resulting in a collision.	Vegetation to be trimmed so that the sign is less obstructed.	Occasional	Limited	Low		Noted. To be resolved in future stages of design.

Figure C.19 Obscured Signs

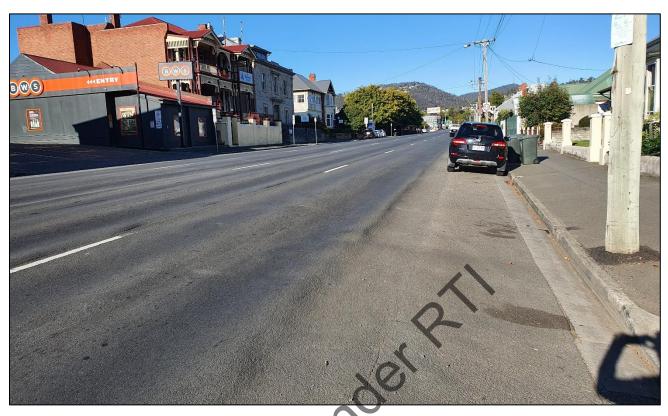
Item 3.13 and Item 3.14

3.13.	The pavement between Molle Street and Antil Street is rutted and corrugated. This may result in a vehicle losing control or a pedestrian tripping.	It is recommended that the pavement be reinstated.	Occasional.	Limited	Low		Agreed, include resurfacing in scope. Note in concept design report / costing design advice.

Figure C.20 Rutted Pavement and excessive crossfall

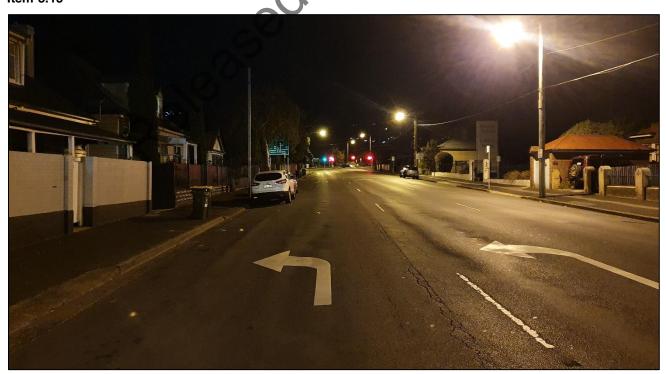
3.15.	The advanced direction sign on the approach to the Southern Outlet is partially obscured by vegetation. This may result in sudden lane changes from drivers, resulting in a collision.	Vegetation to be trimmed so that the sign is less obstructed.	Occasional	Limited	Low		Noted. To be resolved in future stages of design.

Figure C.21 Obscured signs
