MAY 2020

**HOBART CITY DEAL
SOUTHERN
PROJECTS
SUB-PROJECT 1:
SOUTHERN OUTLET
TRANSIT LANE
CONCEPT STAGE
ROAD SAFETY
AUDIT**

Hobart City Deal
Southern Projects
Sub-Project 1: Southern Outlet Transit Lane
Concept Stage
Road Safety Audit

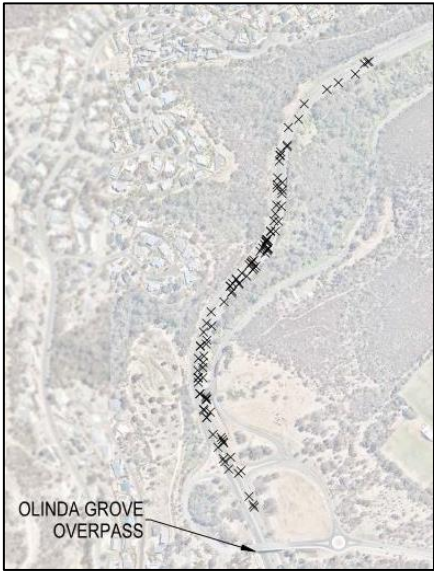
ITEM	AUDIT FINDINGS	AUDIT RECOMMENDATIONS	FREQUENCY	SEVERITY	RISK	CLIENT RESPONSE	
						ACCEPT YES/NO	REASONS/COMMENTS
1.5.	<p>Approximately 40% of the crashes occur within 700m of the Olinda Grove overpass.</p>

<p>This section of road accommodates a number of bends which given the volume of crashes may indicate that the current radii and change between bends is causing difficulty for drivers.</p>	Consider if there is opportunity to improve bend radii through modifications within the concept plans.		-	To Note.	Yes	<p>Noted. The concept design is limited to widening works to create space for a transit lane in the northbound. It is not intended as an overall upgrade project of the Southern Outlet.</p> <p>Geometric and Sight distance departures are included in the Concept Design report for the Department of State Growth's consideration. These are existing issues and have not been rectified in the Concept Design. The concept design is on a like-for-like basis as these significant upgrades have significant cost implications.</p>

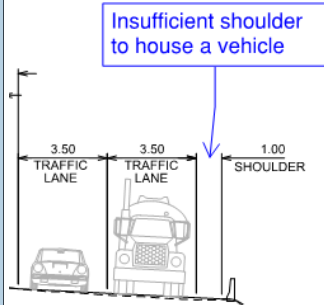
4.1.	<p>Shoulder is shown to have a reduced width that would be inadequate to house a broken-down vehicle between chainage marker 720 and 1180. This may result in an increased likelihood of rear end crashes if vehicles stop on the shoulder.</p> <div><p>Insufficient shoulder to house a vehicle</p>

</div>	<p>Widen shoulder or if not possible, consider the provision of additional signage through this area warning of reduced shoulder.</p>	Probable	Serious	Intolerable	Yes	<p>Noted. The concept design is limited to widening works to create space for a transit lane in the northbound. It is not intended as an overall upgrade project of the Southern Outlet.</p> <p>The existing shoulder is less than 1m in this section. This has been increased to 1.0m. Increasing the shoulder to 3.0-4.0m will have a significant impact on cost.</p>

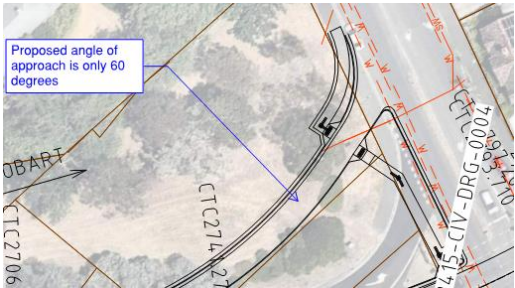
ITEM	AUDIT FINDINGS	AUDIT RECOMMENDATIONS	FREQUENCY	SEVERITY	RISK	CLIENT RESPONSE	
						ACCEPT YES/NO	REASONS/COMMENTS
5.5.	<p>The angle of approach for the left turn slip lane onto Davey Street from the Southern Outlet northbound (CH2760) is approximately 60°. Austroads Guide to Road Design Part 4A indicates that the angle of alignment at a slip lane should be between 70° - 90° to ensure that vehicles are positioned such that drivers are provided with a safe and convenient observation angle to vehicles approaching from their right. Provision of an alignment outside of this range may lead to impeded sight lines result in vehicle accidents.</p>

Re-align the slip lane to meet Austroads design requirements.	Occasional	Serious	High	Yes	Agreed. Concept Design updated.

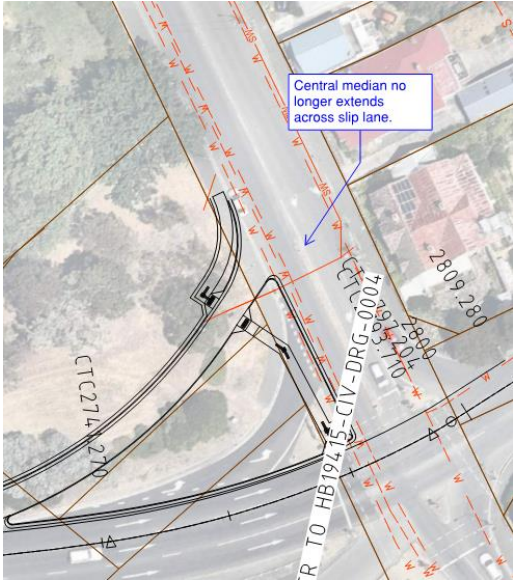
<p>5.6.</p>	<p>Due to the new alignment for the left turn slip lane from the Southern Outlet onto Davey Street (CH2760), the central median along Davey Street no longer fully extends across the front of the slip lane. This may provide vehicles the opportunity to turn right from the slip lane onto Davey Street eastbound and may potentially create conflicts for other vehicles.</p>

<p>Extend the central median across the front of the modified slip lane alignment to enforce the left turn movement.</p>	<p>Probable</p>	<p>Minor</p>	<p>High</p>	<p>Yes</p>	<p>Agreed. Noted in Concept Design Report.</p>
-------------	--	--	-----------------	--------------	-------------	------------	--

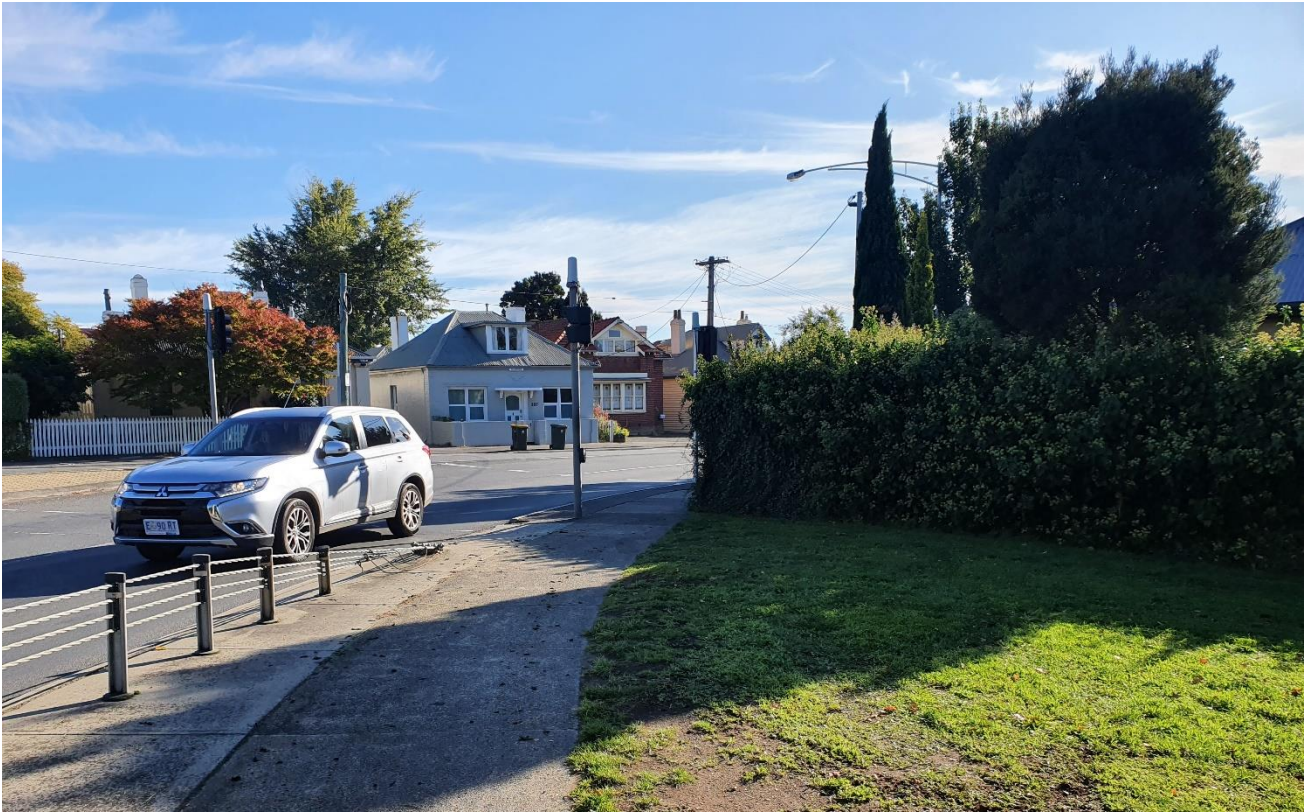
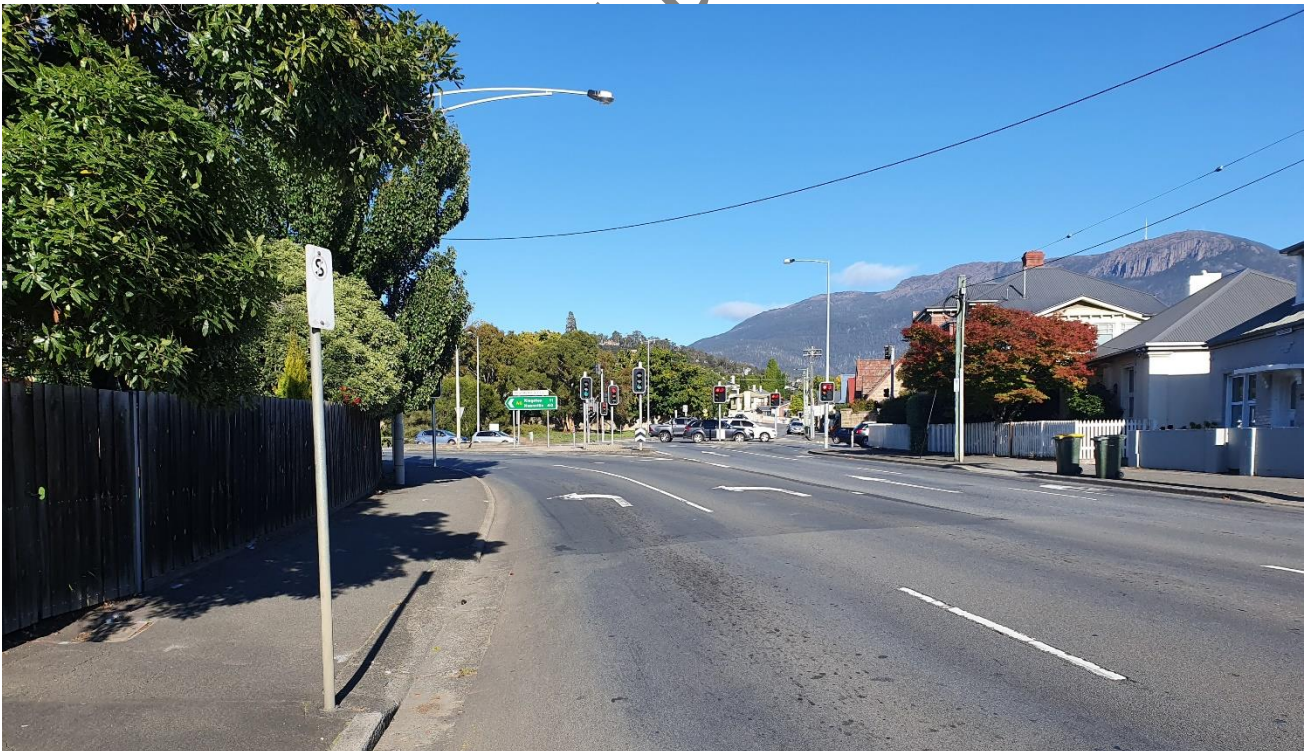
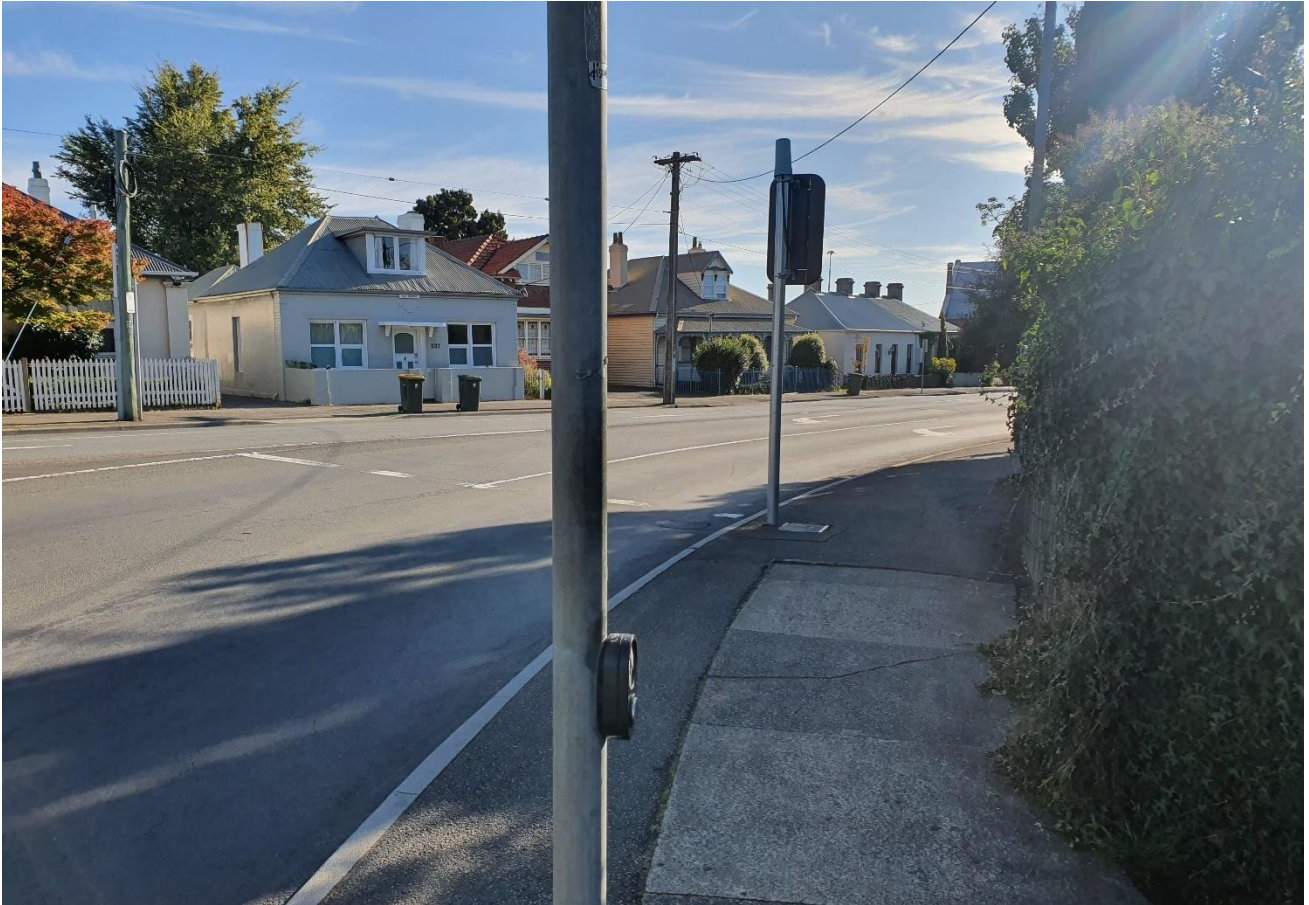
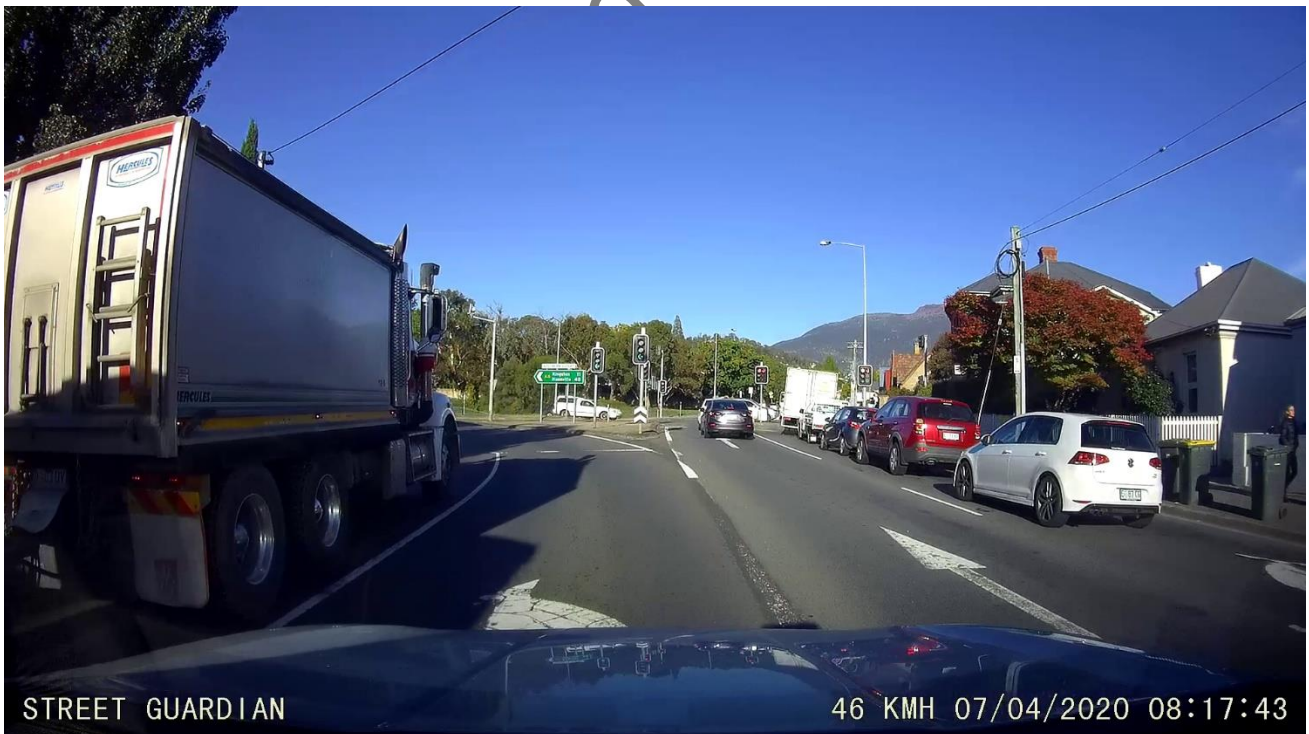
Item 2.1

Figure C.1 Davey Street Pedestrian Crossing

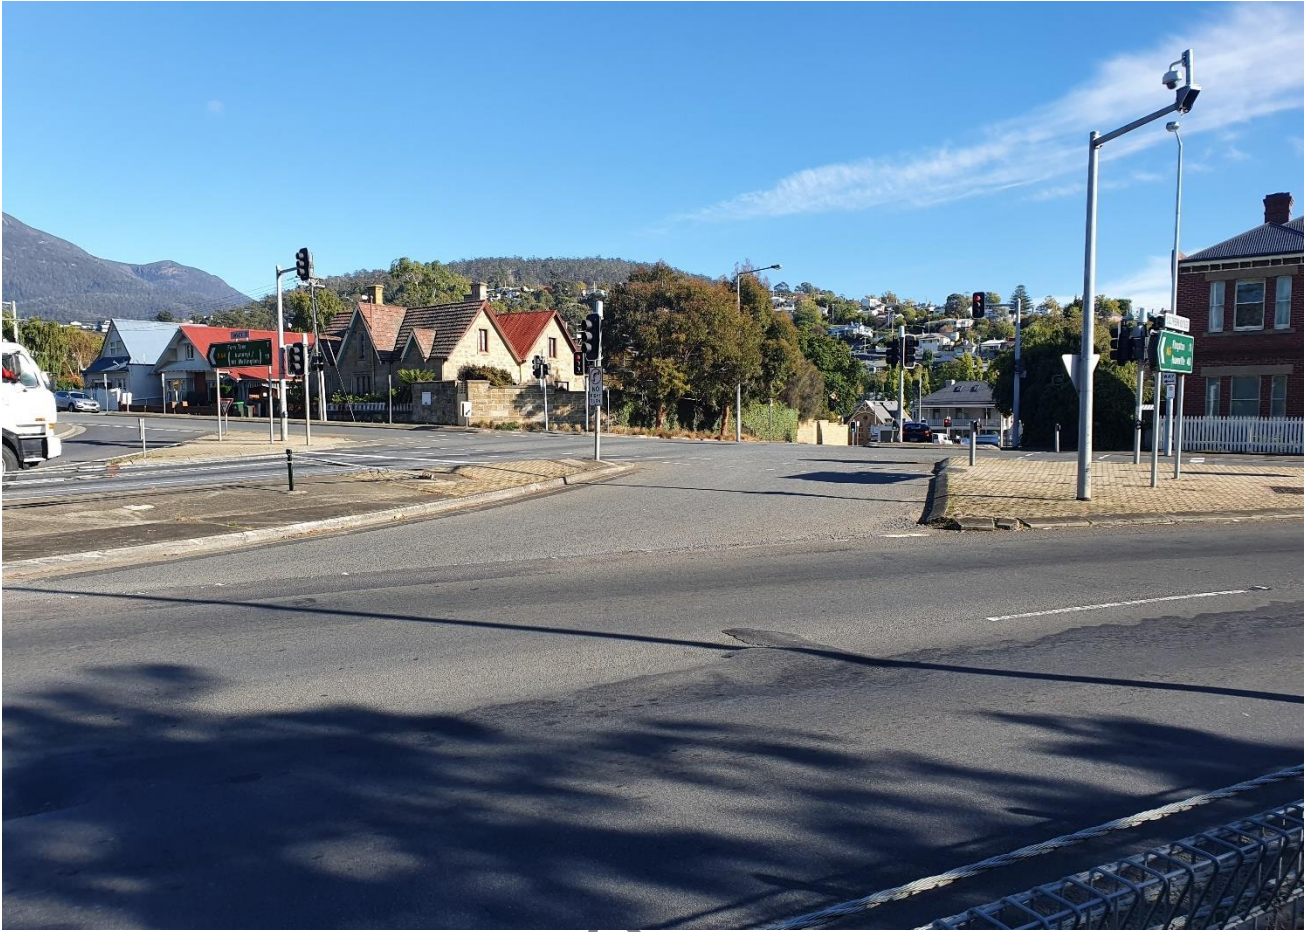
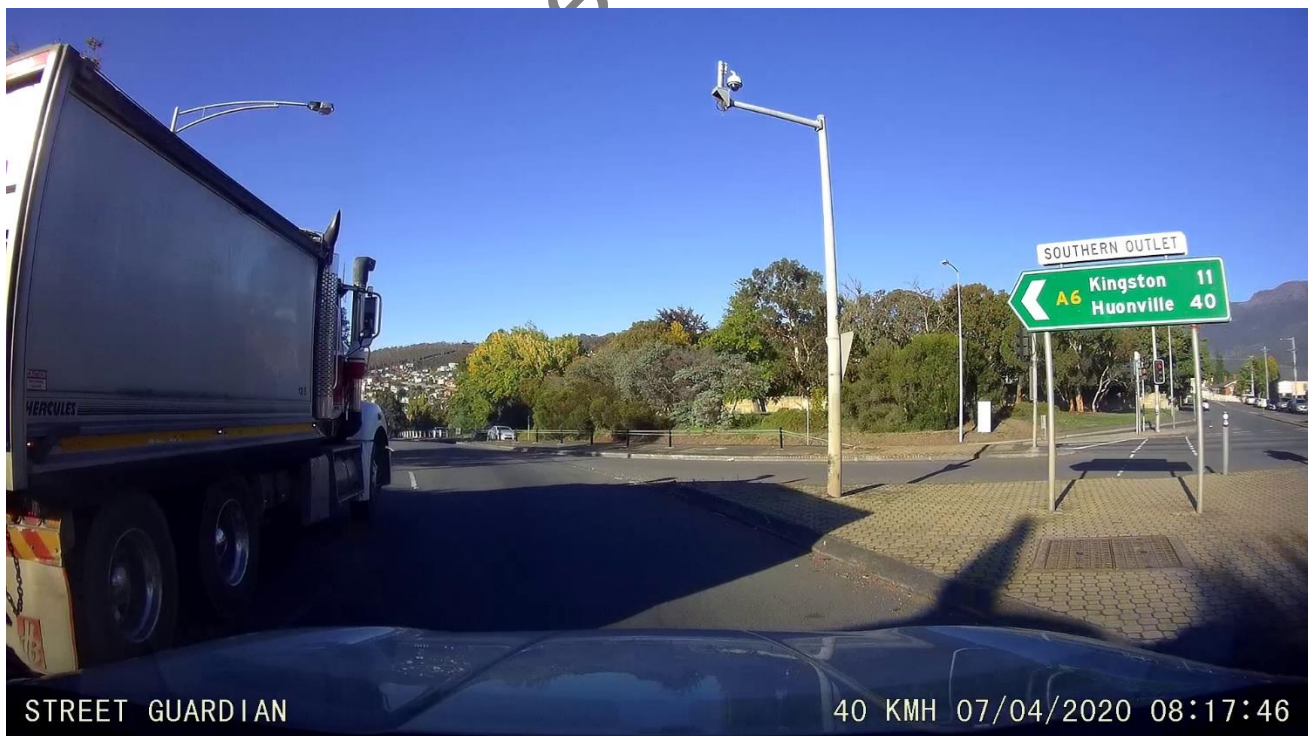
Item 2.2

Figure C.5 Davey Street Lane Merge

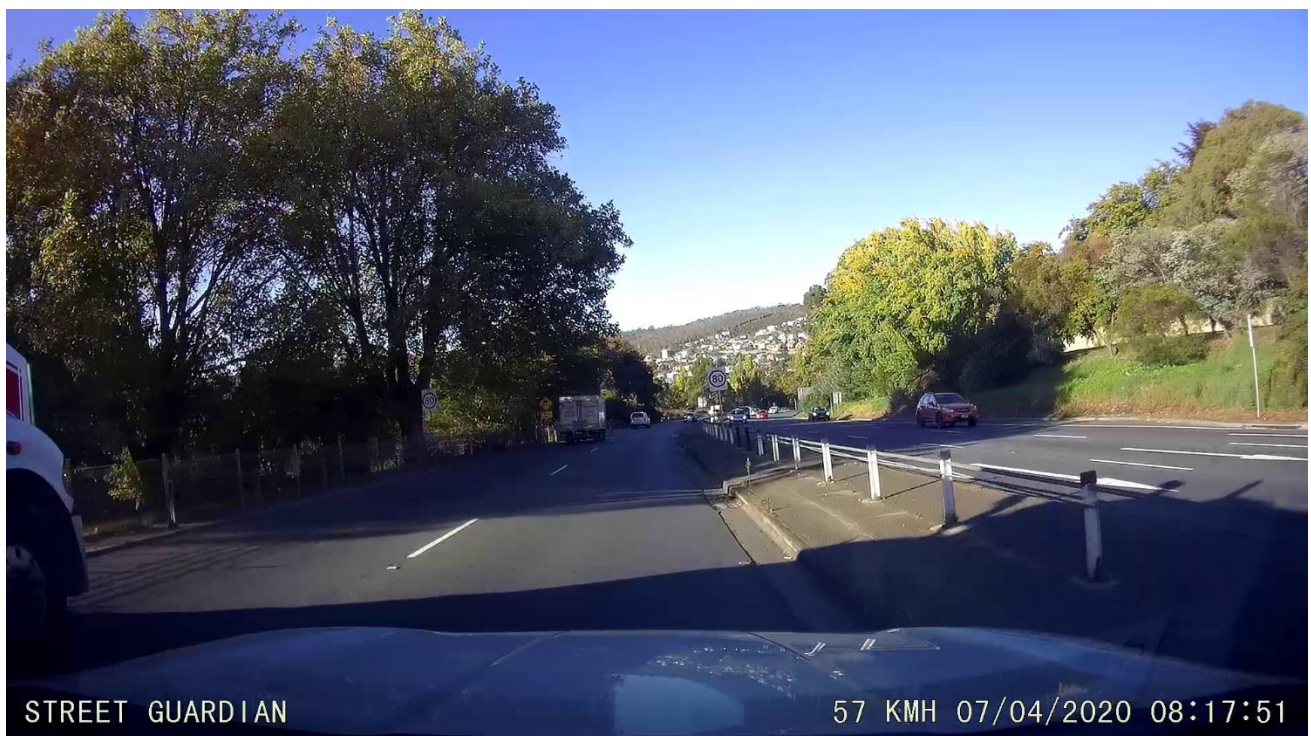
Item 2.3

ITEM	AUDIT FINDINGS	AUDIT RECOMMENDATIONS	FREQUENCY	SEVERITY	RISK	CLIENT RESPONSE	
						ACCEPT YES/NO	REASONS/COMMENTS
2.3.	The Tensioned Wire Rope Safety Barrier (TWRSB) in the median between Davey Street and the commencement of the concrete median barrier is located behind barrier kerb. An errant vehicle may vault the TWRSB into the opposing traffic lane due to the presence of the barrier kerb	Replace TWRSB and barrier kerb median with concrete safety barrier. Alternatively consideration could be given to investigating the removal of barrier kerb to remove the potential hazard it can pose.	Improbable	Catastrophic	High	Yes	Noted. The concept design is limited to widening works to create space for a transit lane in the northbound. It is not intended as an overall upgrade project of the Southern Outlet. There is no work proposed at this location at this time.

Figure C.7 Wire Rope Barrier and Kerb

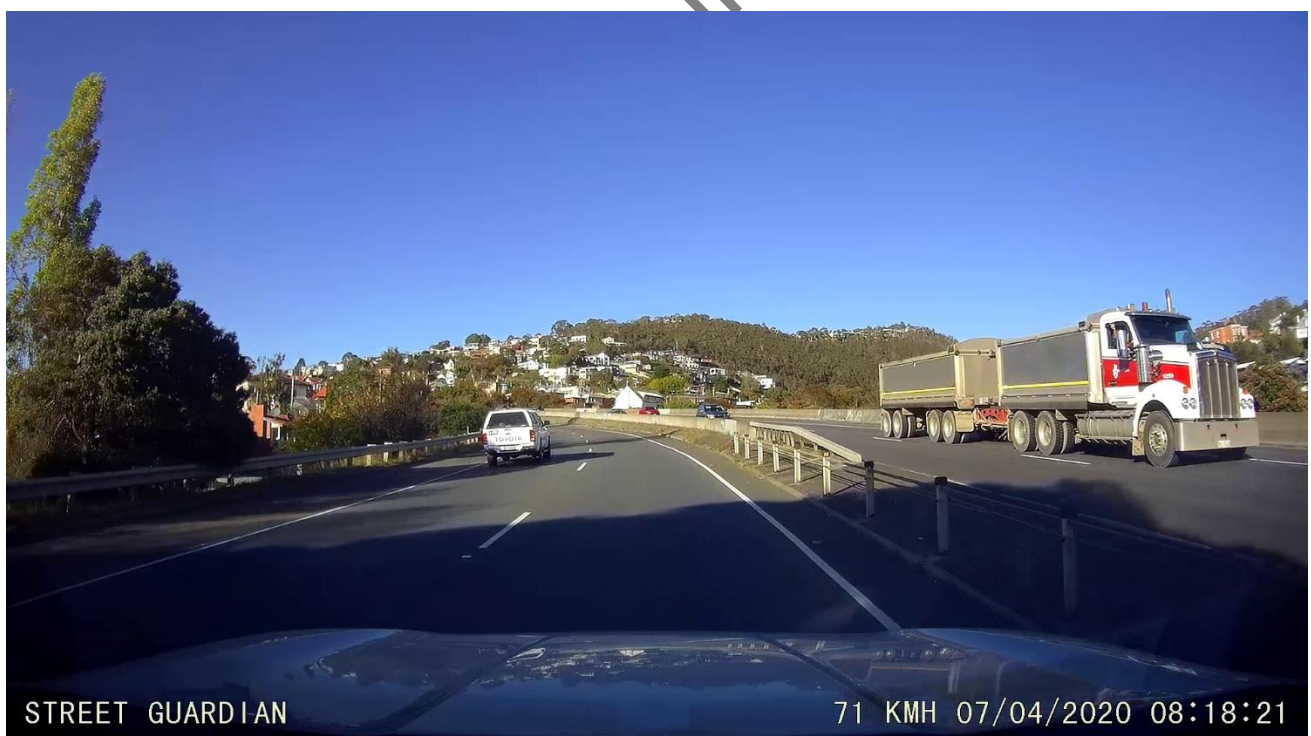
Item 2.4

2.4.	Steel box beam safety barrier forms part of the transition from TWRSB to concrete barrier in the median south of Lynton Avenue Overpass. The box beam arrangement may result in an errant southbound vehicle being launched in the event of an impact	Replace arrangement with a crash cushion	Improbable	Serious	Medium	Yes	Noted. The concept design is limited to widening works to create space for a transit lane in the northbound. It is not intended as an overall upgrade project of the Southern Outlet. There is no work proposed at this location at this time.

Figure C.8 Barrier End Terminal

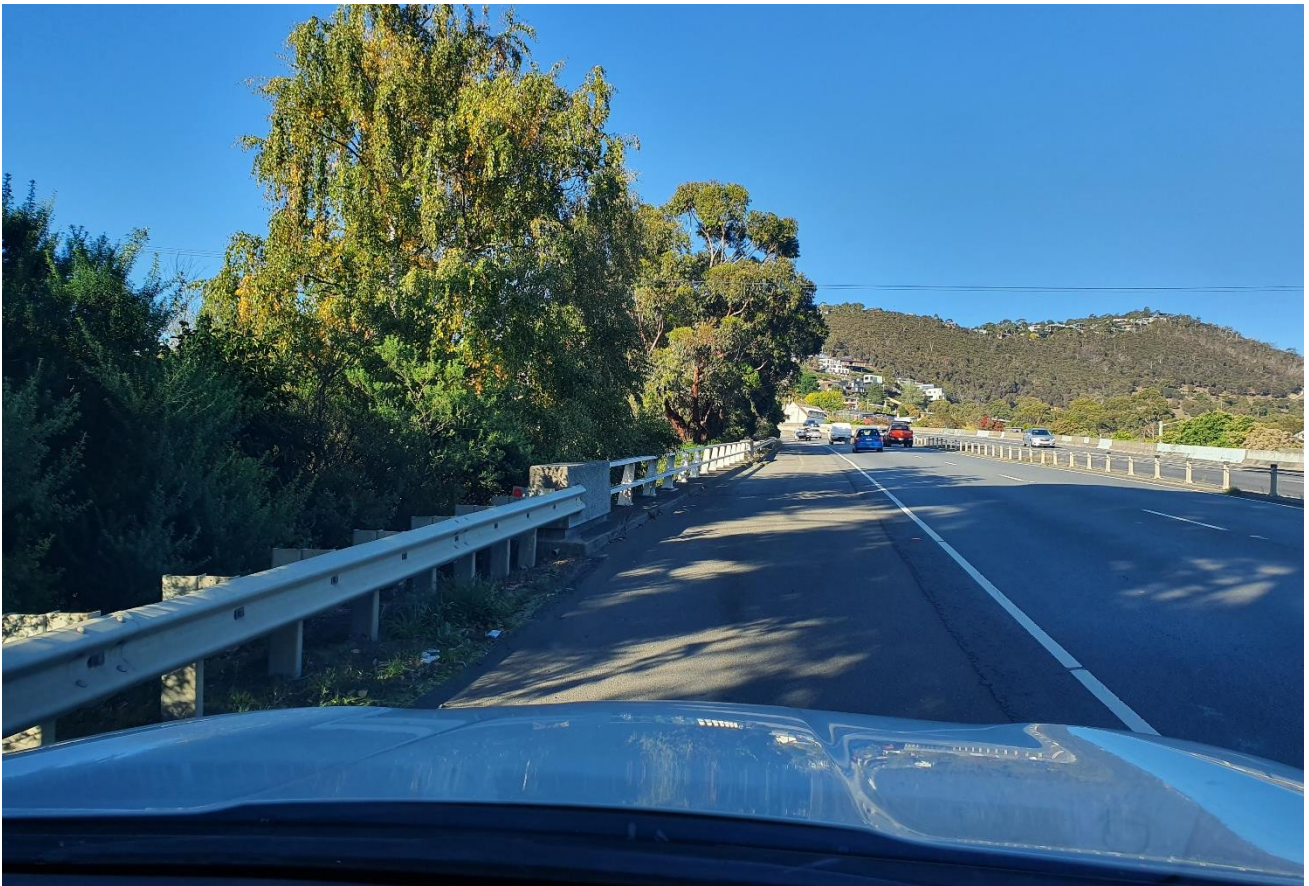
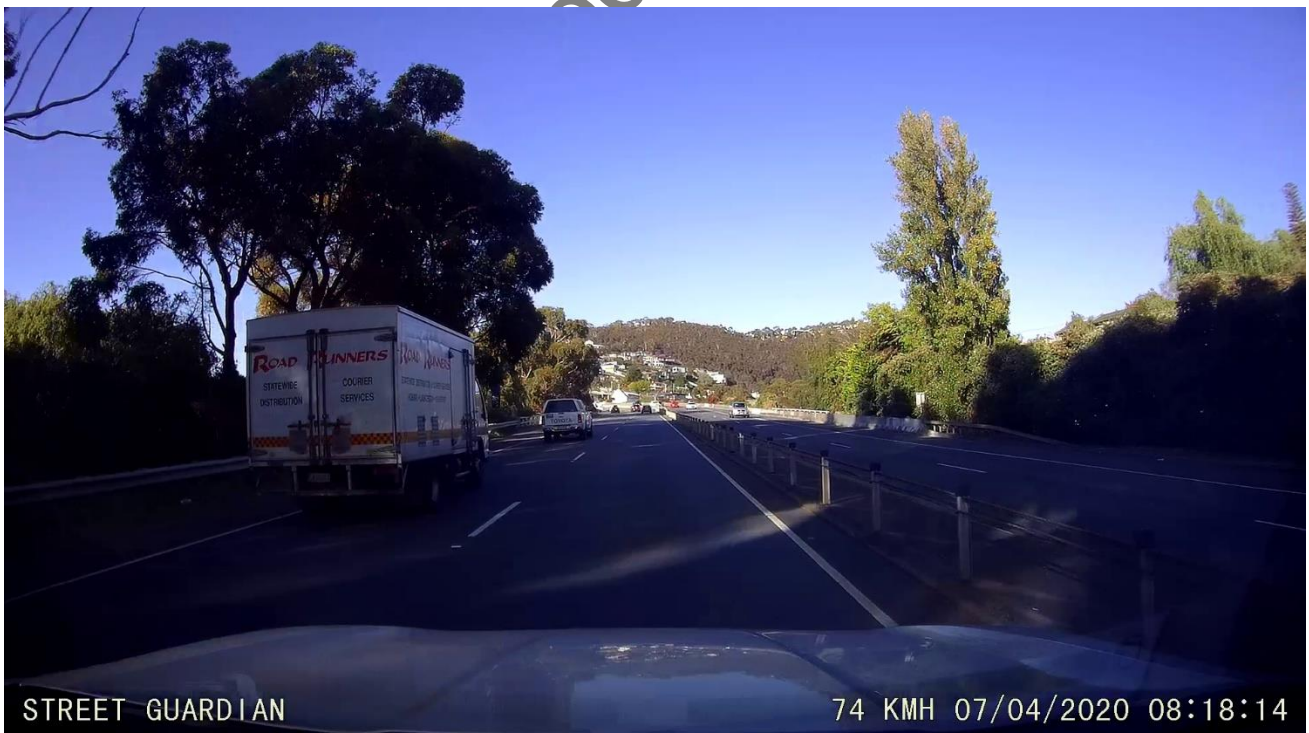
Item 2.5

2.5.	The safety barrier approach to the Lynton Avenue Overpass may not have sufficient stiffness to prevent an errant vehicle from colliding with the concrete parapet	Upgrade connection to provide double nested w-beam or thrie beam connection	Improbable	Serious	Medium	Yes	Noted. The concept design is limited to widening works to create space for a transit lane in the northbound. It is not intended as an overall upgrade project of the Southern Outlet. There is no work proposed at this location at this time.

Figure C.9 Safety Barrier

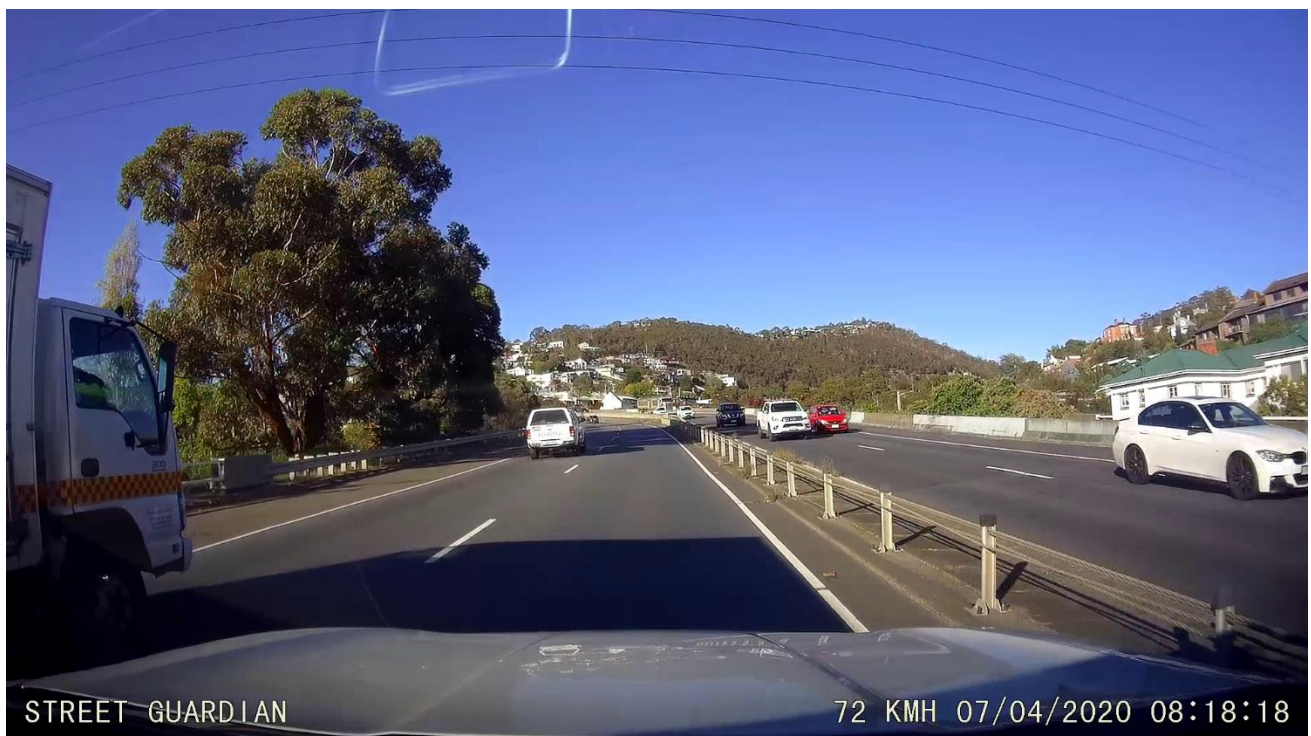
Item 2.6

2.6.	The safety barrier on the Lynton Avenue Overpass may not be sufficient for the high traffic volumes and percentage of heavy vehicles that use the road which may result in large vehicles breaking through the barrier	Upgrade safety barrier in accordance with AS5100	Improbable	Serious	Medium	Yes	Noted. The concept design is limited to widening works to create space for a transit lane in the northbound. It is not intended as an overall upgrade project of the Southern Outlet. There is no work proposed at this location at this time.

Figure C.11 Safety Barrier End Terminal

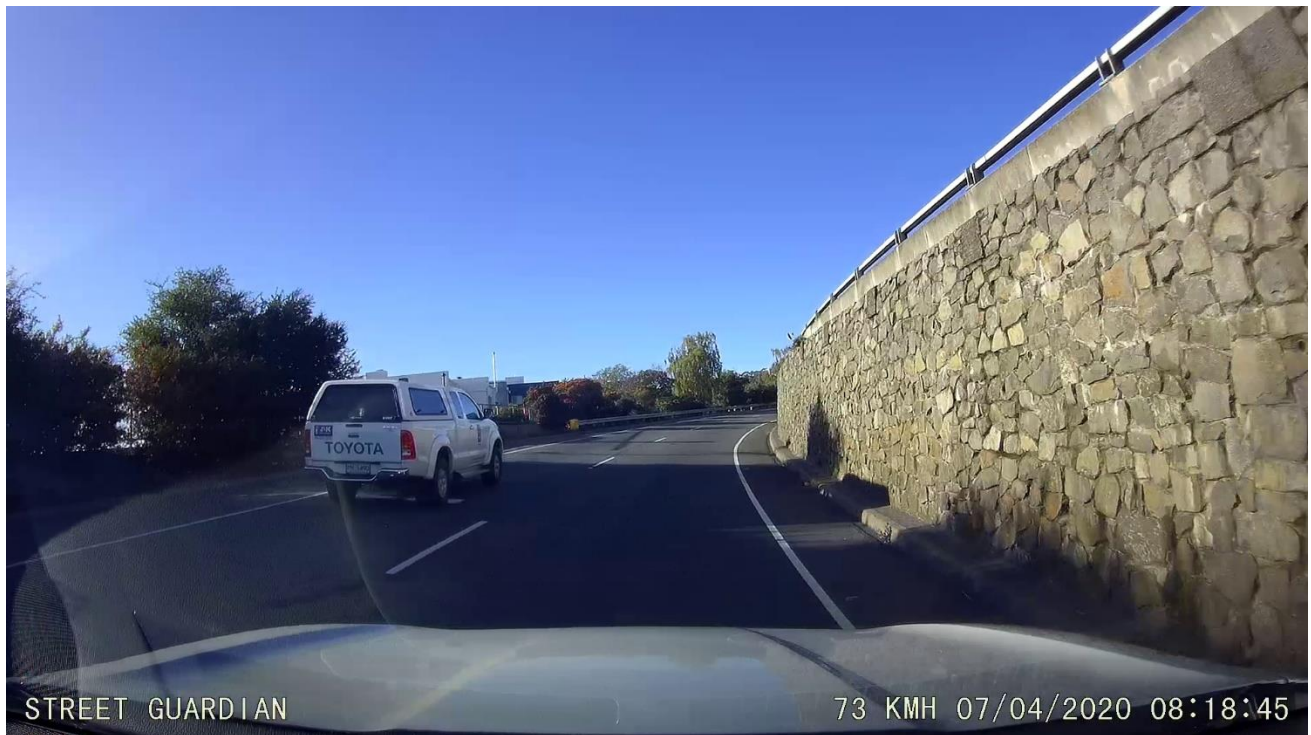
Item 2.8

Figure C.13 Safety Barrier Gap

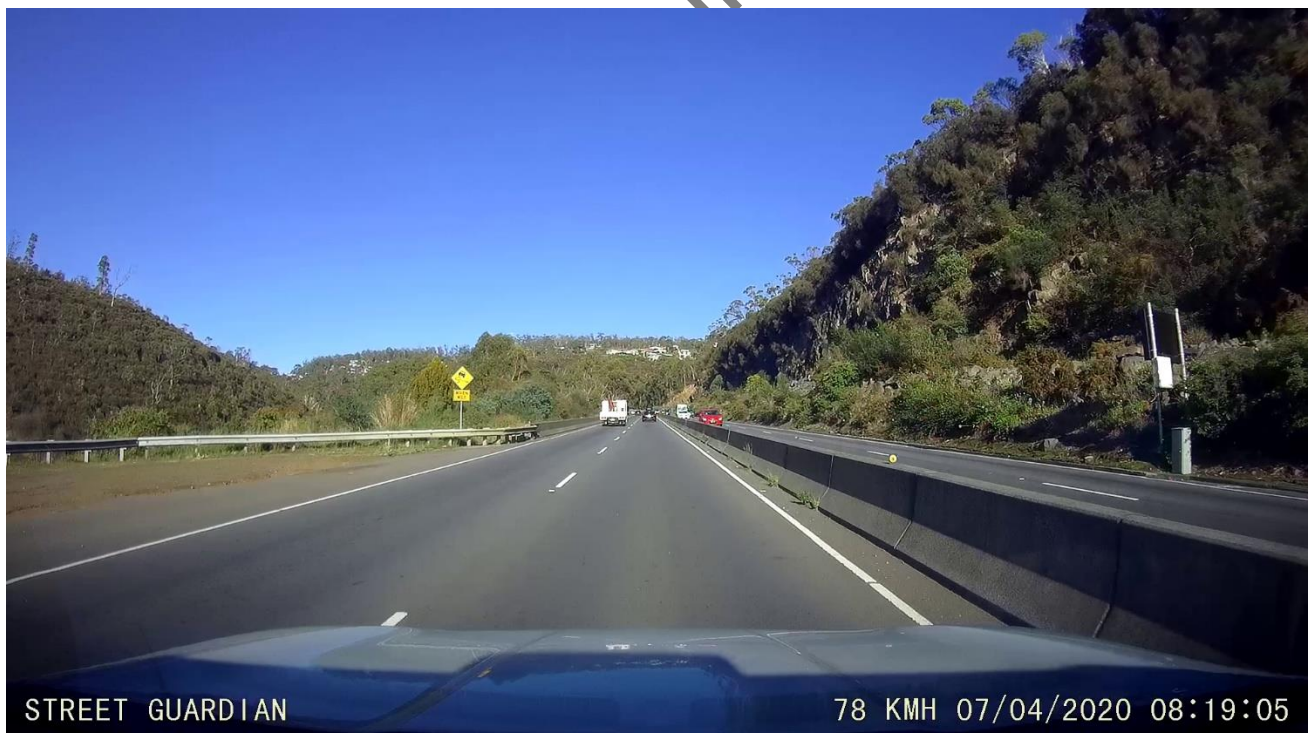
Item 2.9

2.9.	There is a pull-over area on the left hand side just before the start of the concrete safety barrier. The connection of the w-beam safety barrier to the concrete barrier is inadequate to prevent an errant vehicle colliding with the end of the concrete barrier	Taper concrete safety barrier on departure side or install crash cushion	Occasional	Serious	High	Yes	Noted. The concept design is limited to widening works to create space for a transit lane in the northbound. It is not intended as an overall upgrade project of the Southern Outlet. There is no work proposed at this location at this time.

Figure C.14 Safety Barrier End Terminal Near Pull-Over Area

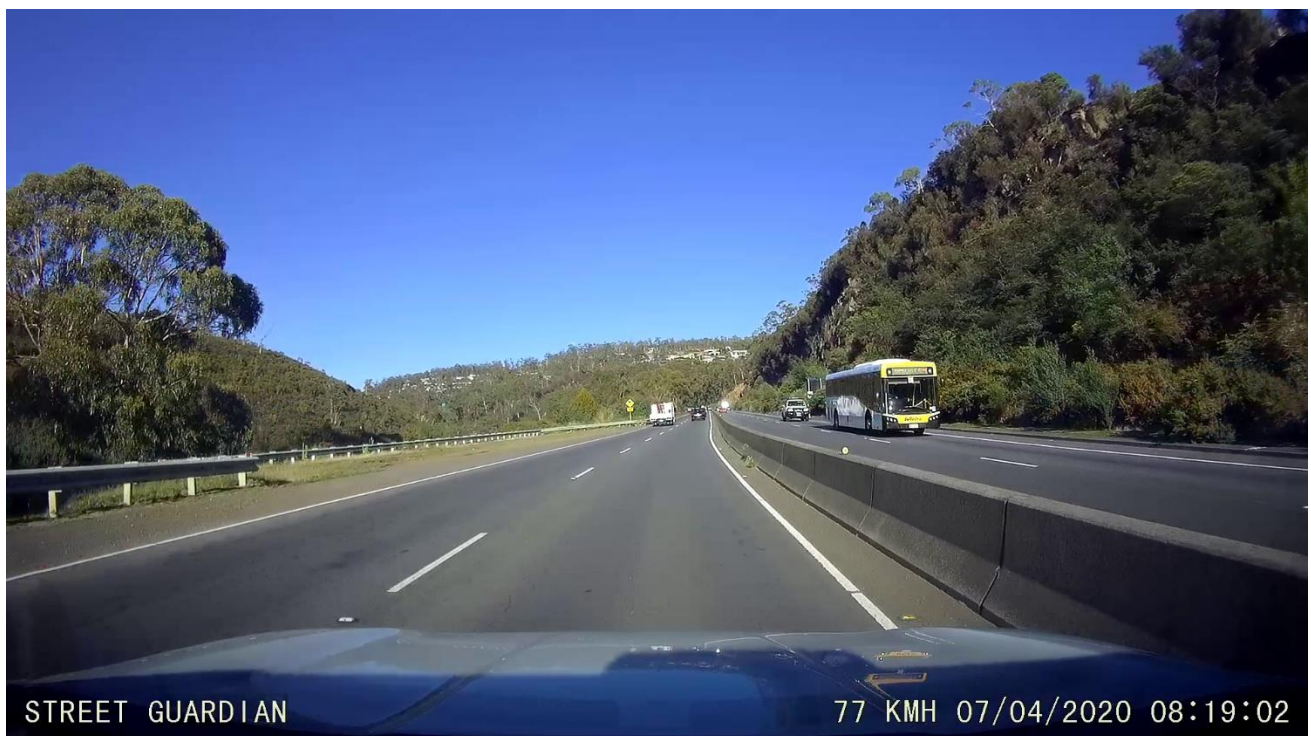
Item 2.10

ITEM	AUDIT FINDINGS	AUDIT RECOMMENDATIONS	FREQUENCY	SEVERITY	RISK	CLIENT RESPONSE	
						ACCEPT YES/NO	REASONS/COMMENTS
2.10.	Vehicles re-joining the road from the pull-over area need to accelerate on a steep grade and from an unsealed surface. This may result in an exiting vehicle being involved in a rear end collision	Seal pull-over area	Probable	Minor	High	Yes	Agreed, note added to drawing.

Figure C.15 Pull-Over Area

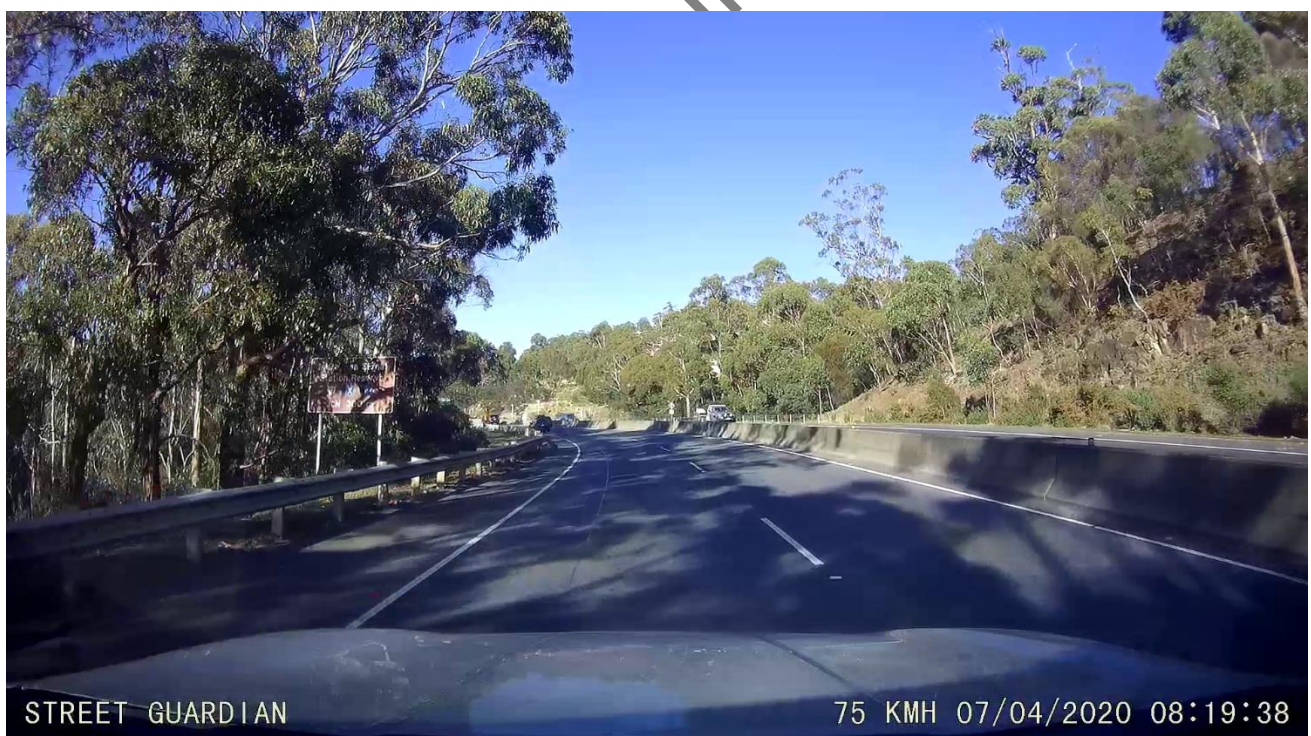
Item 2.12

2.12.	There is a tourist sign located just prior to the Olinda Grove Interchange that is partially obscured by vegetation	Trim vegetation	-	-	To Note.	Yes	Noted.

Figure C.16 Obscured Sign

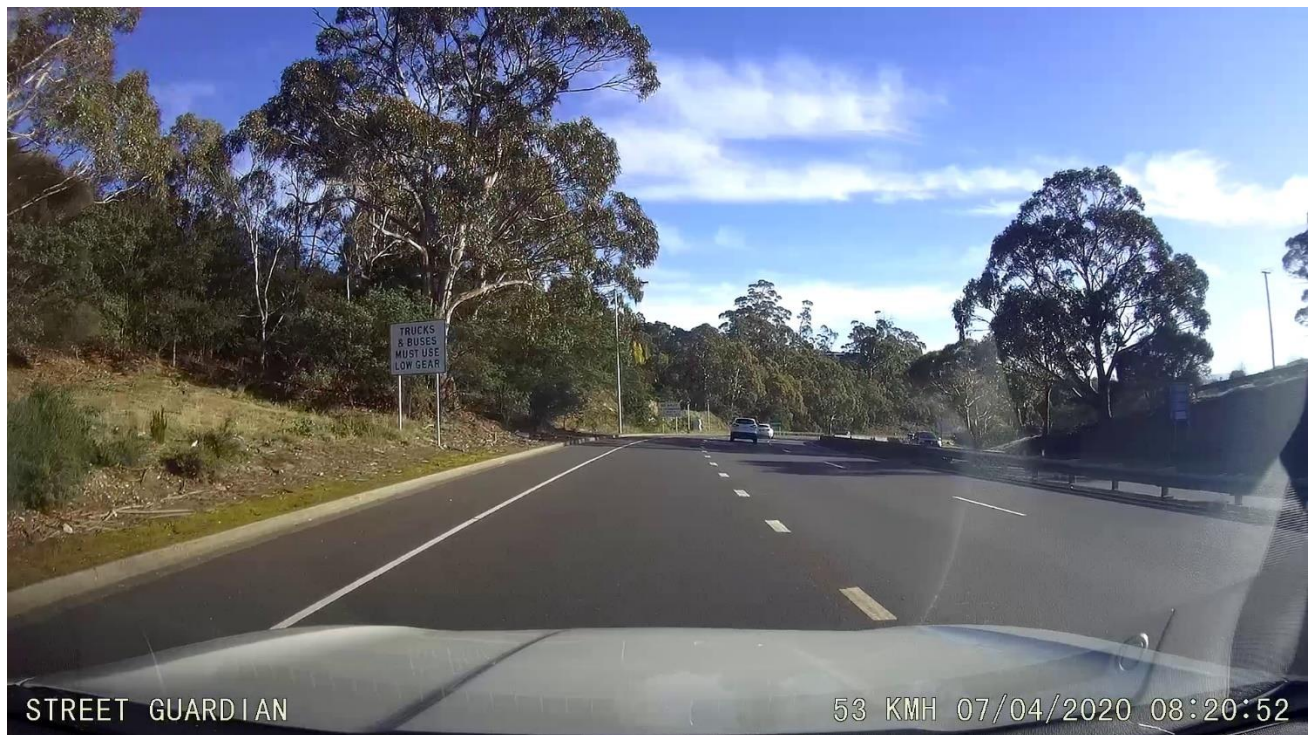
Item 3.1

Figure C.17 Northbound Merge from Olinda Grove

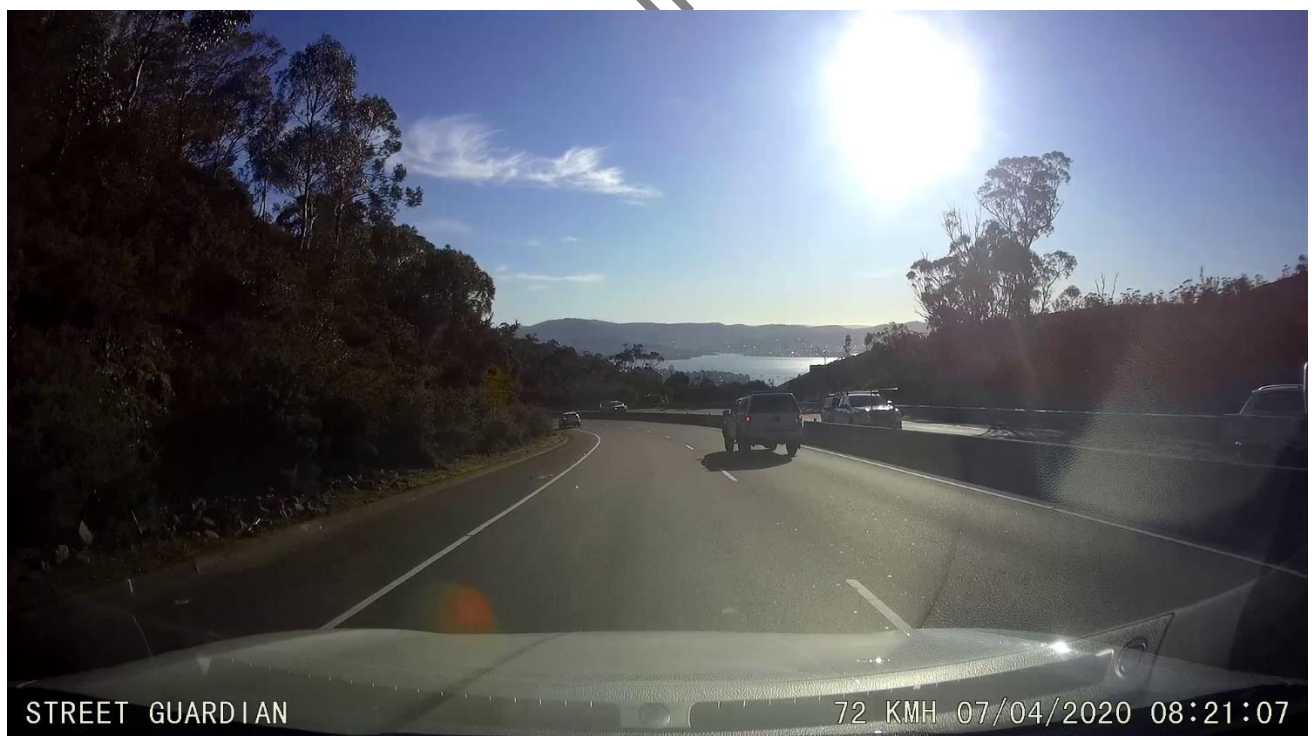
Item 3.4

Figure C.18 Obscured Sign

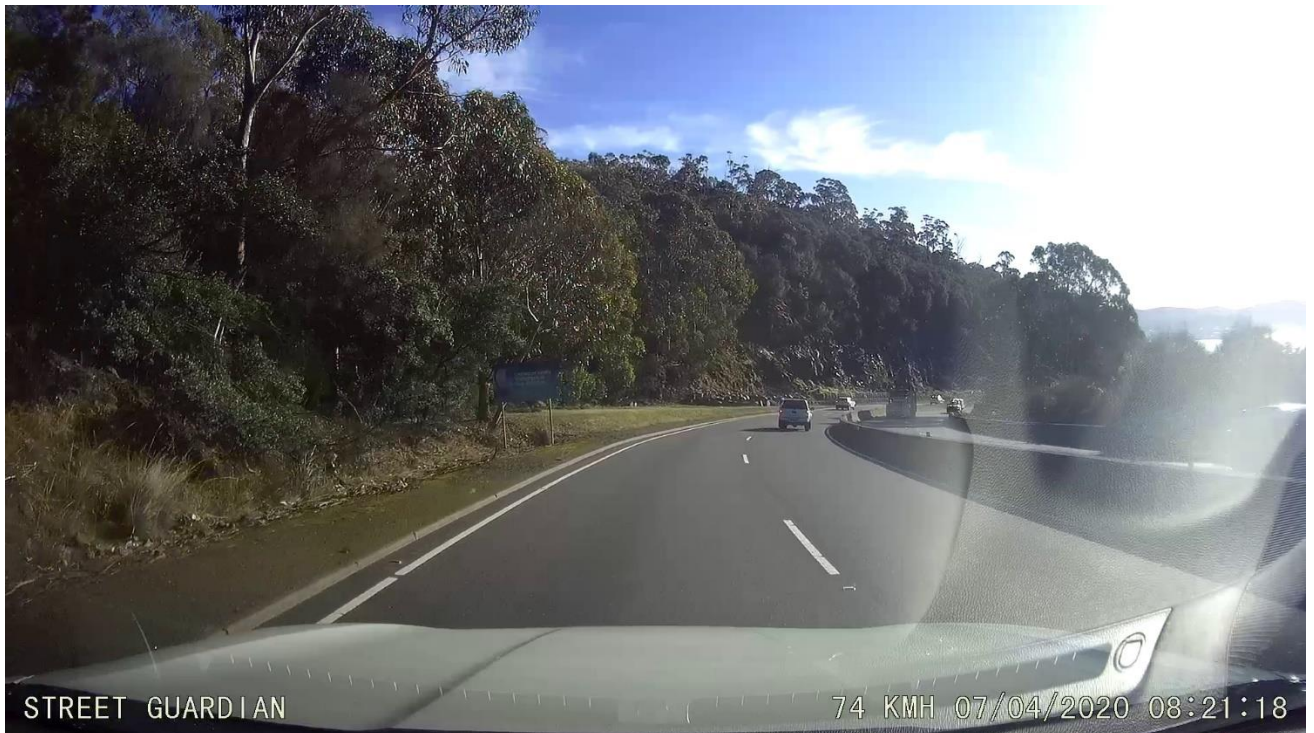
Item 3.5

3.5.	There is a TasWater advertising sign located on a tight right hand curve. The sign is distracting from the driving task which at this location is relatively demanding	Relocate or remove sign	-	-	To Note.	Yes	Noted. To be resolved in future stages of design under consultation with Taswater and DSG

Figure C.19 Sign

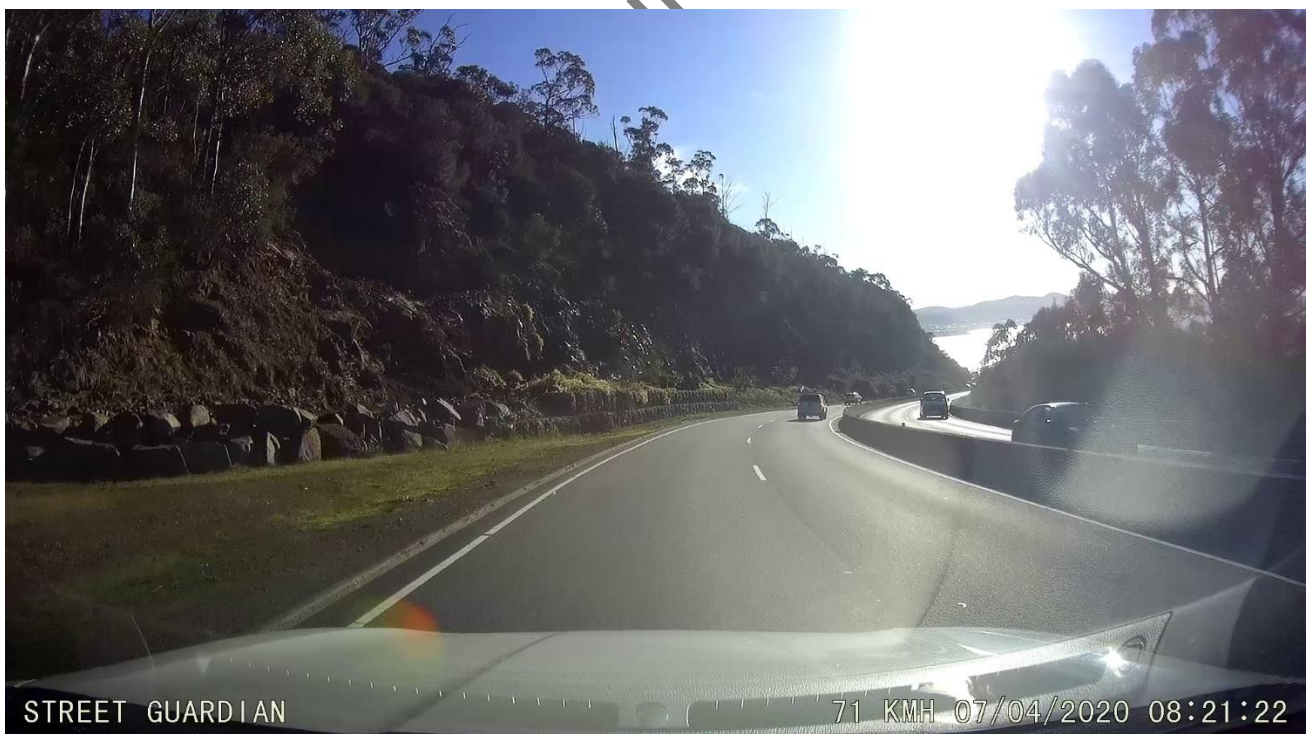
Item 3.6

ITEM	AUDIT FINDINGS	AUDIT RECOMMENDATIONS	FREQUENCY	SEVERITY	RISK	CLIENT RESPONSE	
						ACCEPT YES/NO	REASONS/COMMENTS
3.6.	There are large rocks and gabion baskets which have been placed close to the road on the outside of a horizontal curve to assist with rock fall protection from cutting behind. The rocks and gabion baskets are within the run off area for an errant vehicle and would increase the severity of a run off road crash	Install safety barrier	Occasional	Serious	High	Yes	Noted. The concept design is limited to widening works to create space for a transit lane in the northbound. It is not intended as an overall upgrade project of the Southern Outlet. Currently there is no barrier provided on the western side of the road (cut side).

Figure C.20 Rocks in clear zone
