MAY 2020

**HOBART CITY DEAL
SOUTHERN
PROJECTS
SUB-PROJECT 1:
SOUTHERN OUTLET
TRANSIT LANE
CONCEPT STAGE
ROAD SAFETY
AUDIT**

Hobart City Deal
Southern Projects
Sub-Project 1: Southern Outlet Transit Lane
Concept Stage
Road Safety Audit

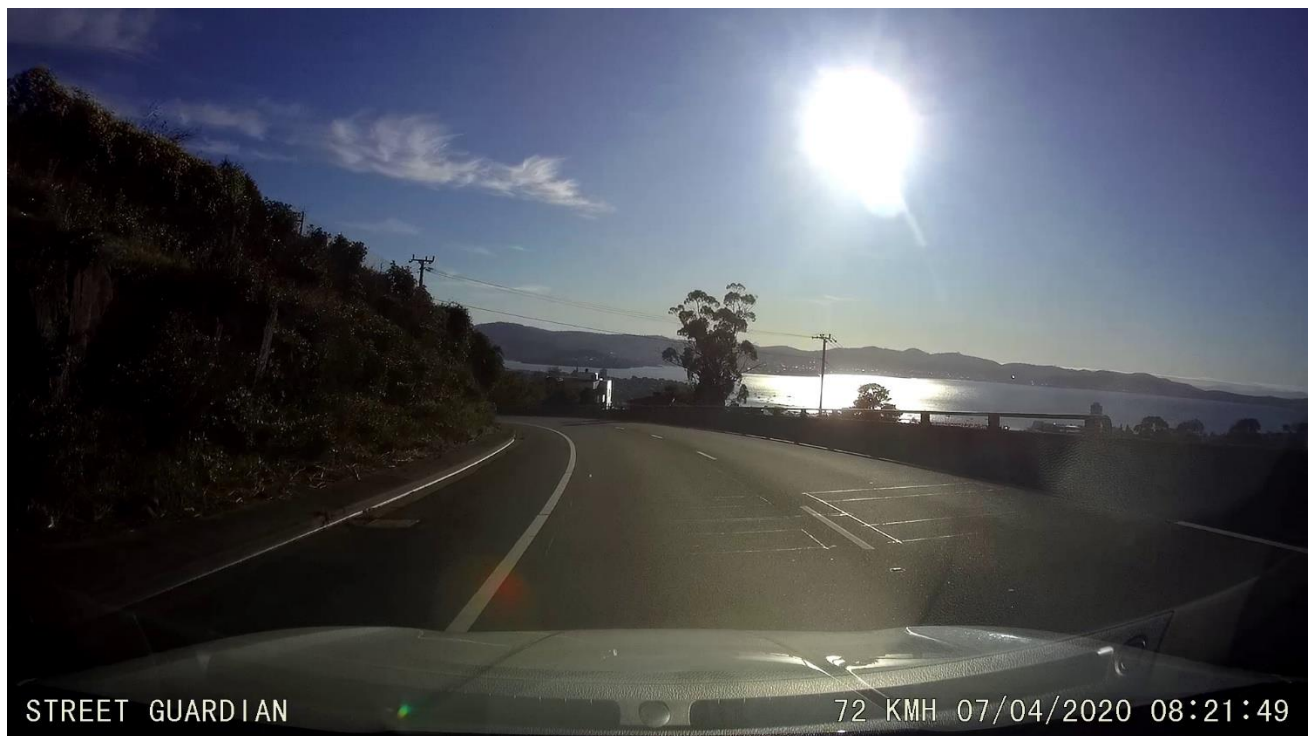
Item 3.7

3.7.	There are exposed rock cuttings adjacent to the road which are a hazard to an errant vehicle	Install safety barrier	Occasional	Minor	Medium	Yes	As above.

Figure C.21 Rocky Outcrop

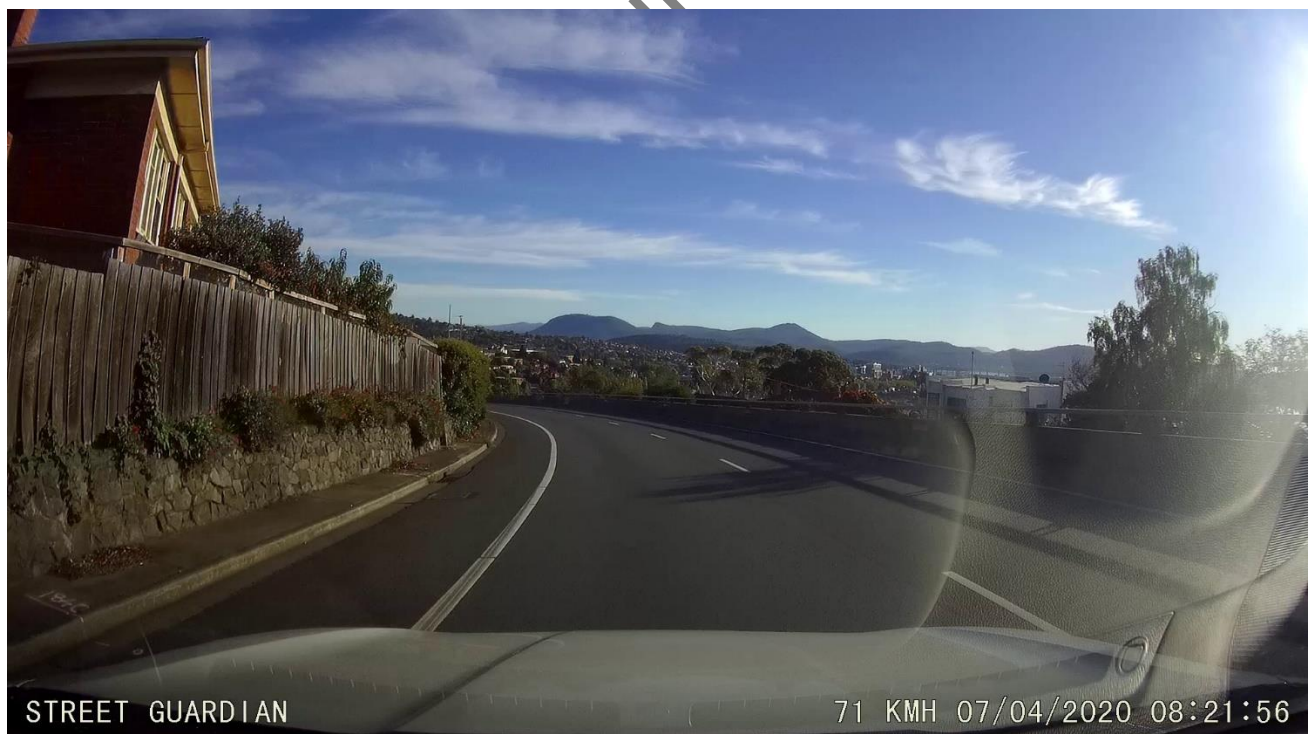
Item 3.8

Figure C.22 Retaining Wall in Crash Zone

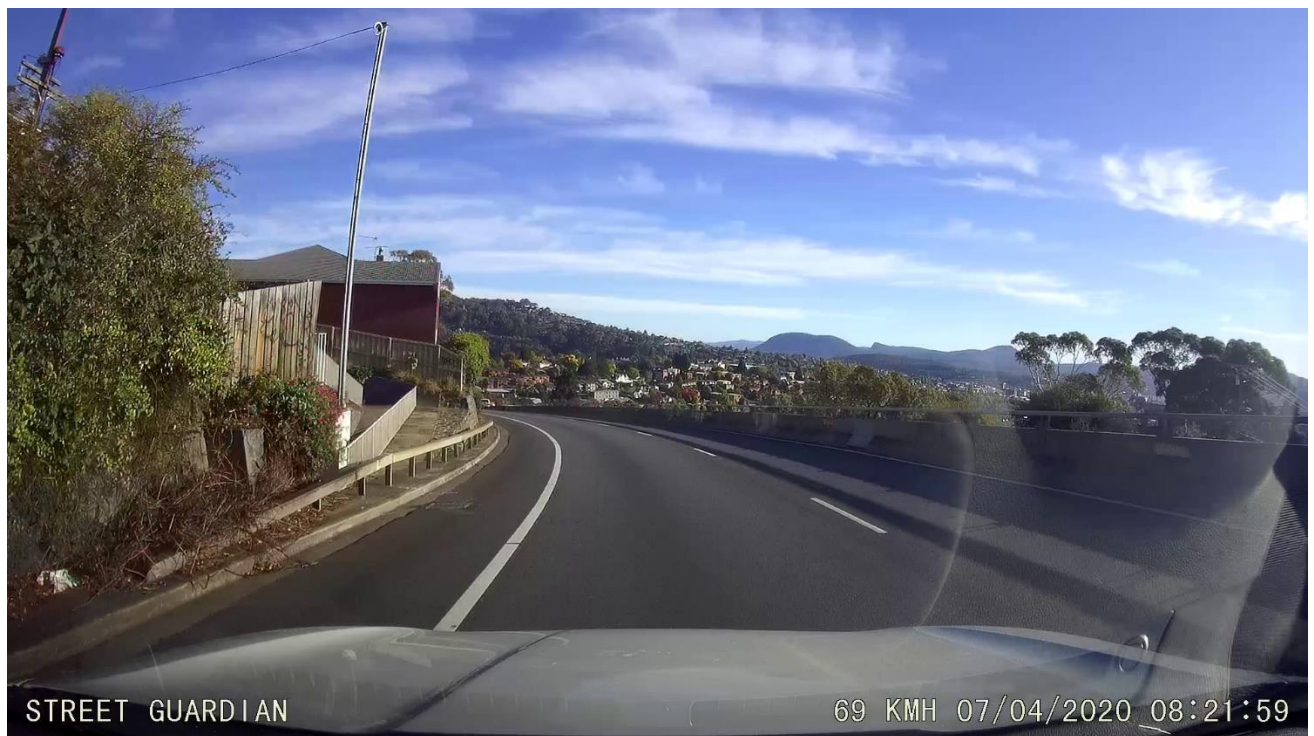
Item 3.9

3.9.	There is a steel box beam safety barrier near the pedestrian underpass. The box beam is inadequate to protect an errant vehicle from entering the space near the entrance to the pedestrian underpass	Install concrete safety barrier	Occasional	Serious	High	Yes	Barrier in design to be continuous through this area

Figure C.23 Safety Barrier

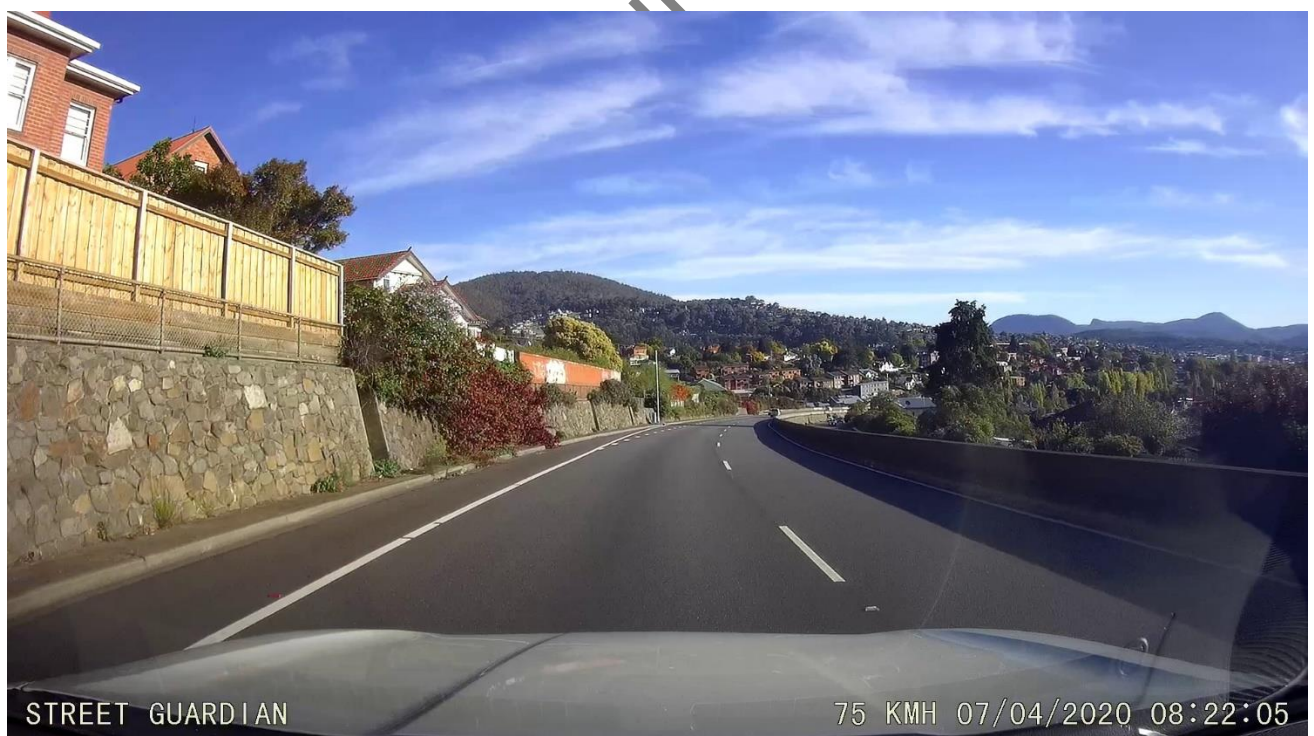
Item 3.10

Figure C.24 Wall in Crash Zone

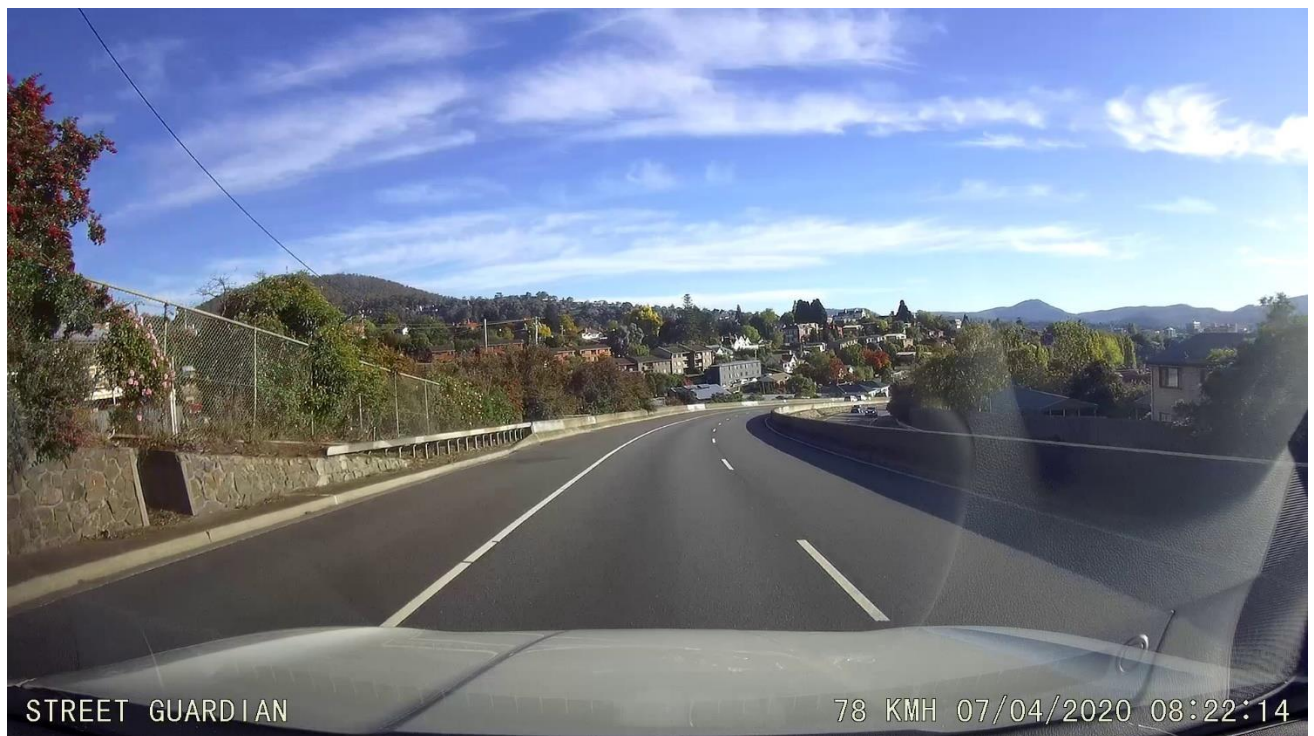
Item 3.11

ITEM	AUDIT FINDINGS	AUDIT RECOMMENDATIONS	FREQUENCY	SEVERITY	RISK	CLIENT RESPONSE	
						ACCEPT YES/NO	REASONS/COMMENTS
3.11.	There is a steel box beam safety barrier on the approach to the concrete safety barrier south of Lynton Avenue Overpass. The interaction of the barrier kerb, box beam barrier and transition on the concrete barrier may result in an errant vehicle being launched in the event of a collision	Upgrade connection to provide double nested w-beam or thrie beam connection	Occasional	Serious	High	Yes	Noted. The concept design is limited to widening works to create space for a transit lane in the northbound. It is not intended as an overall upgrade project of the Southern Outlet. There is no work proposed at this location at this time.

Figure C.25 Safety Barrier

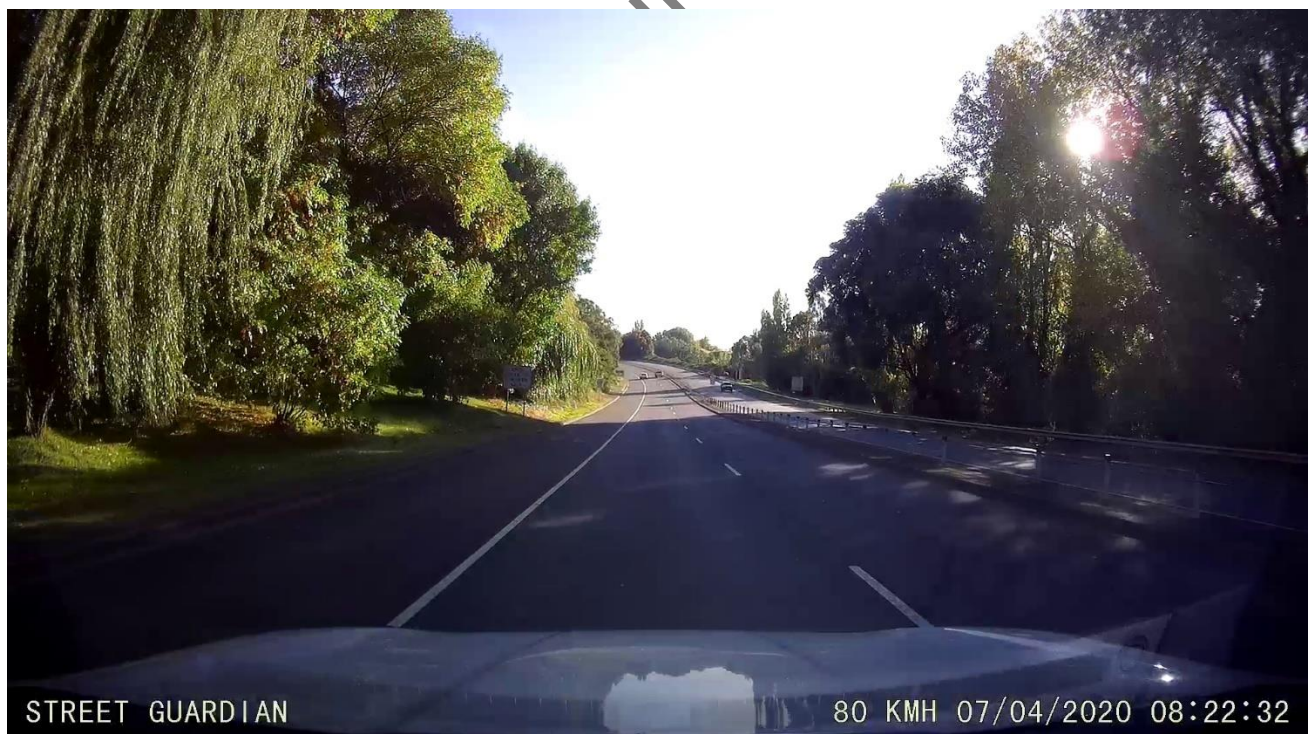
Item 3.12

3.12.	There are multiple roadside signs between Lynton Avenue Overpass and Davey Street which are obscured by vegetation or have poor illuminance	Trim or remove vegetation. Replace signs with poor illuminance.	-		To Note.	Yes	Vegetation should be maintained/remediated in construction

Figure C.26 Obscured Signs

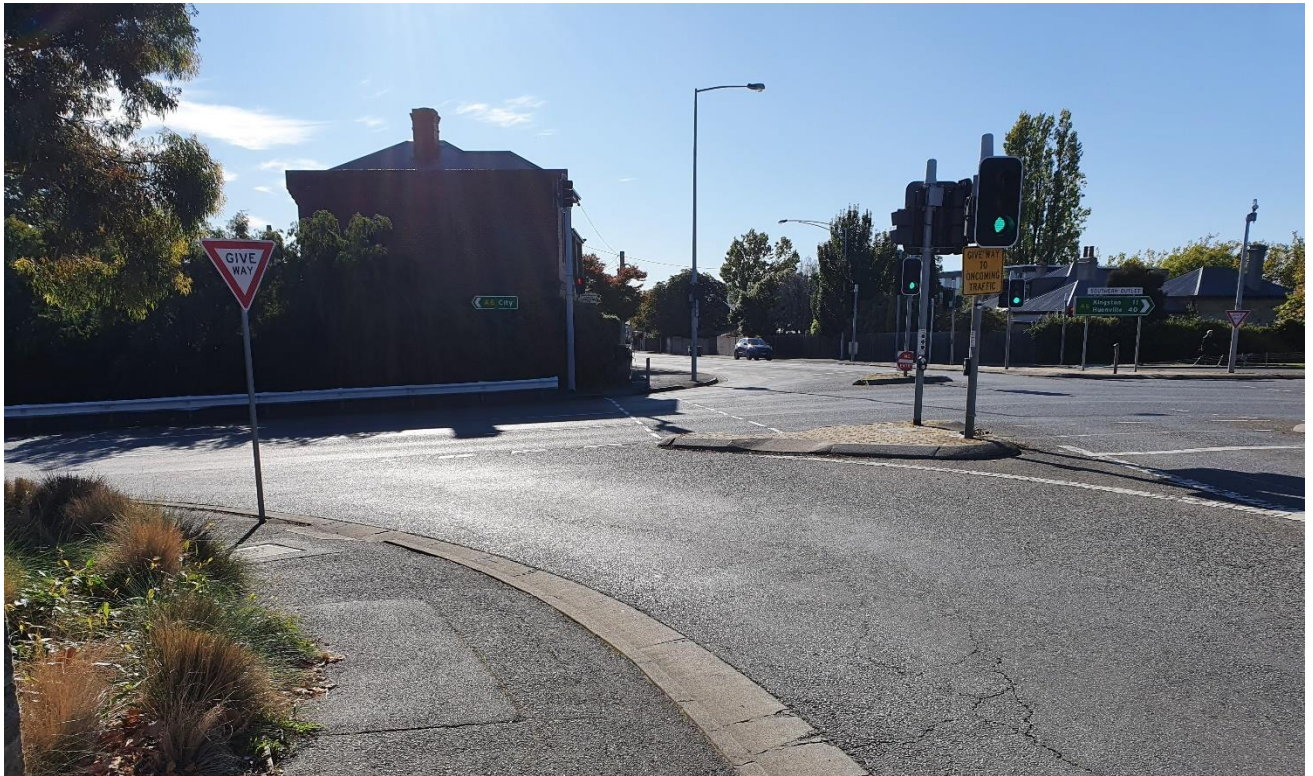
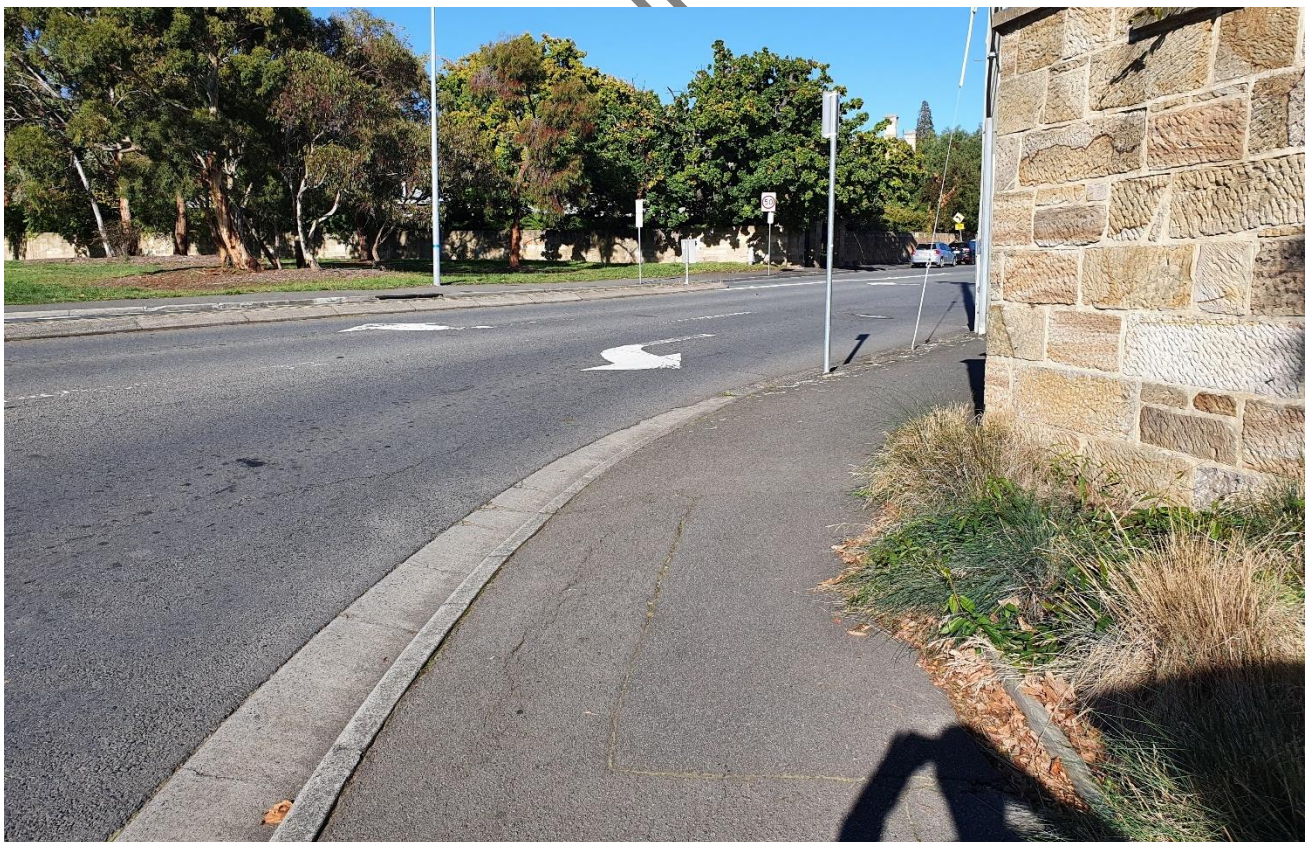
Item 3.13

Figure C.27 Davey Street Uncontrolled Pedestrian Crossing

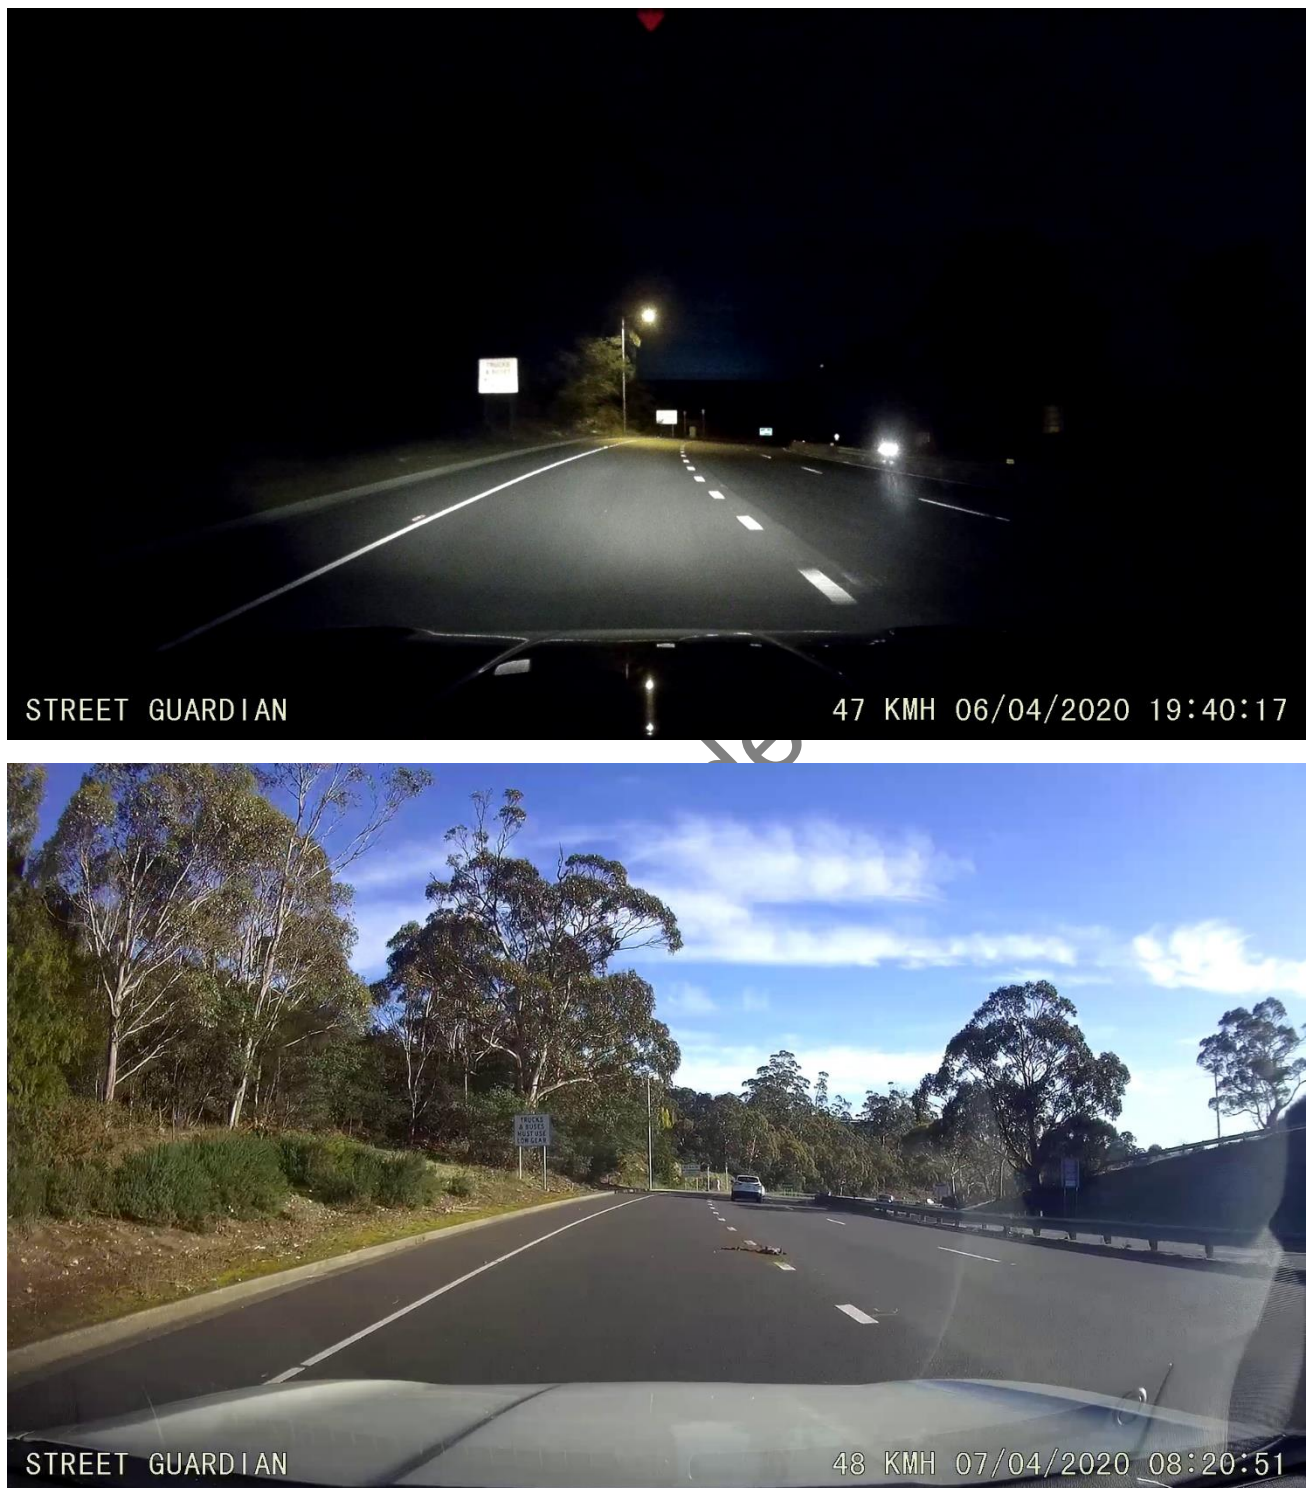
Item 3.14

ITEM	AUDIT FINDINGS	AUDIT RECOMMENDATIONS	FREQUENCY	SEVERITY	RISK	CLIENT RESPONSE	
						ACCEPT YES/NO	REASONS/COMMENTS
3.14.	<p>Bushland directly interfacing with the northbound side of the Southern Outlet may allow for an increased likelihood of wildlife travelling onto the road creating obstructions to vehicle leading to potential accidents. Existing evidence of roadkill indicates that this may be a frequent occurrence.</p> <p>Inspection of the site indicated that between the nighttime and day time visits, wildlife was hit along a section of the road indicating the possibility of this occurring.</p>	<p>Provide warning signage that wildlife may enter the road reserve in order to alert drivers to be aware.</p> <p>Alternatively create a barrier to prevent wildlife accessing the road</p>	Occasional	Minor	Medium	Yes	Signage to be reviewed in future stages of design

Figure C.29 Impacted Wildlife – Comparison between night and day inspection
