AFL High Performance Centre
Rosny, Tasmania

Aboriginal Heritage Assessment Report
Final Draft Version 1

Project name		AFL High Performance Centre Strategic Alignment					
Document title		AFL High Performance Centre Rosny Parklands Option 2 Geotechnical Review					
Project number		12626209					
File name		12626209-REP_AFL HPC Geotechnical Review & Investigation Scoping.docx					
Status Code	Revision	Author	Reviewer		Approved for issue		
			Name	Signature	Name	Signature	Date
S4	0	Out of scope	Out of scope	Out of scope	Out of scope	Out of scope	20/02/24
[Status code]							
[Status code]							
[Status code]							
[Status code]

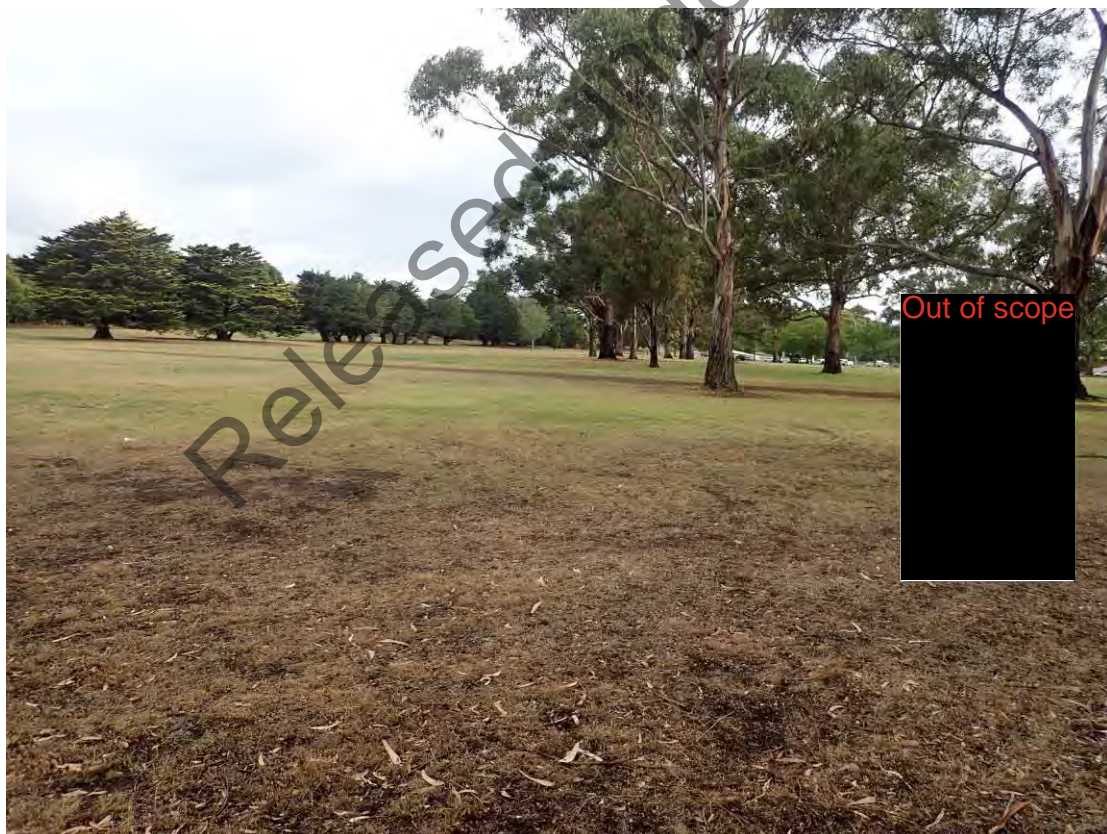
Plate 9: View north across the southern portion of the study area, where visibility averaged 20%

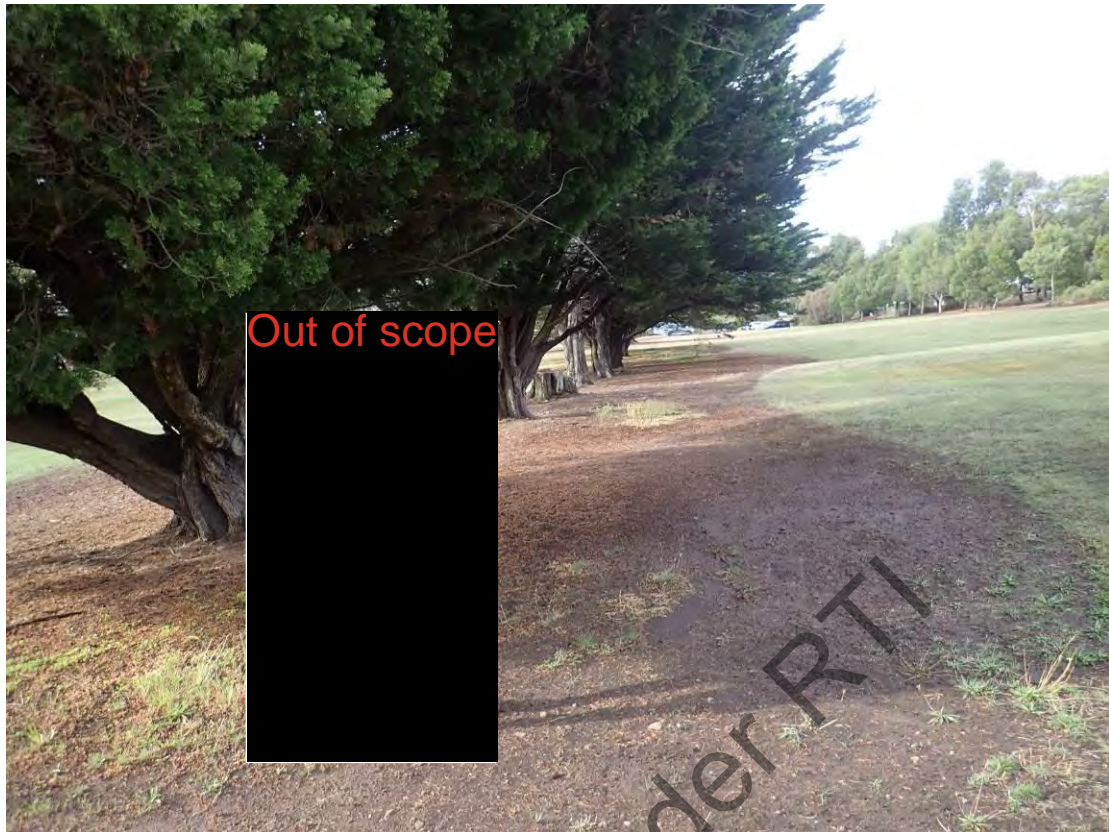
Plate 10: View north at erosion scalds around trees in the southern portion of the study area providing improved visibility

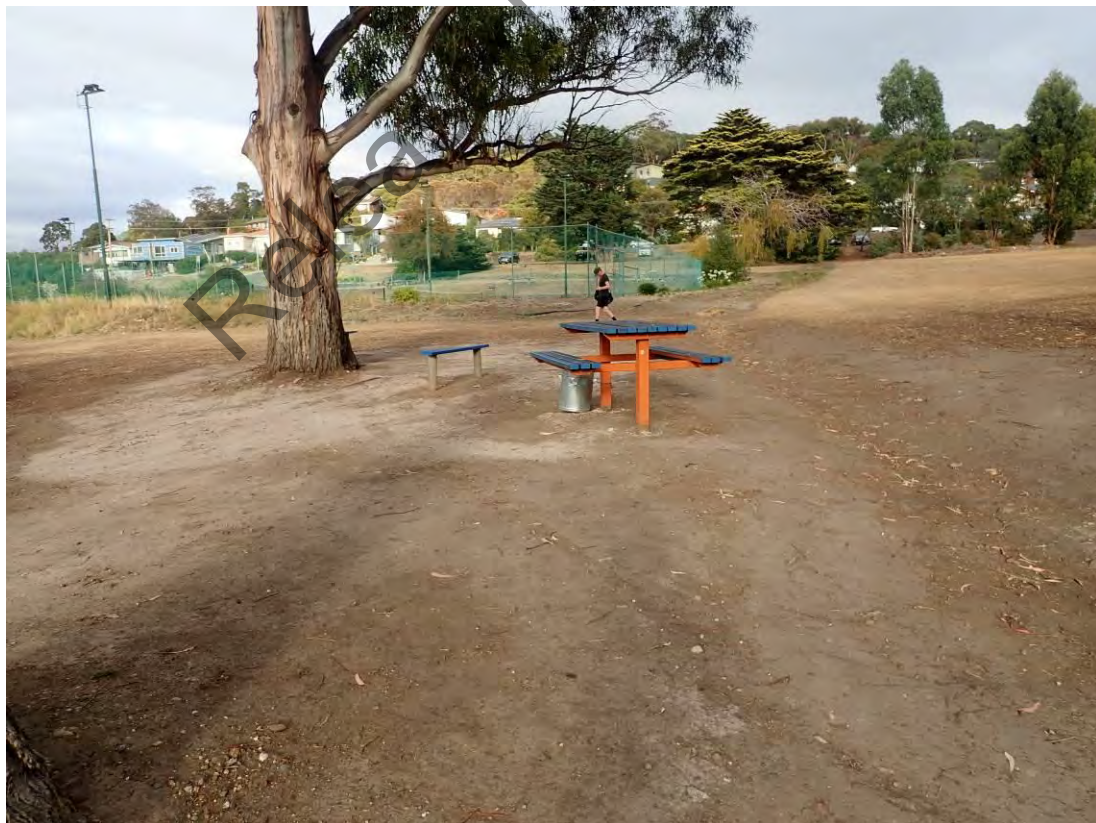
Plate 11: View west at erosion scalds in the southern portion of the study area providing improved visibility

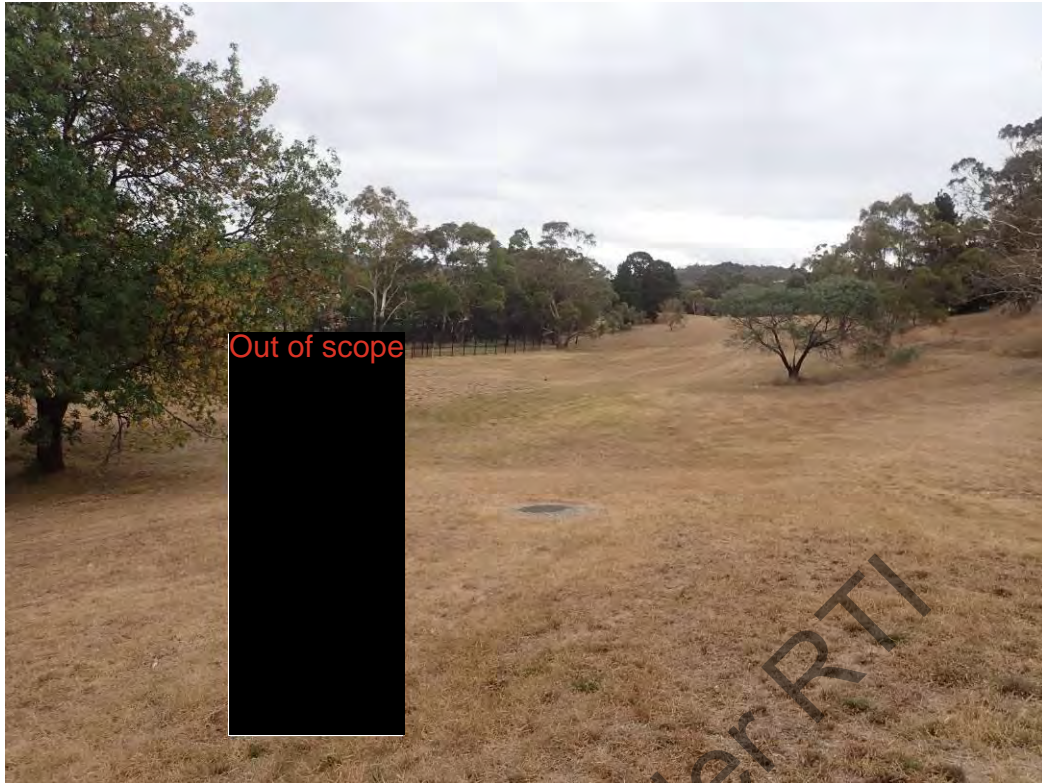
Plate 12: View north-west across the north part of the study area, with visibility at 30%

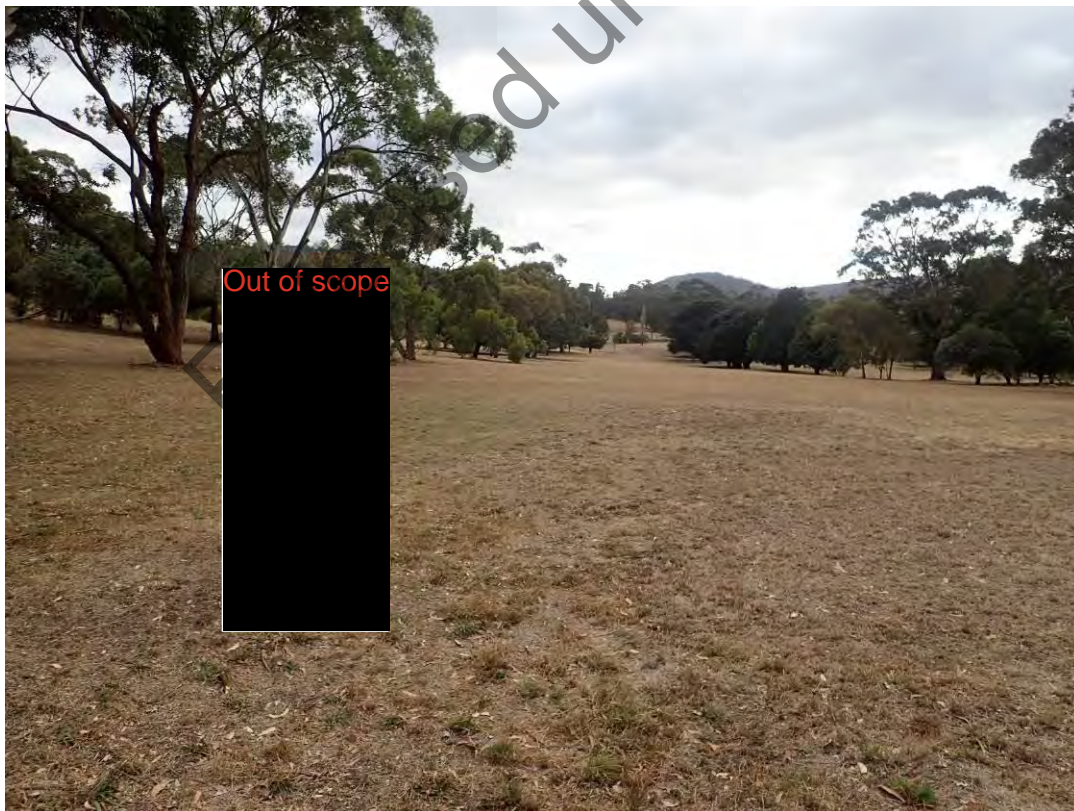
Plate 13: View north-west showing typical surface visibility in the north part of the study area

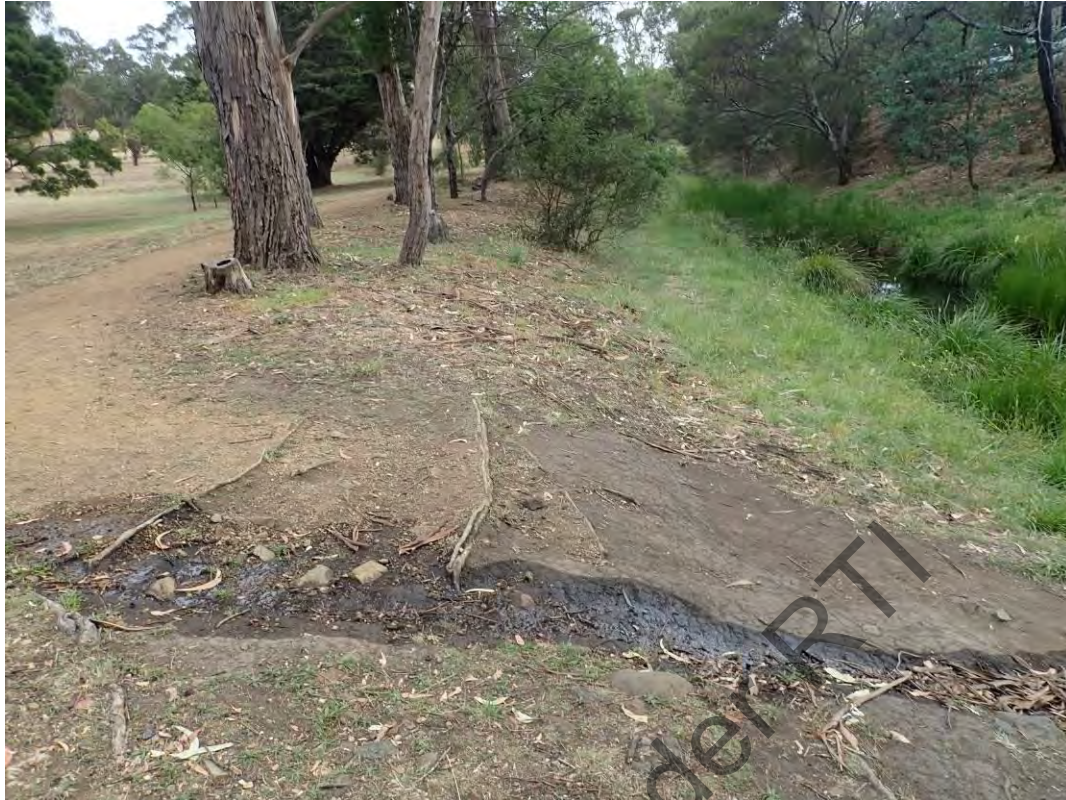
Plate 14: View north-west at erosion scalds along Kangaroo Bay Rivulet in the north of the study area providing locales of improved visibility

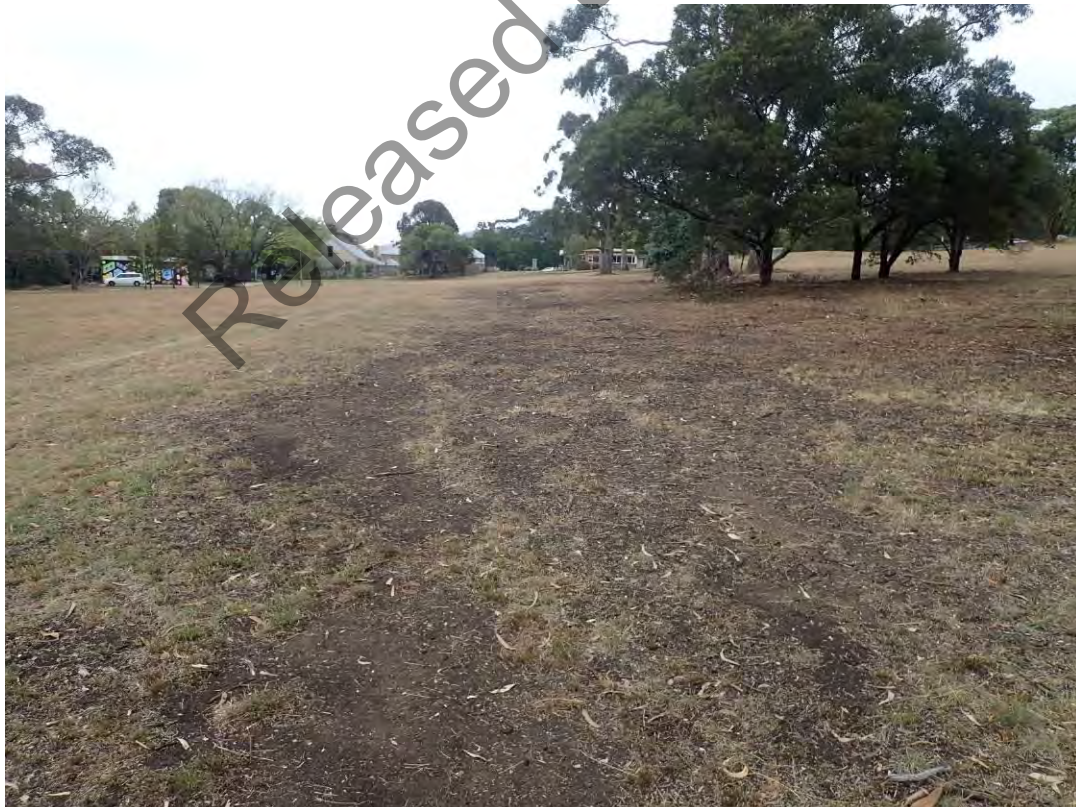
Plate 15: View south at erosion scalds in the north of the study area providing improved visibility

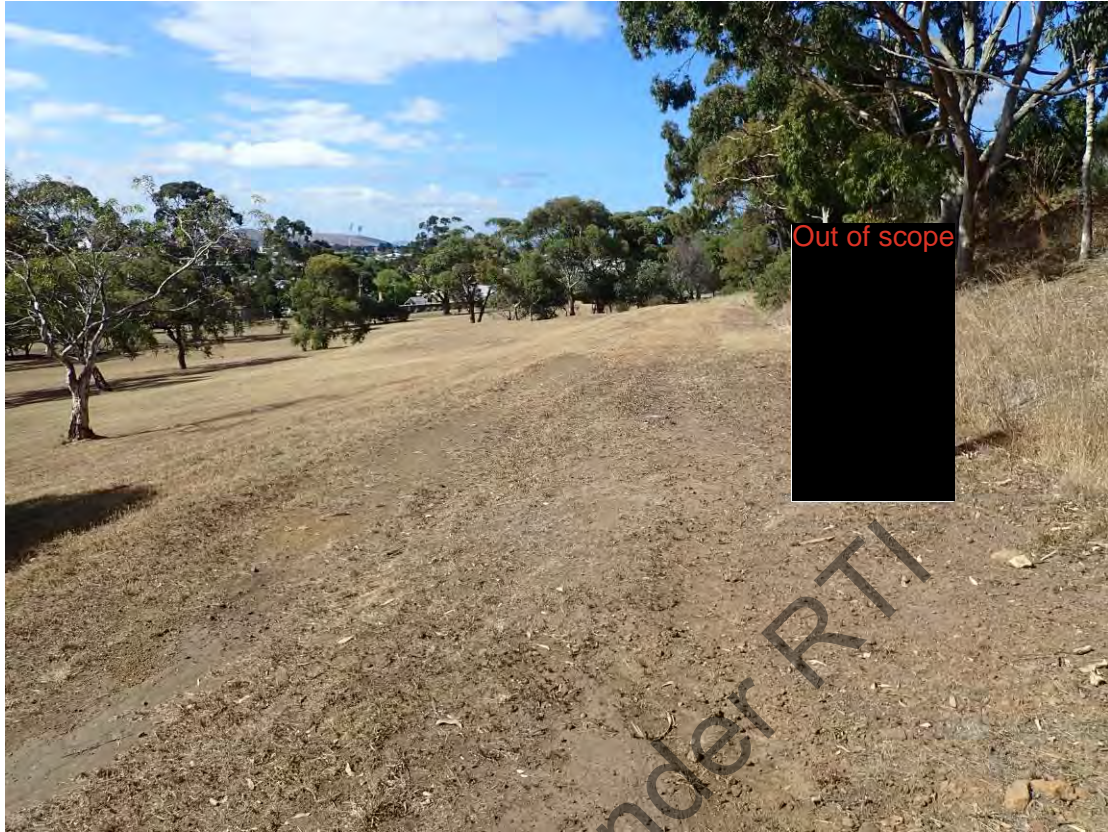
Plate 16: View west at erosion scalds along the north edge of the study area providing improved visibility

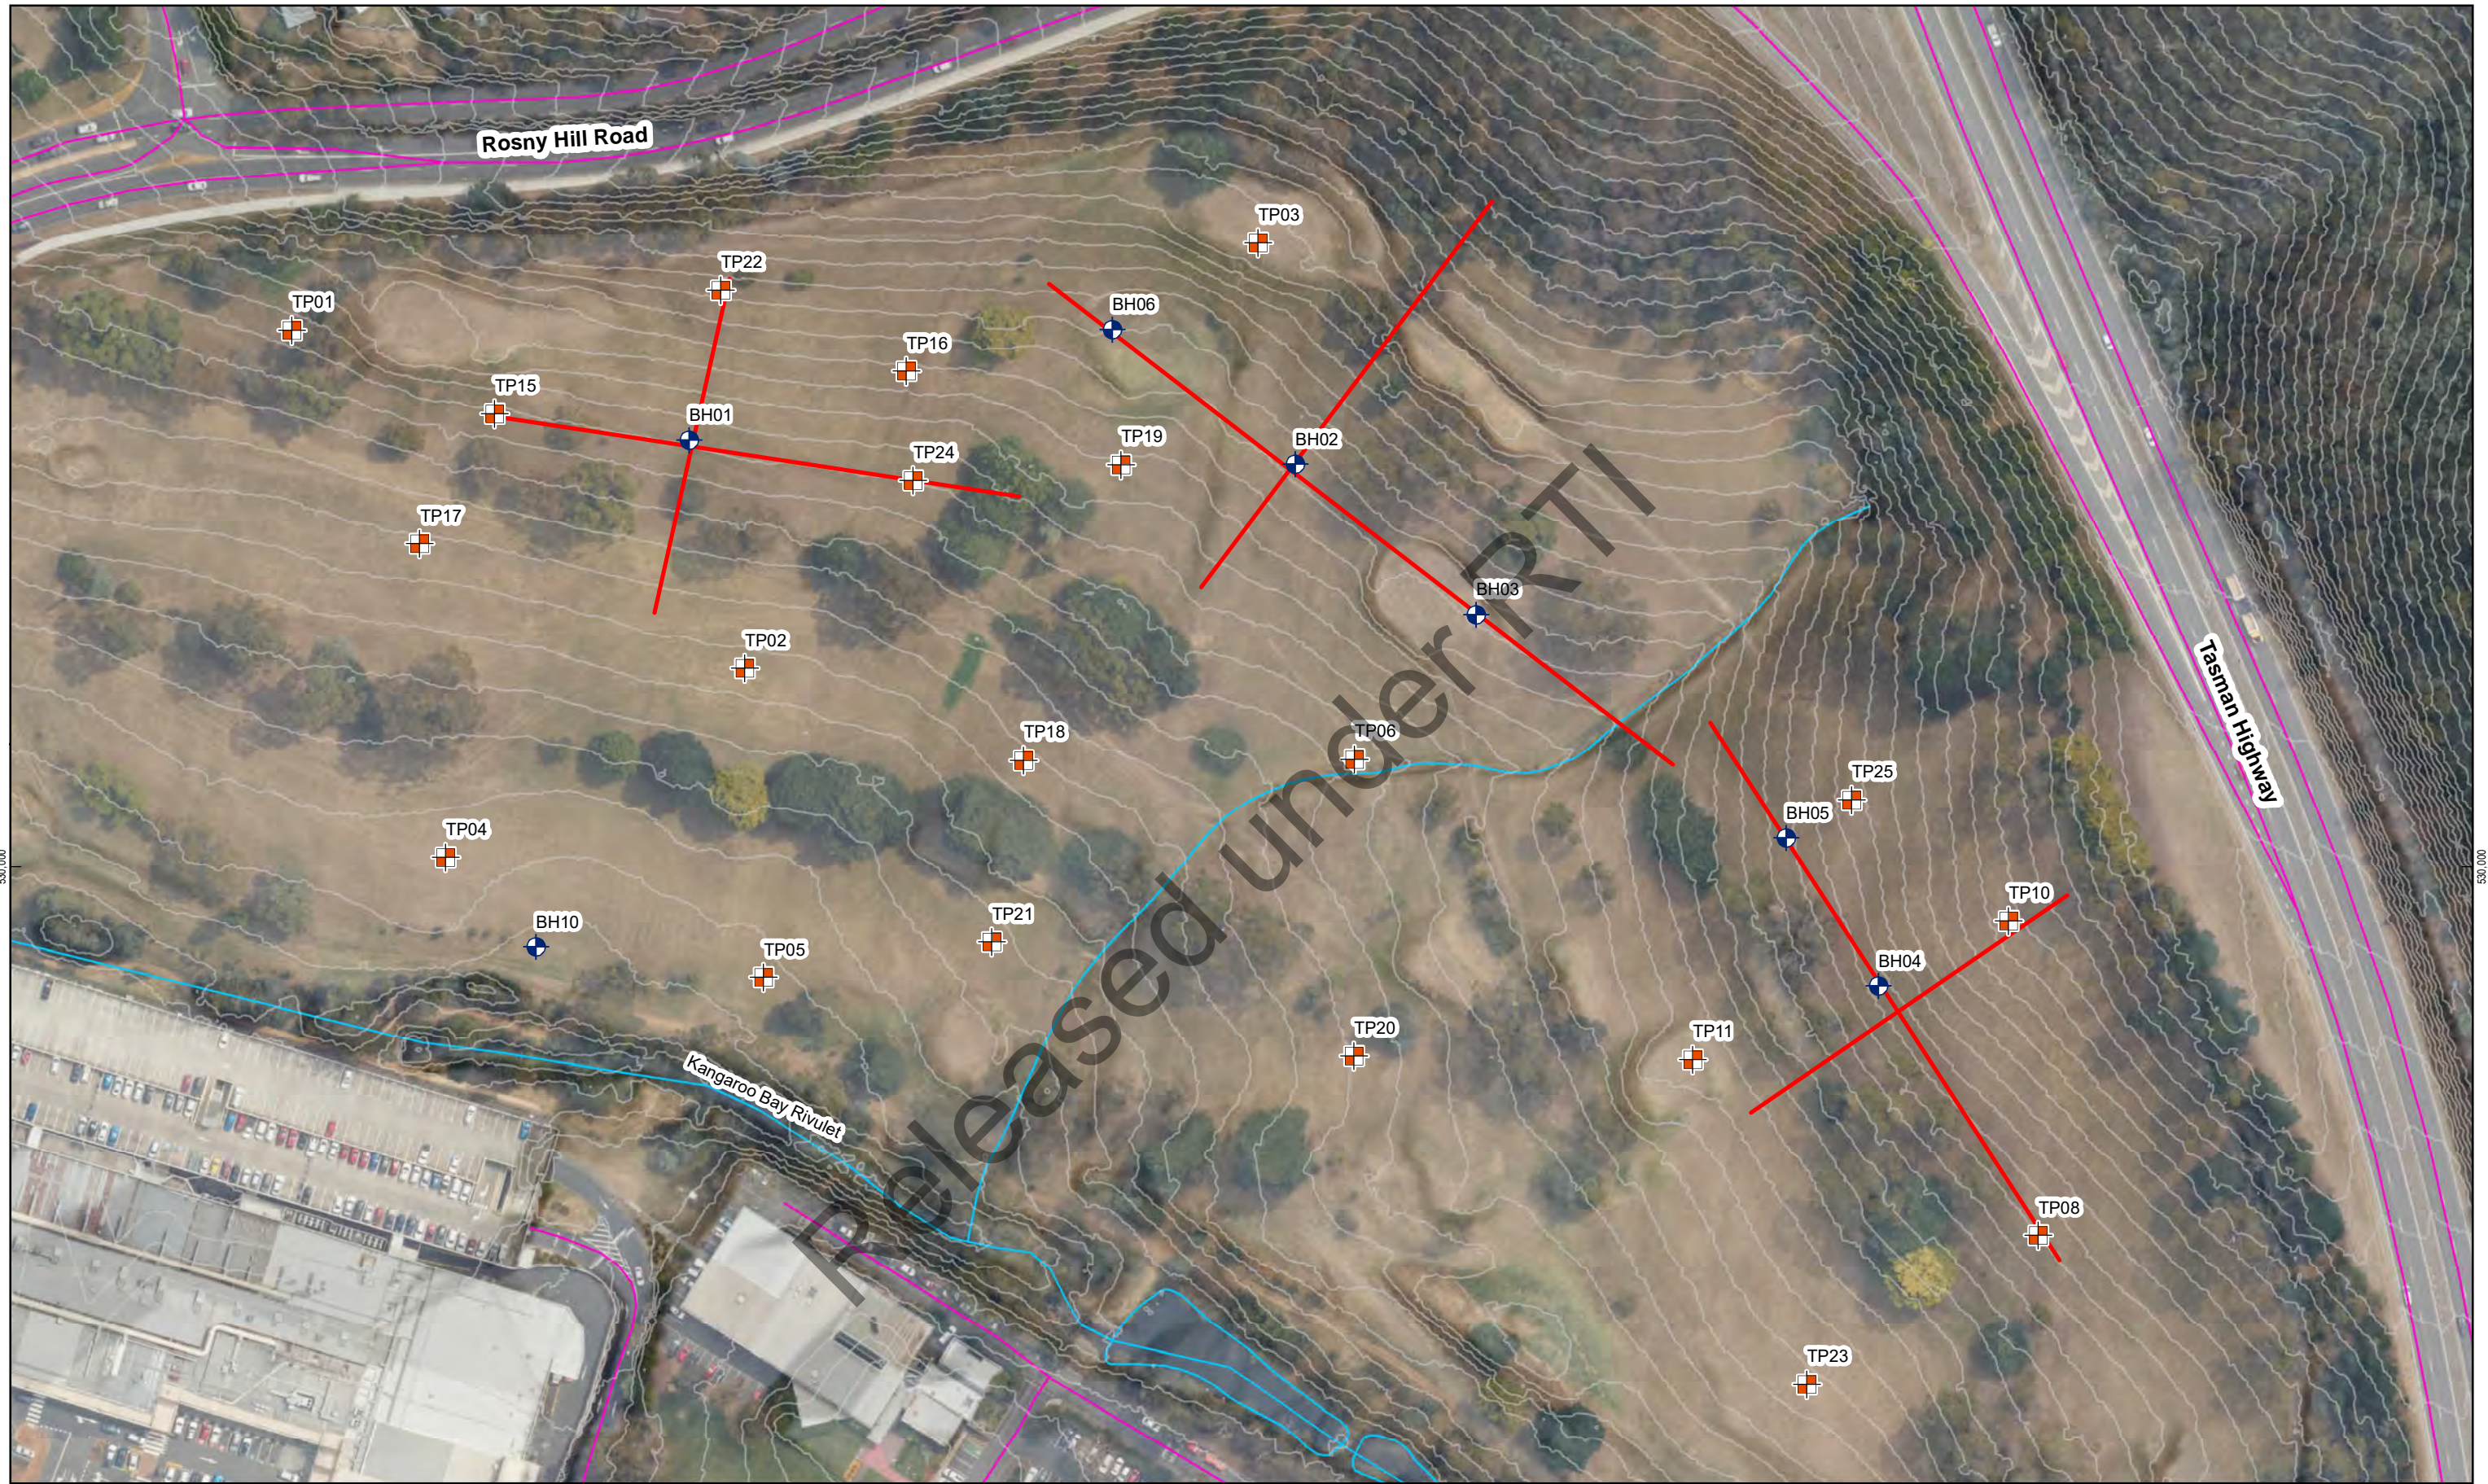
Borehole (7)	Seismic Investigation Lines
Test Pit (20)	Roads
	Watercourses

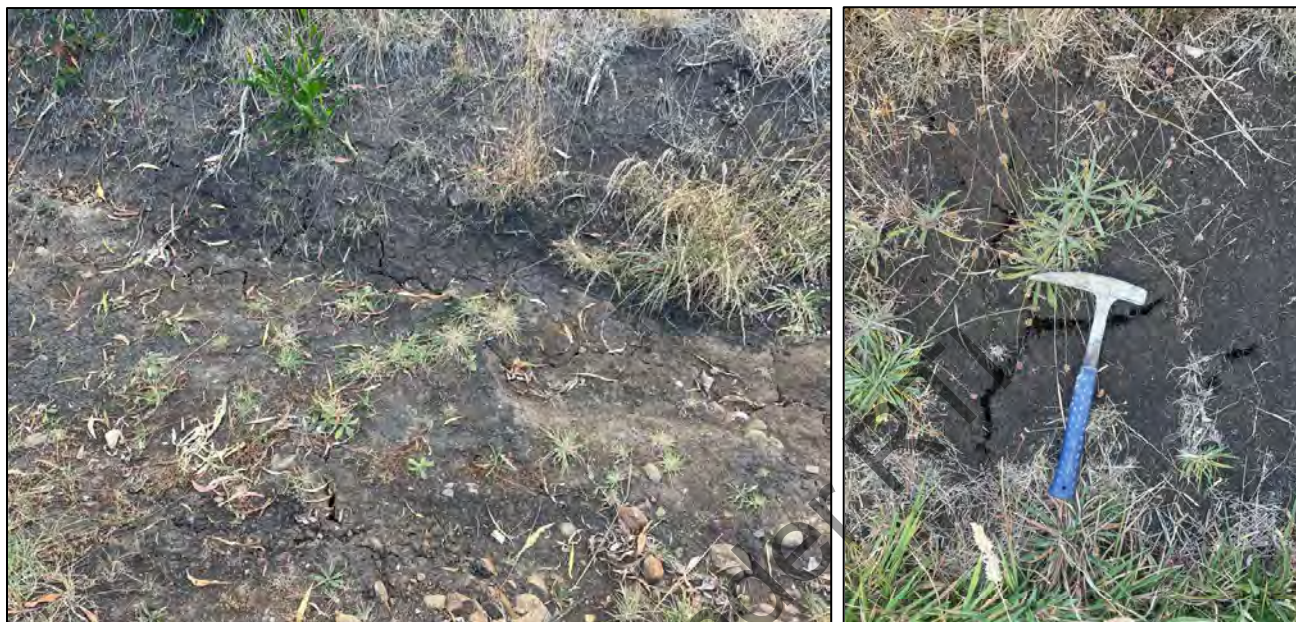
Figure 5 High plasticity surficial soils within the drainage channel (left) and generally across the site (right)

The surficial soils within the drainage channel, and generally across the site, appear to be derived from dolerite (i.e. either colluvium or residual soil). Desiccation cracking up to 30 mm wide was observed within these surficial soils, which is typical for doleritic soils (refer to Figure 5) due to their high plasticity.

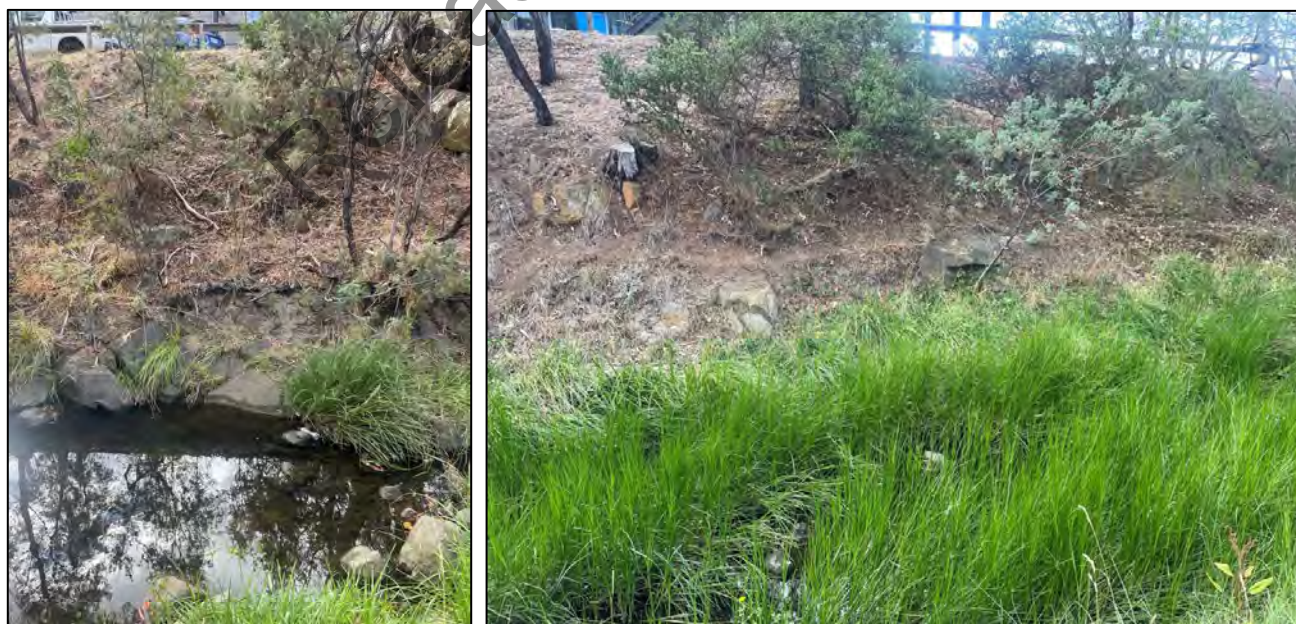
Figure 6 Possible outcropping dolerite in Kangaroo Rivulet

Kangaroo Rivulet appears to be sporadically lined with alluvial cobbles and boulders of dolerite origin, with some possible moderately to slightly weathered dolerite outcrop in the lower bank (refer to Figure 6).

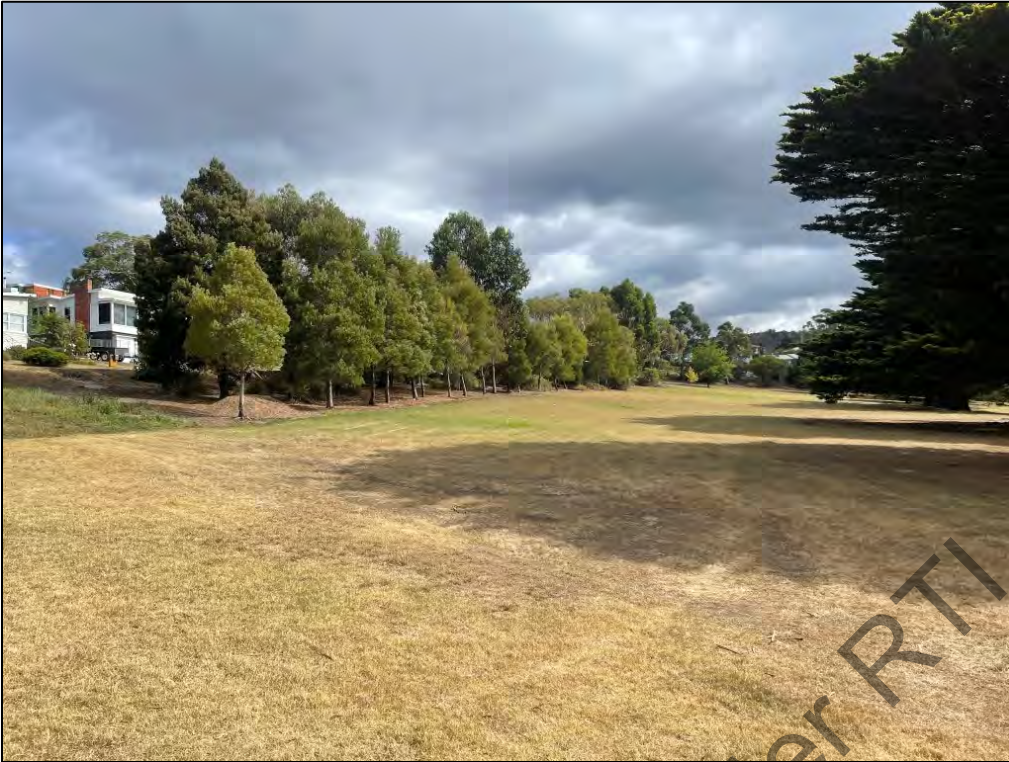
Figure 9 *Tree line and minor fill embankment below Bastick Street*

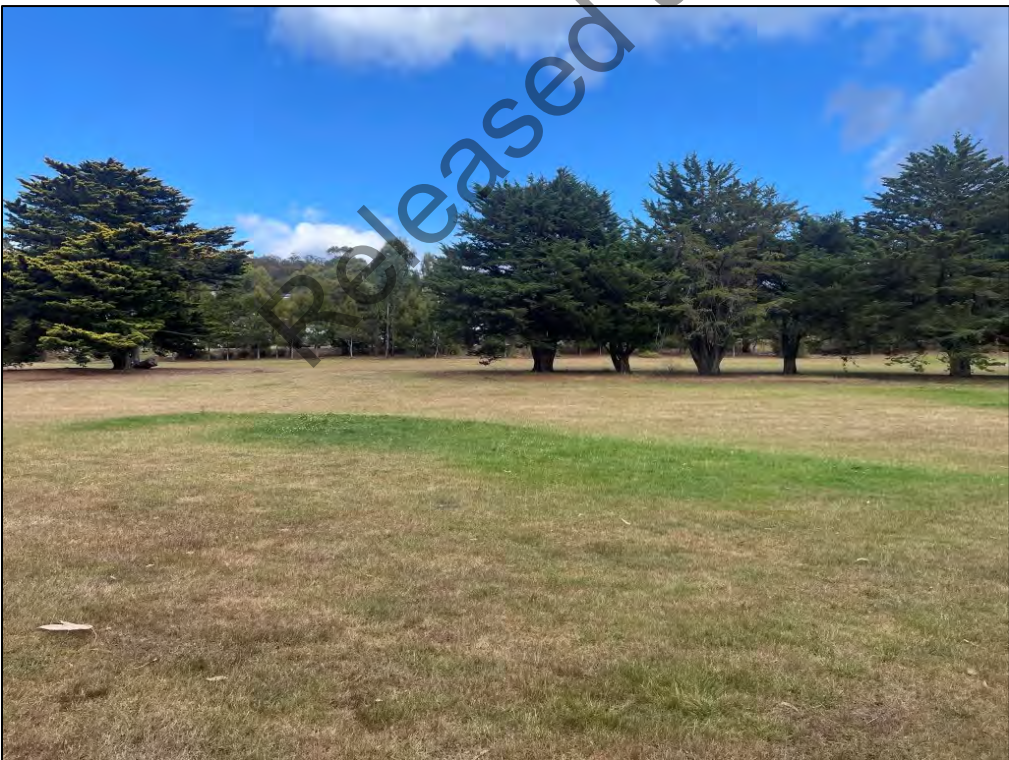
Figure 10 *Green, lush grass potentially a sign of seepage*

An isolated area of lush, green grass was observed in the northeastern quadrant of the proposed oval, which may be indicative of seepage or perhaps a leaking service.

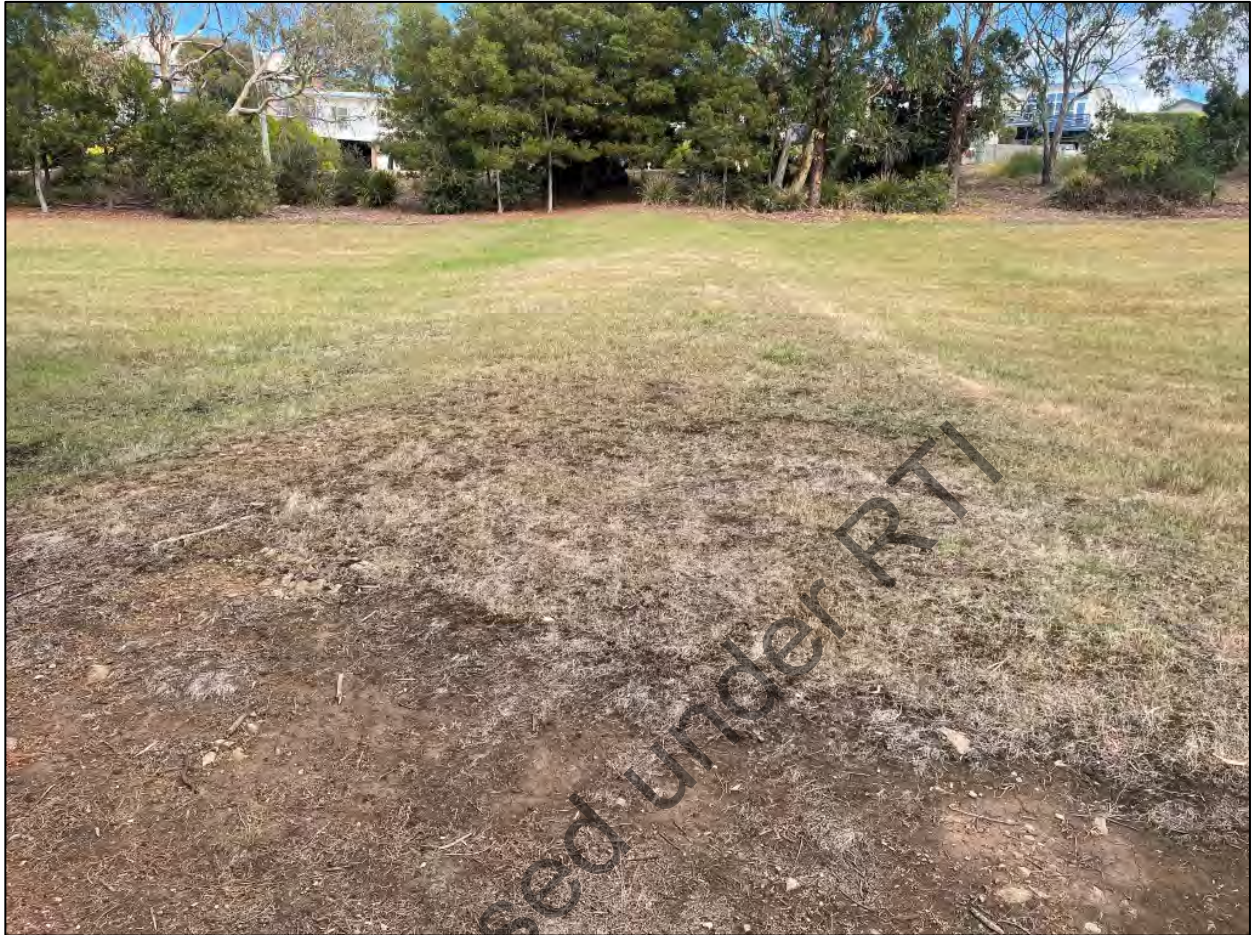
Figure 11 *Linear hump to northeast of the proposed oval of unknown origin*

A small linear hump was noted to exist immediately to the northeast of the proposed oval. The reason for this feature is unknown, but it is inferred to be man-made and perhaps remnant earthworks from the old Royal Tasmania golf course or associated with an underground service trench (refer to Figure 11).

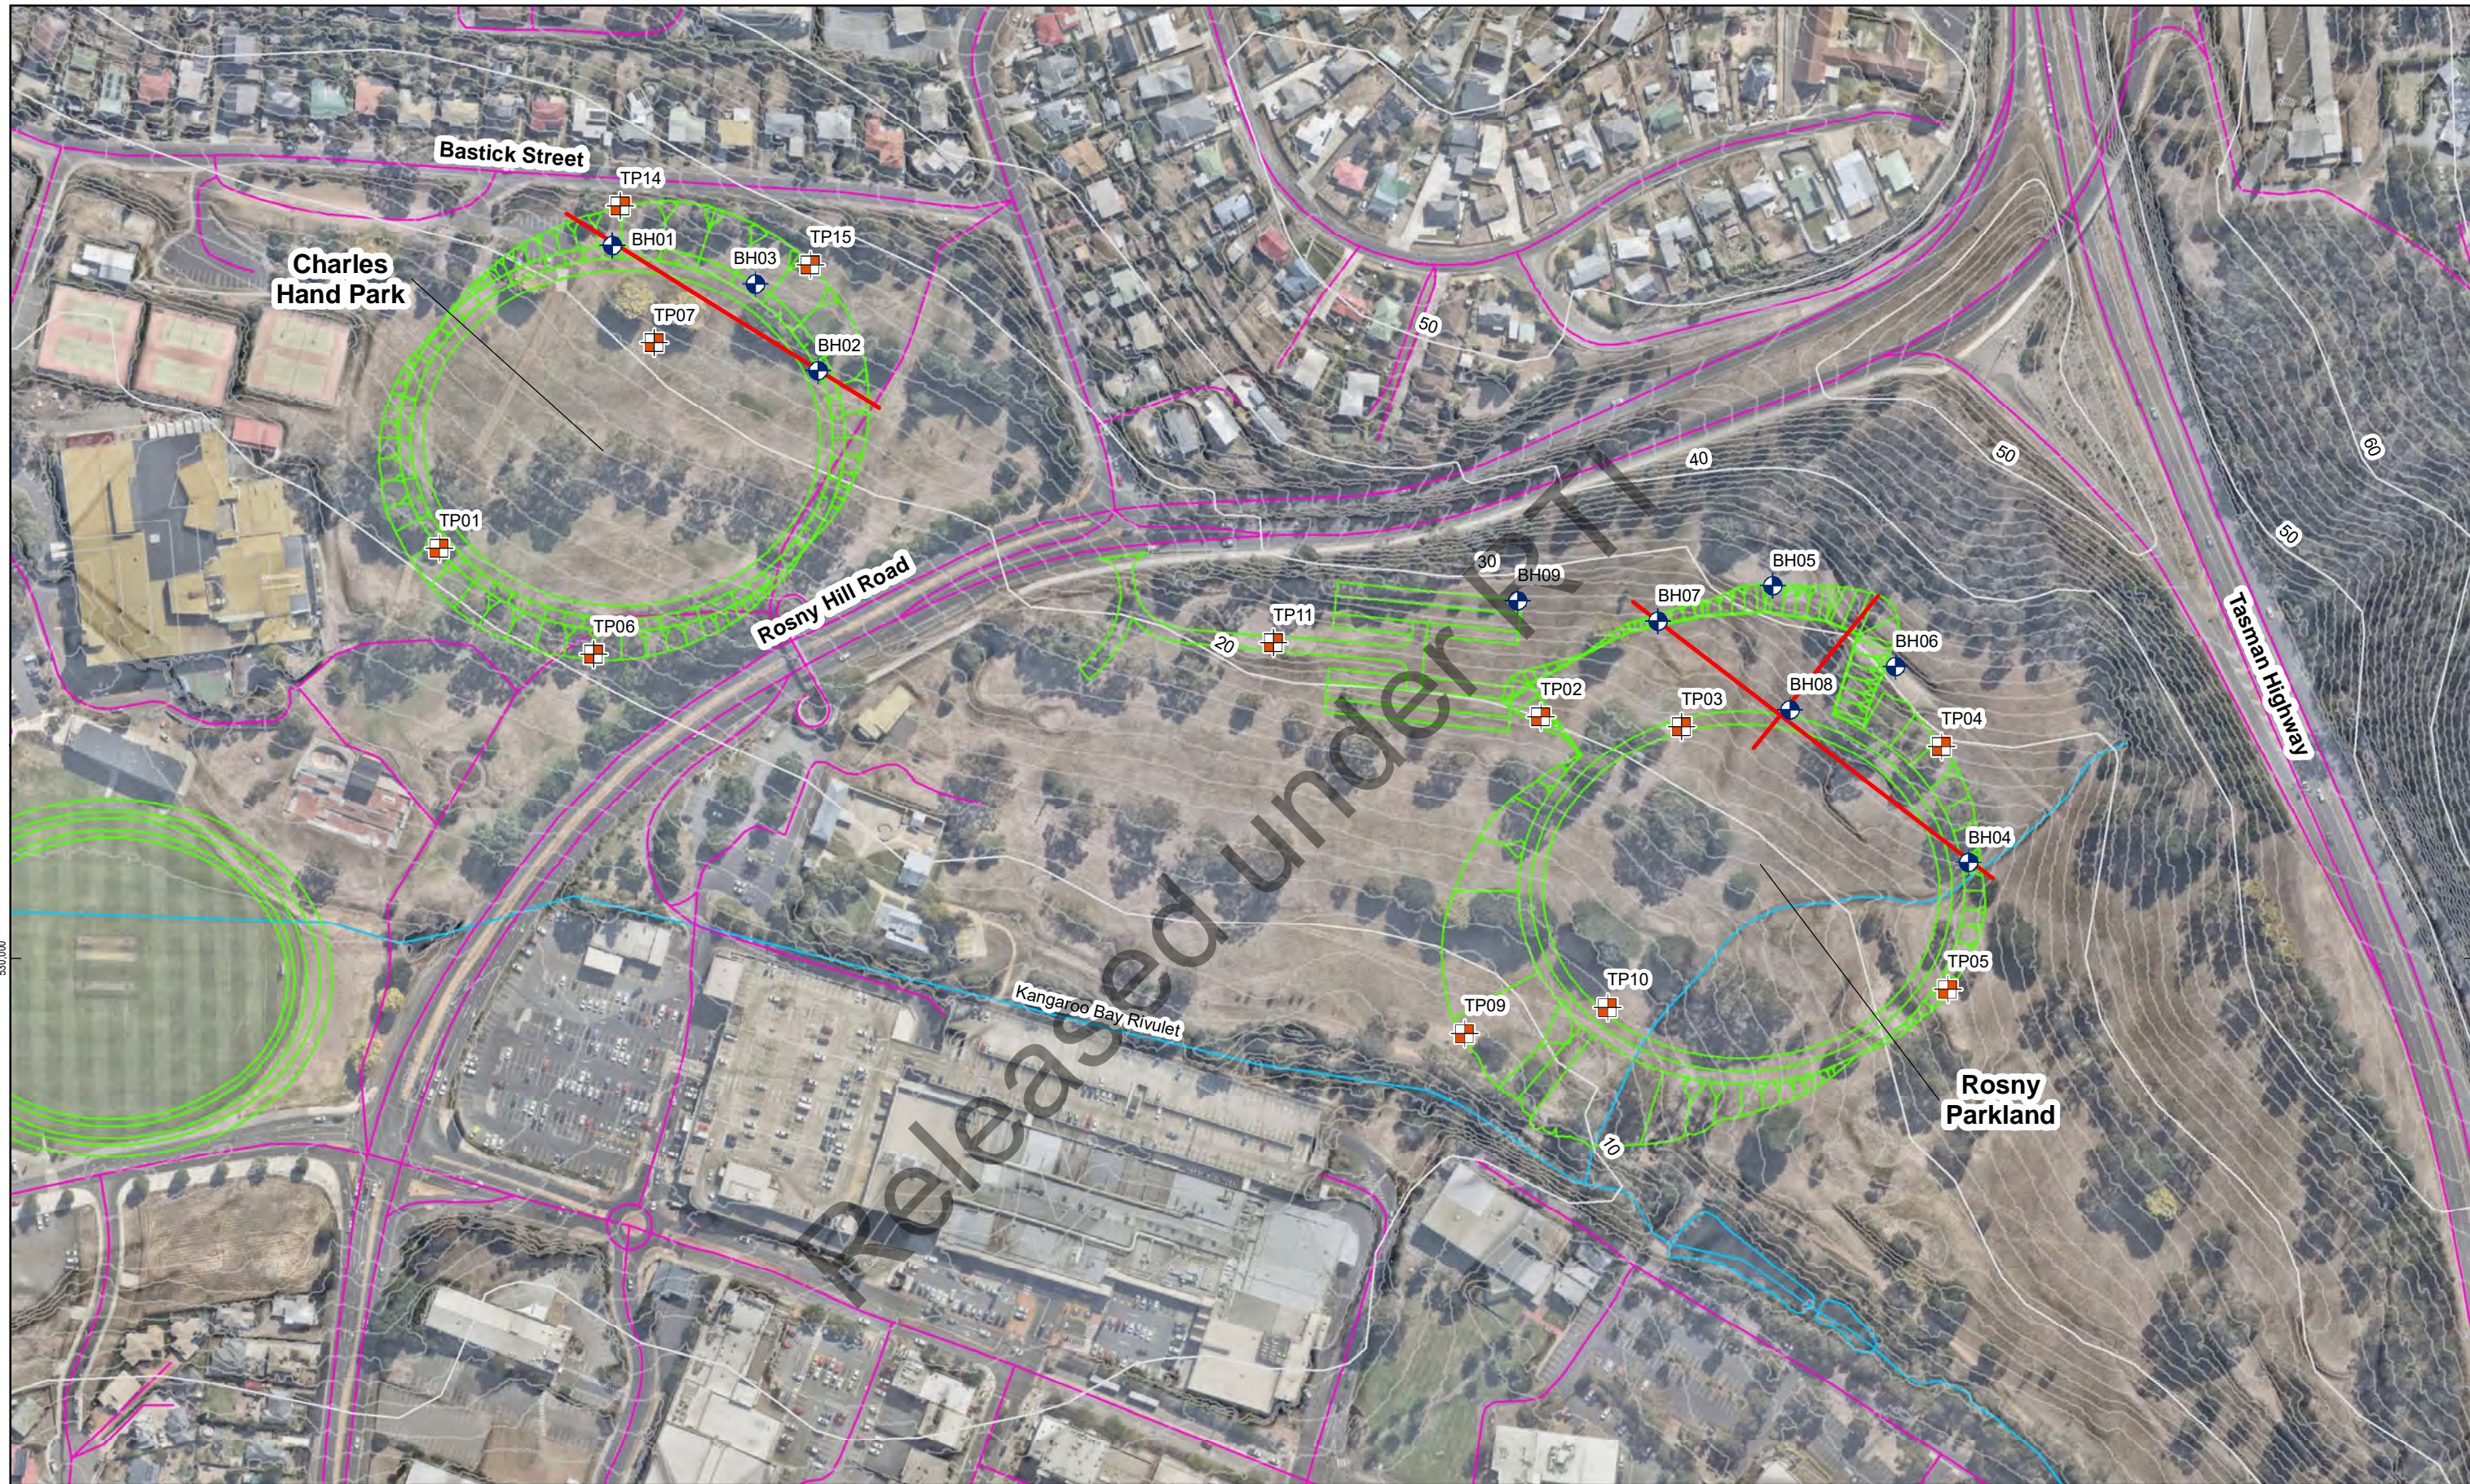
Site plan with proposed test site locations

Civil Works Design	Roads	Proposed Test Locations
Proposed Seismic Lines	Elevation contours	
	Watercourses	
		Borehole (9)
		Test Pit (12)

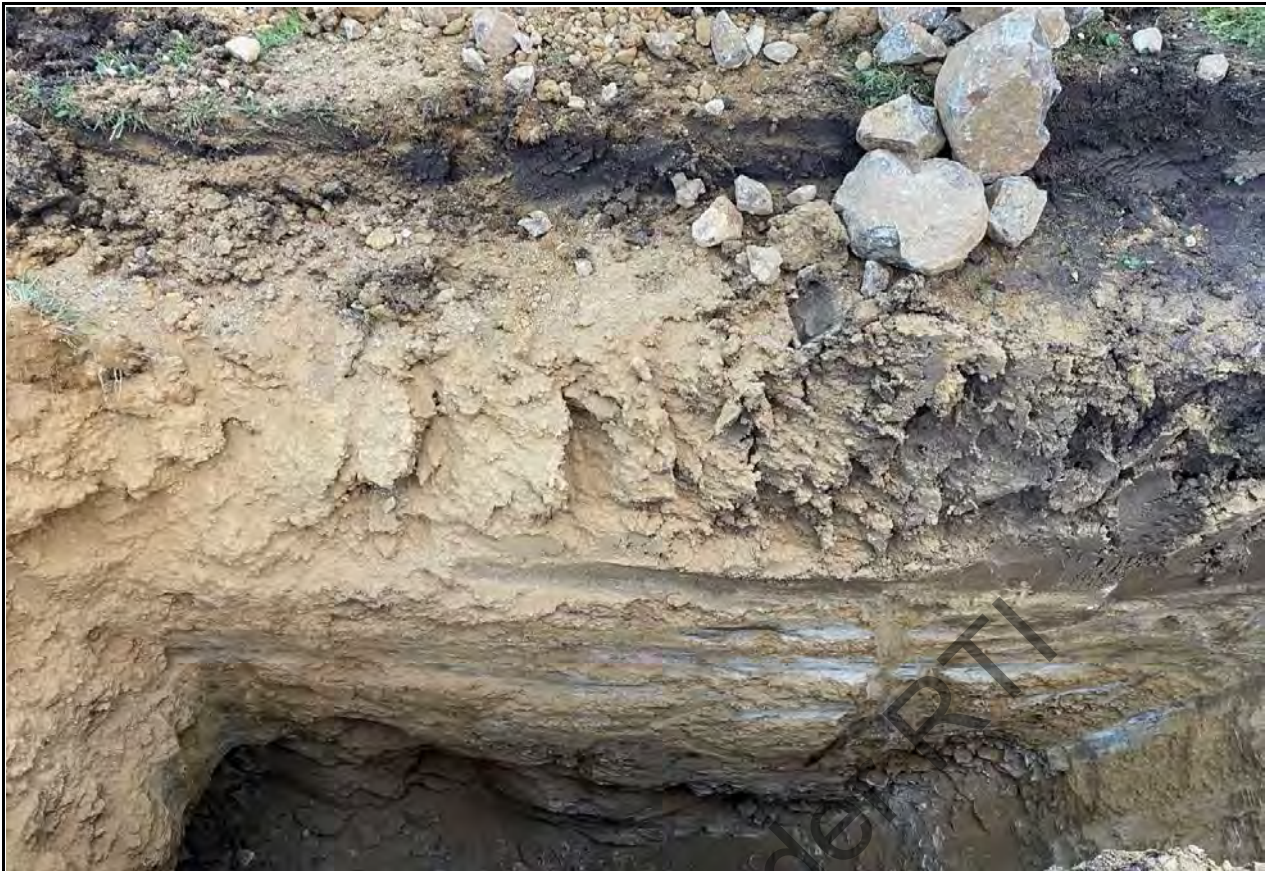
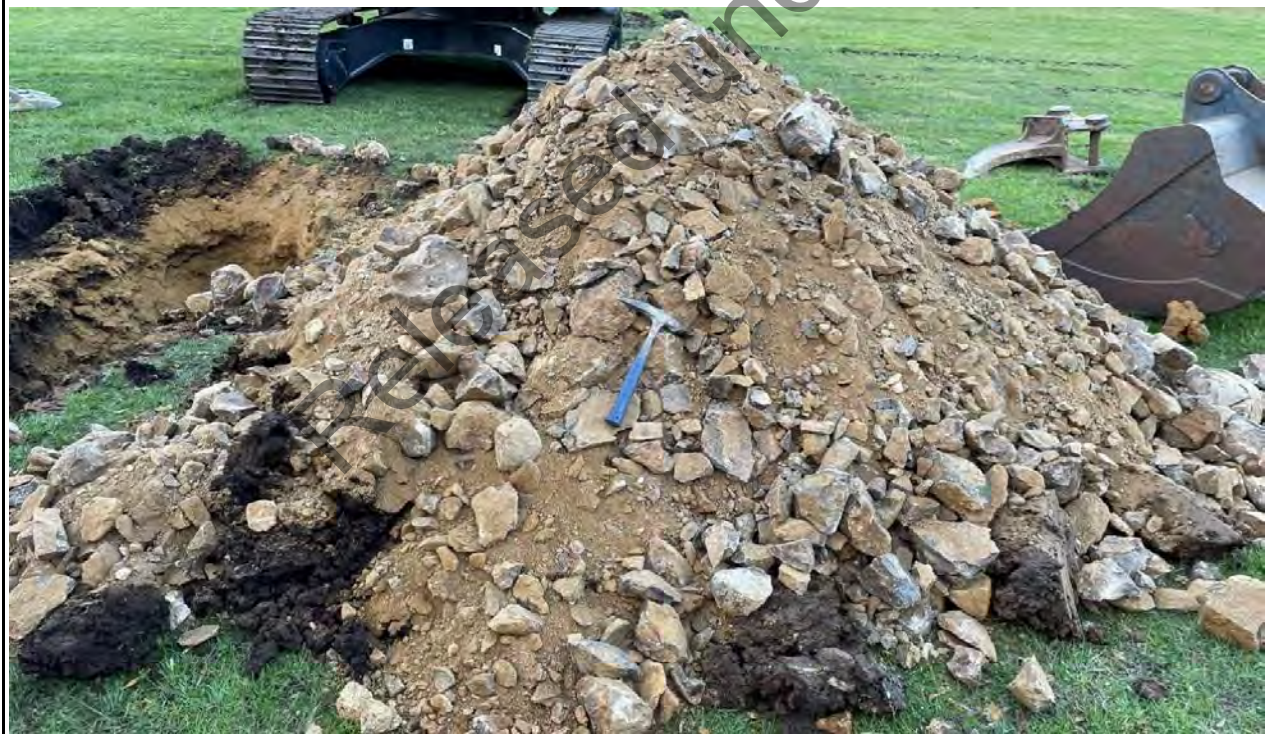
2.30 24.90	○	With HW cobbles (dolerite), subrounded to subangular, blue-grey with orange-brown weathering								
		3.00 24.20	■	DOLERITE, grey-brown, MW, H - VH strength, close to very close defects, trace corestones, Fe staining								
3				Limit of Test Pit							Slow excavation, near refusal	3
4												4
5												5
