AFL High Performance Centre
Rosny, Tasmania

Aboriginal Heritage Assessment Report
Final Draft Version 1

Project name		AFL High Performance Centre Strategic Alignment					
Document title		AFL High Performance Centre Rosny Parklands Option 2 Geotechnical Review					
Project number		12626209					
File name		12626209-REP_AFL HPC Geotechnical Review & Investigation Scoping.docx					
Status Code	Revision	Author	Reviewer		Approved for issue		
			Name	Signature	Name	Signature	Date
S4	0	Out of scope	Out of scope	Out of scope	Out of scope	Out of scope	20/02/24
[Status code]							
[Status code]							
[Status code]							
[Status code]

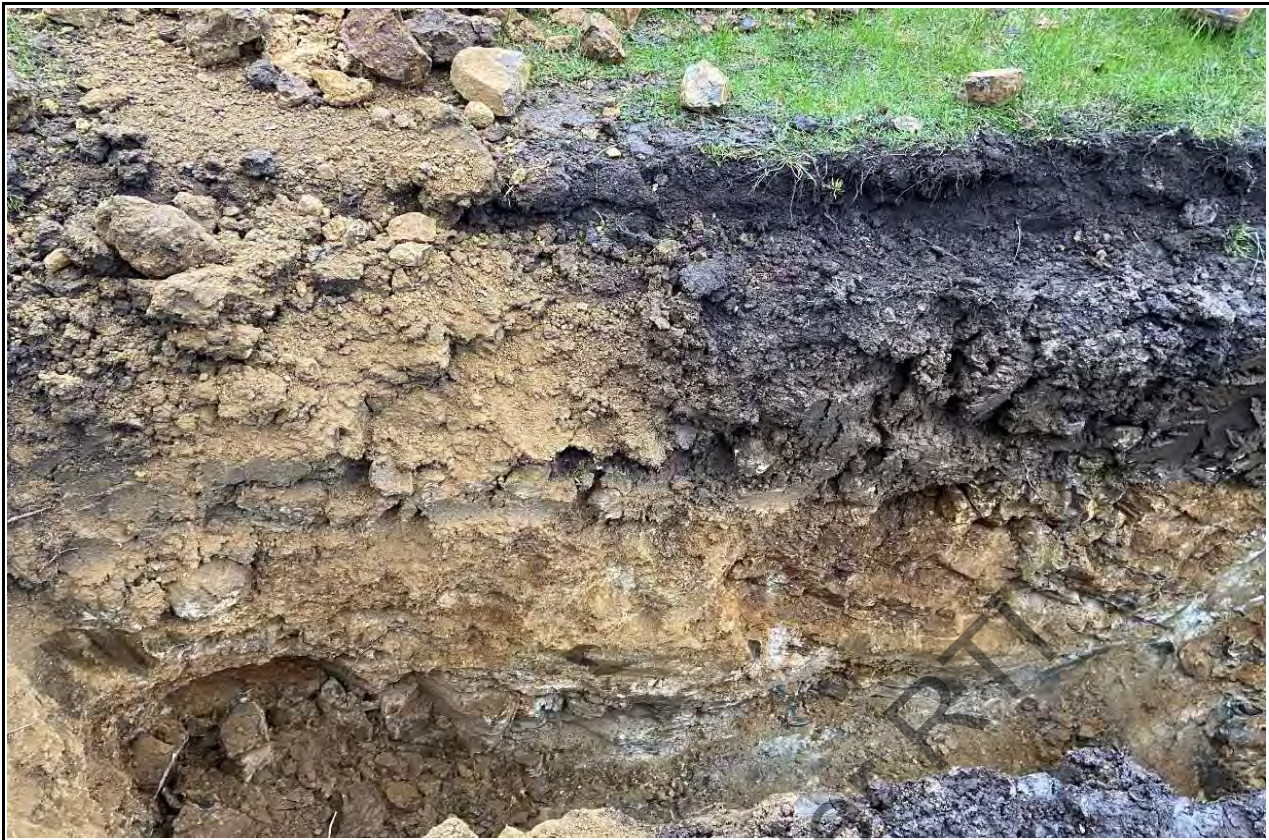
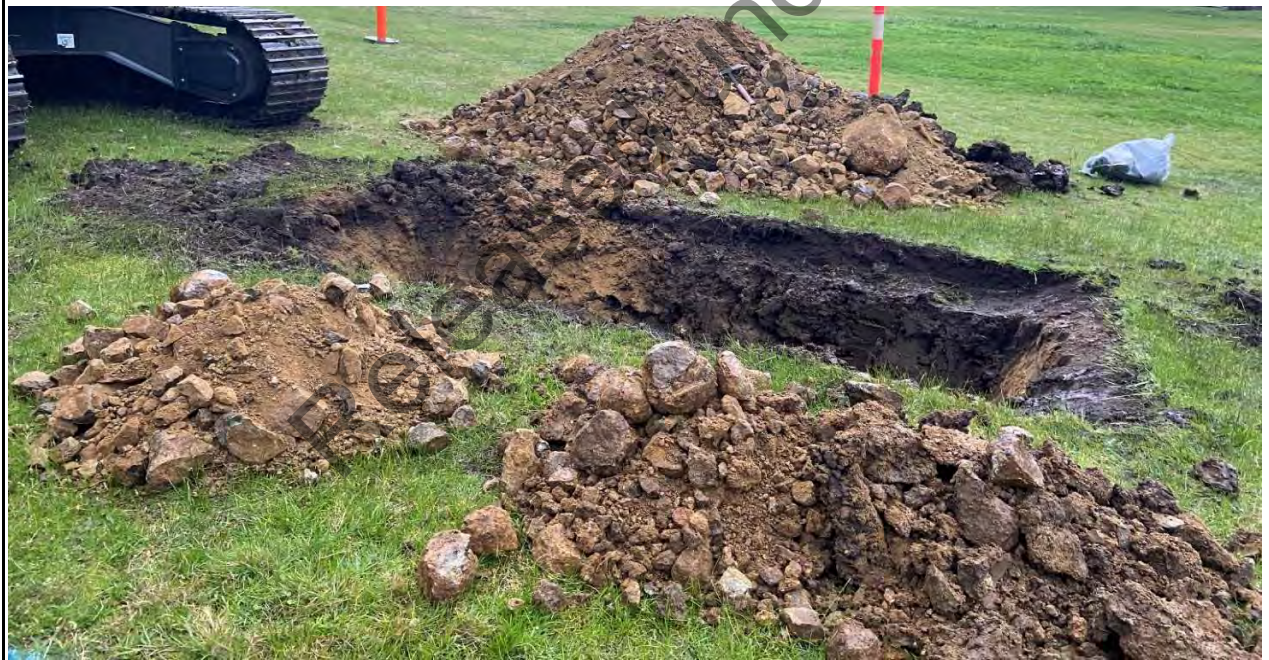
TP_C01

EXCA		MATERIAL						ADDITIONAL DATA		
Scale (m)	Water	Depth / (RL) metres	Graphic Log	Description Soil Name (USC Symbol) Other Minor Components, Plasticity or Particle Characteristics, Colour, Moisture Condition, Consistency, Structure	Group Symbol	Moisture Condition	Consistency / Relative Density	Samples & Tests	Comments/Observations In situ test results	SCALE (m)
1		0.30		TOPSOIL: CLAY with sand, high plasticity, dark-brown, sand is fine to medium grained, some rootlets and roots	CH	M	St	DCP	DCP Blows/100mm: 8/7/6/2/2/6/8/9/16/20*	1

13.60		CLAY with sand, high plasticity, brown, sand is fine to medium grained, w>PL [Residual Soil]	CH	M	St-VSt	PP	PP @ 0.4m = 200kPa (UCS)	
		0.50		trace gravel, sand is fine to coarse grained, gravel is fine, fissured, slickensided surfaces, w~PL		M-D	H	PP D	PP @ 0.5m = >600kPa (UCS) D (0.5-0.8m)

0.80		DOLERITE, orange-brown, Fe stained, HW, L-H strength, typically L, very close defects (20-200mm)					1.2m: Teeth grinding, variable strength. Recovered as Sandy GRAVEL with cobbles (up to 200mm)	
2		1.20		HW-MW, M-H strength						2

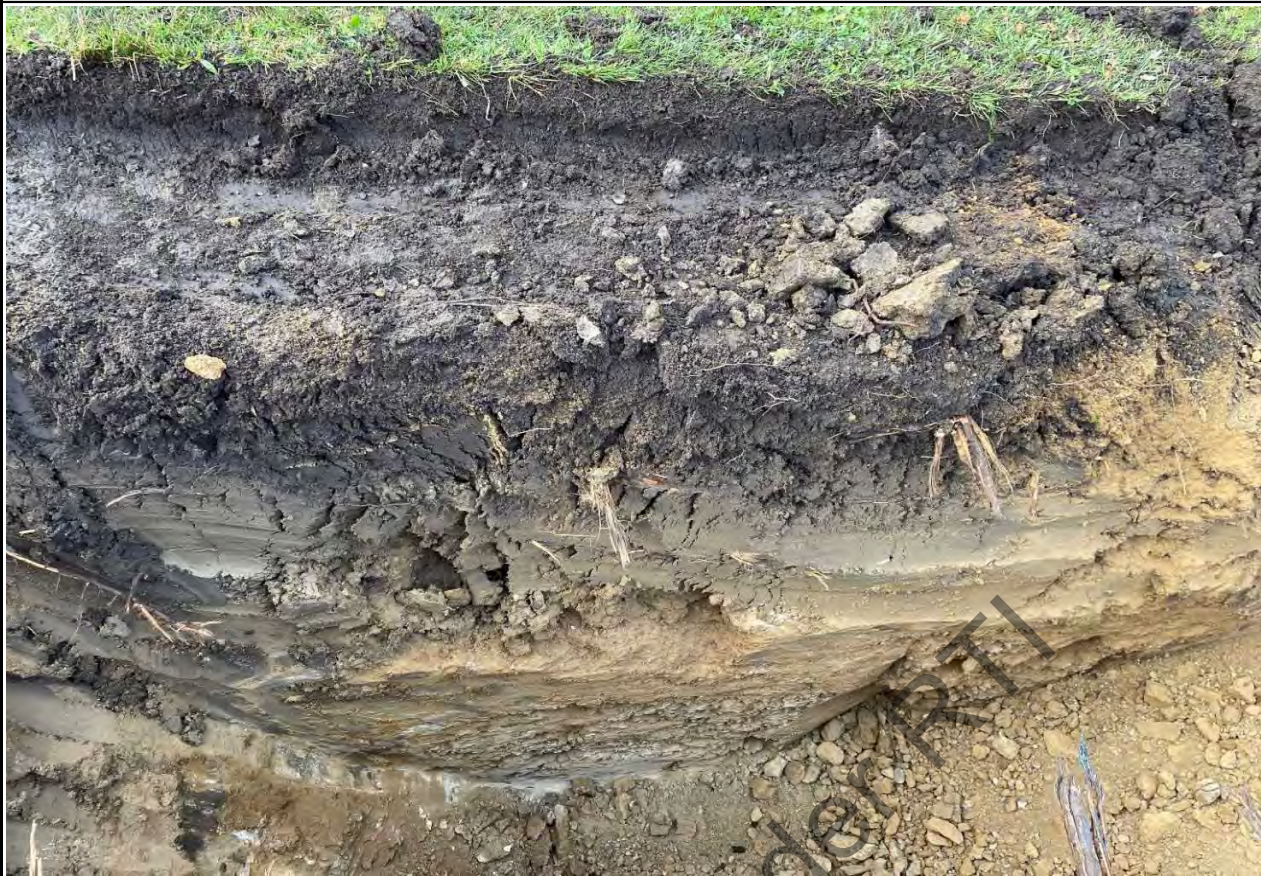
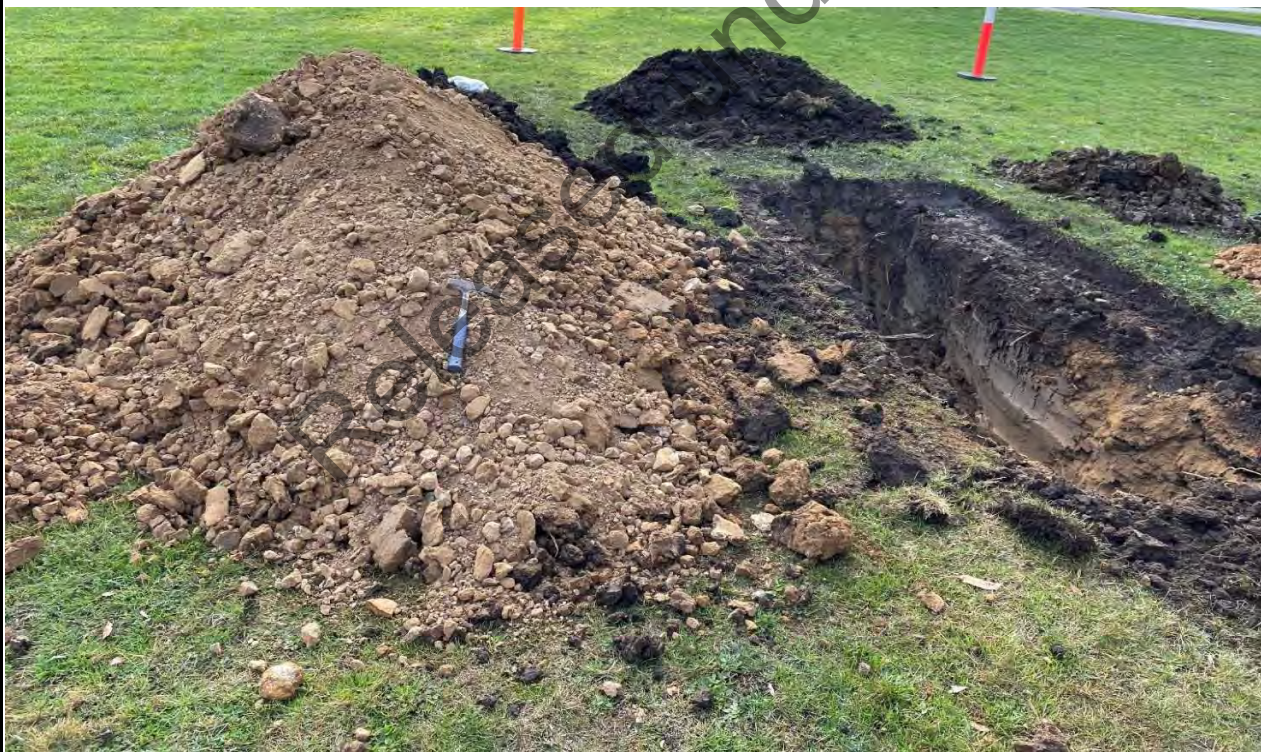
EXCA		MATERIAL						ADDITIONAL DATA				
Scale (m)	Water	Depth / (RL) metres	Graphic Log	Description			Group Symbol	Moisture Condition	Consistency / Relative Density	Samples & Tests	Comments/Observations <small>In situ test results</small>	SCALE (m)
				Soil Name (USC Symbol) Other Minor Components, Plasticity or Particle Characteristics, Colour, Moisture Condition, Consistency, Structure								
1		0.30		TOPSOIL: Sandy SILT, low plasticity, dark-brown, fine grained, friable, rootlets and roots			ML	M	St	DCP	DCP Blows/100mm: 4/5/6/11 *Refusal after 20mm penetration Excavated as GRAVEL with cobbles, slow excavation	1

0.90		DOLERITE, HW-MW, H-VH strength, grey-brown, Fe stained, very close to close defects (20-200mm)								
		1.20		Limit of Test Pit. Near Refusal - very slow excavation with 3 toothed, 450mm wide bucket								
	GNE	12.10										
2												2
3												3

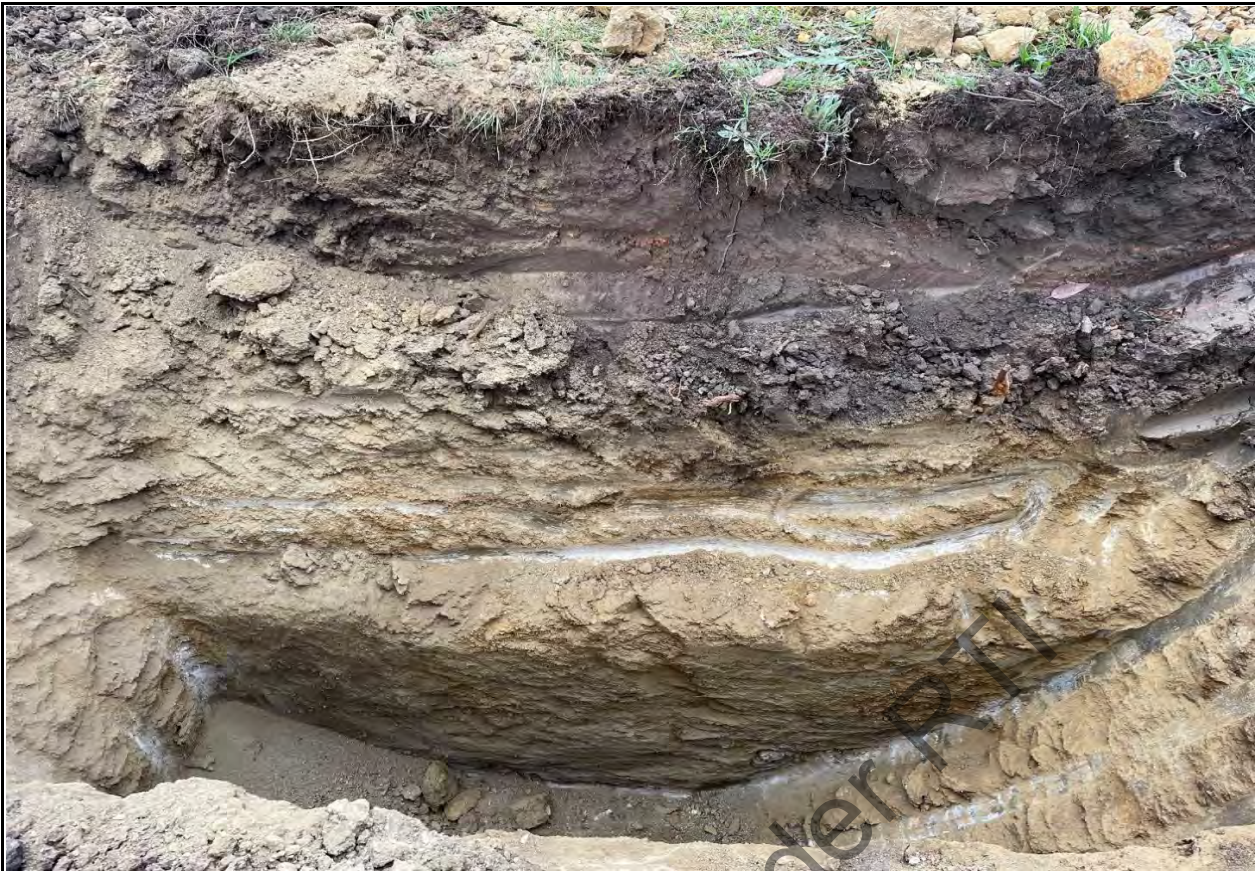
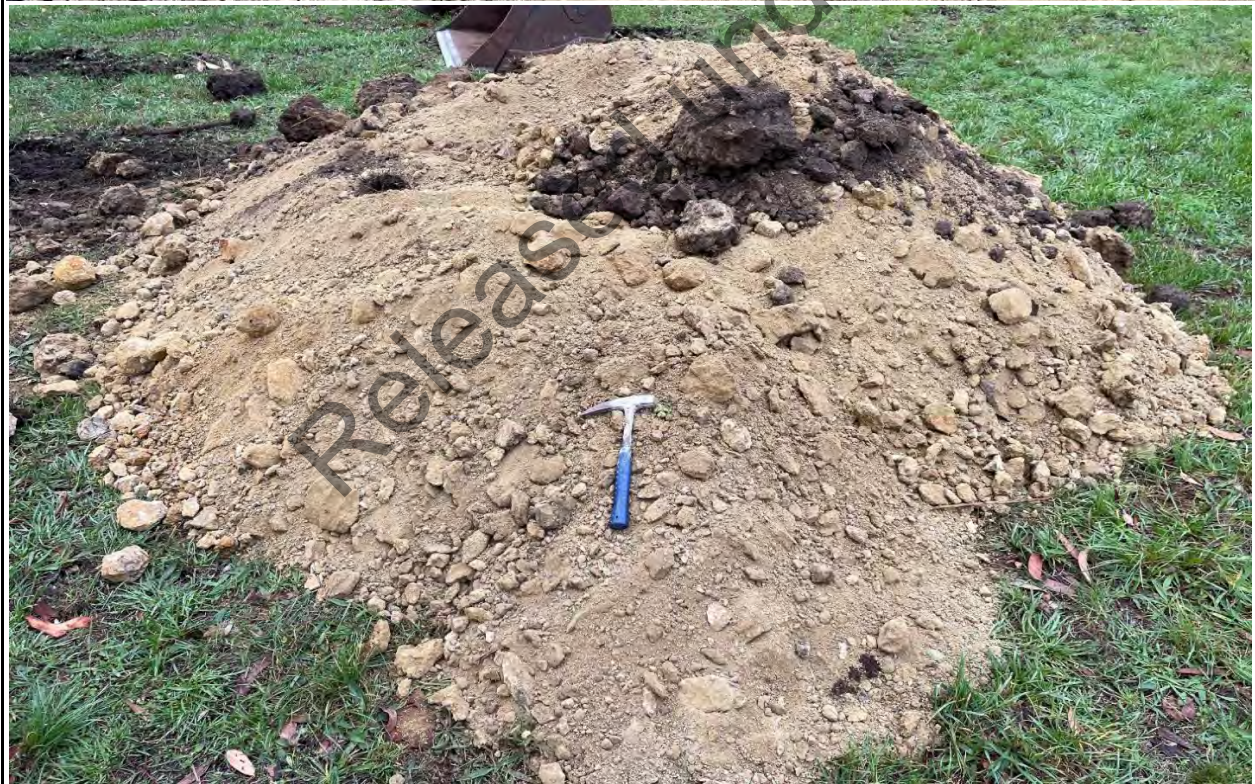
EXCA		MATERIAL						ADDITIONAL DATA			
Scale (m)	Water	Depth / (RL) metres	Graphic Log	Description Soil Name (USC Symbol) Other Minor Components, Plasticity or Particle Characteristics, Colour, Moisture Condition, Consistency, Structure	Group Symbol	Moisture Condition	Consistency / Relative Density	Samples & Tests	Comments/Observations In situ test results	SCALE (m)	
1		0.20		TOPSOIL: Sandy SILT, dark brown, frequent rootlets, sand is fine coarse grained, trace ironstone fragments	ML	M	L - MD	DCP	DCP Blows / 100mm: 2/6/7/7/9/13/20* *50mm penetration Consistent with DCP note below D (0.2 - 0.5m) PP @ 0.4m = >600kPa (UCS) D D (0.5 - 0.7m) PP @ 0.6m = >600kPa (UCS) DCP @ 0.7 - 0.81m: Top of XW rock (saprolite). Blows / 100mm: 20/21*. *20 blows for 10mm penetration 1.5m: Teeth scraping 1.6m: Ripper used to penetrate. Recovered as Silty GRAVEL with cobbles. Intact cobbles shatter with firm pick blow PL (1.6 - 1.7m): 4x samples tested - results below: Is(50) = 0.78 MPa, 0.81 MPa, 0.61 MPa, 1.25 MPa 2.1m: Ripper used to penetrate	1

1.60		12.90	DOLERITE, orange-brown, Fe Staining throughout, HW, VL-H, typically M, very close to close defects						
3		2.60		Limit of test Pit. Refusal with 3-toothed, 450mm wide bucket					*Requires ripper to penetrate due to test pit confinement	3	
4		11.90								4

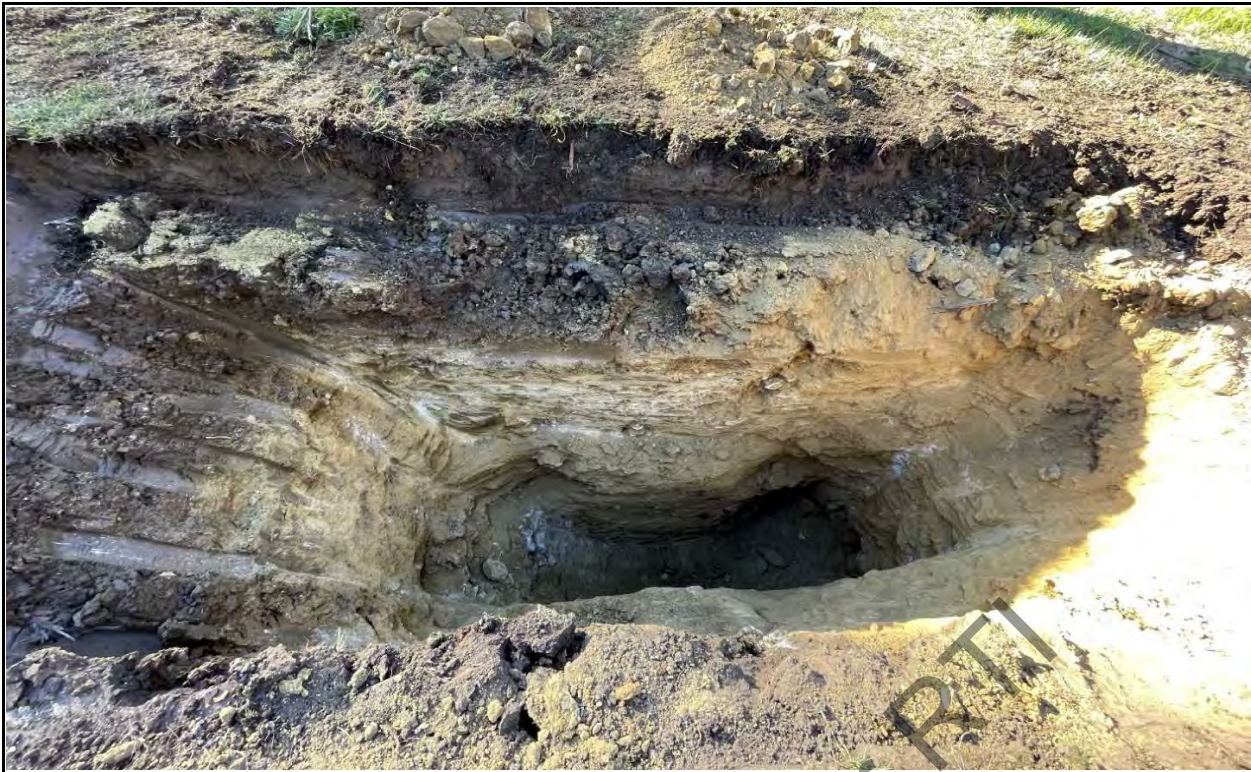
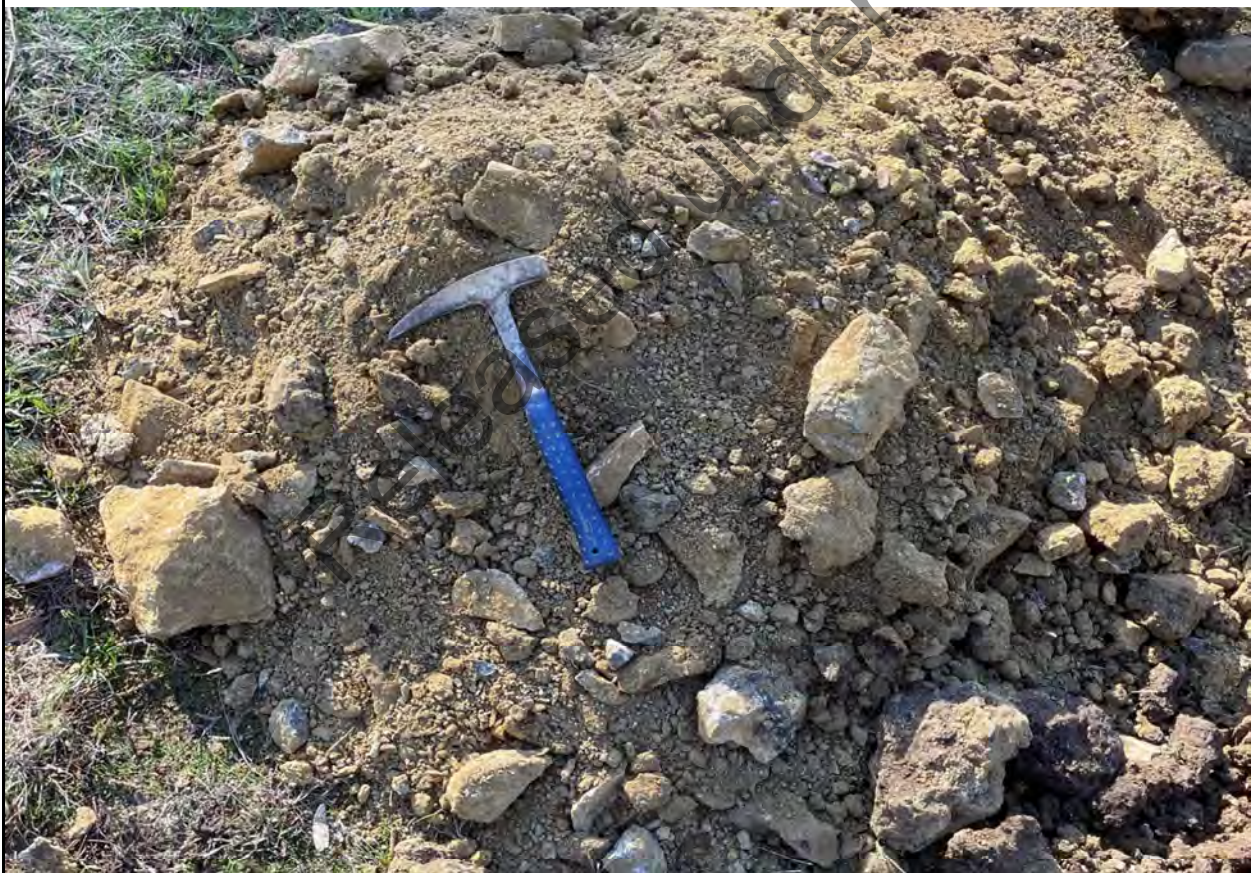
0.70 30.10	●●●●●●●●●●	Silty SAND, fine to coarse grained, orange-brown, friable [XW Dolerite]		SM	D	D-VD			
		1.00 29.80	●●●●●●●●●●	trace cobbles (100-200mm), subrounded to angular, HW, L - M strength							
2	GNE	1.70 29.10	●●●●●●●●●●	Mixture of Silty Gravelly SAND (50%) and COBBLES (50%), orange-brown, fine to coarse grained, gravel is fine to coarse, angular to subangular, dolerite, cobbles are HW-MW, typically H strength dolerite [XW Dolerite]		-	M-D	VD		Bucket scraping @ 1.7m, fast excavation prior. Variable weathering some pockets of HW-MW dolerite	2
3		3.00 27.80	●●●●●●●●●●	Refusal with 3-toothed, 450mm wide bucket (inferred on HW dolerite).							3
4											4

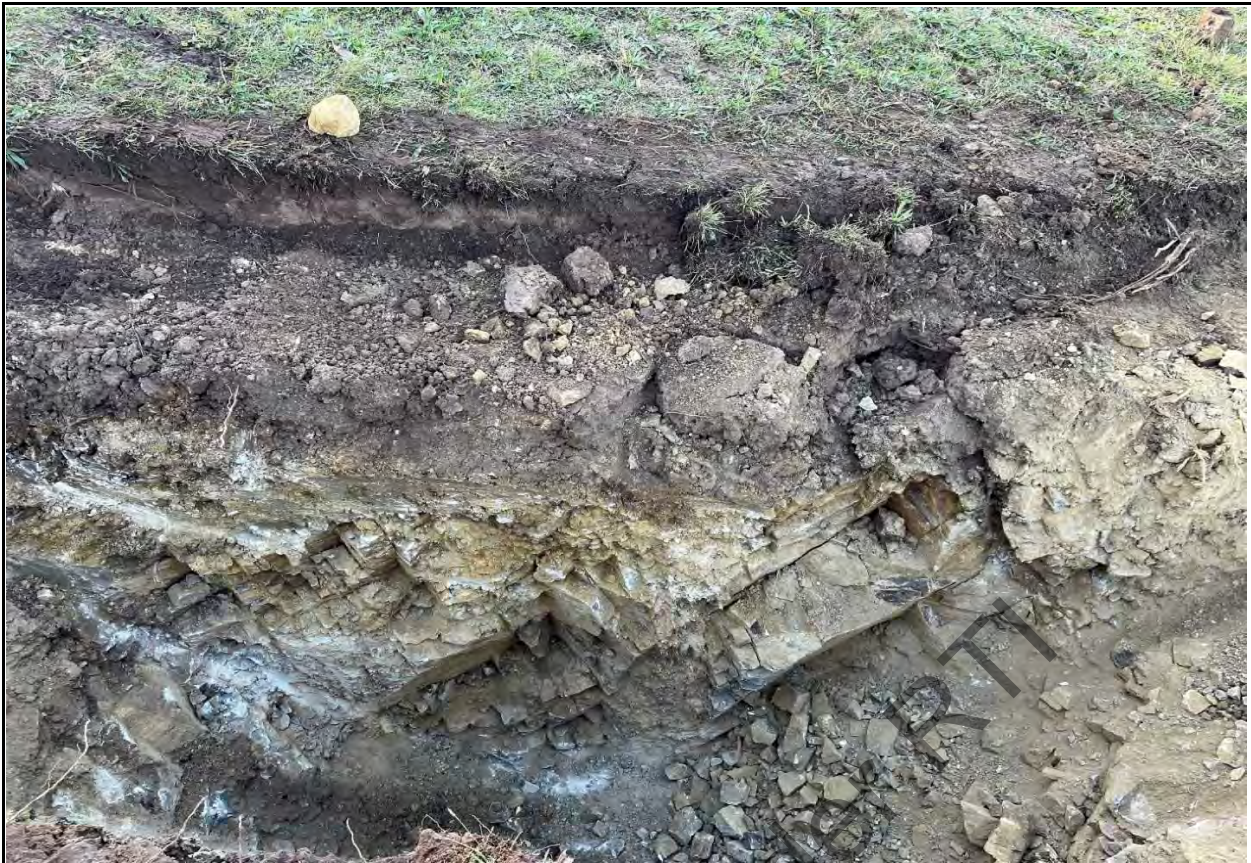
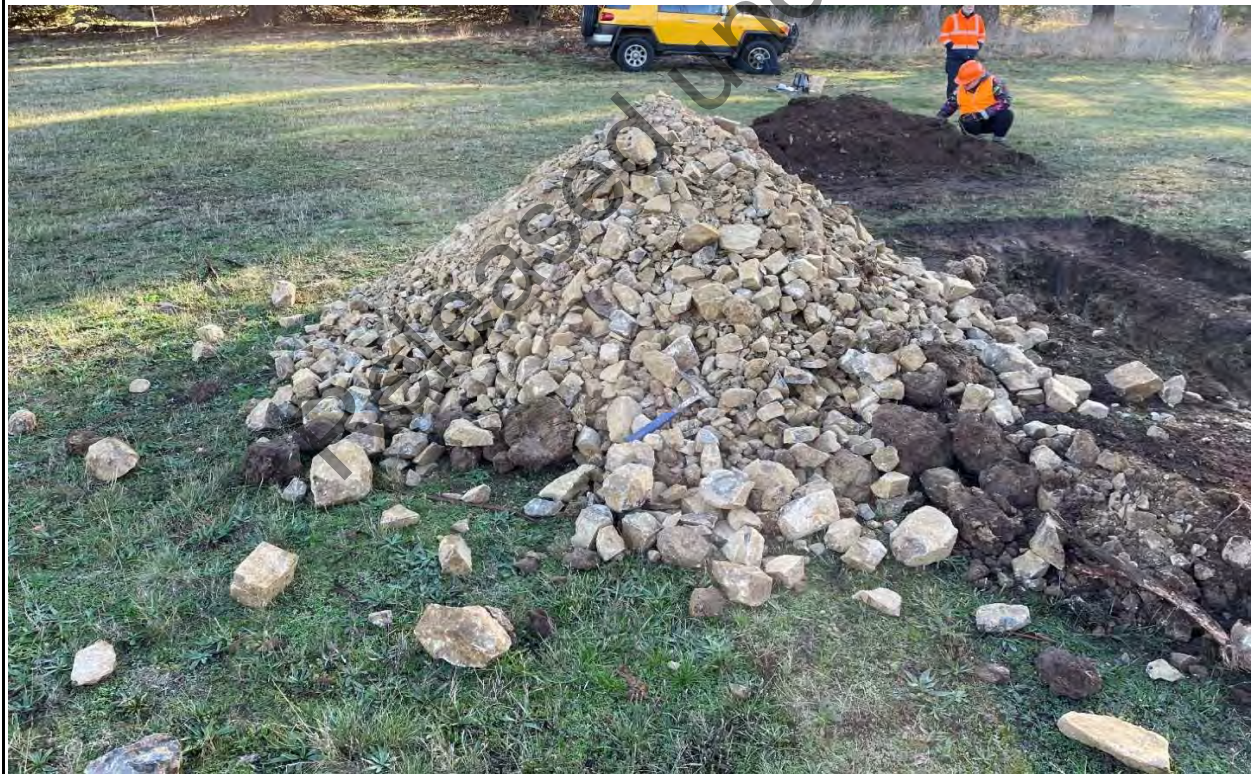
1.30 37.10		DOLERITE, coarse grained, porphyritic, HW, VL-M strength, orange-brown to grey, very close to close jointing (<100mm), Fe staining at joints and XW material						Is(50)

1.80 36.60		As above, MW, VH - EH strength, close defects (60 - 200mm)								
2	GNE			Refusal with 3 toothed, 450mm wide bucket.								2
3												3
4												4

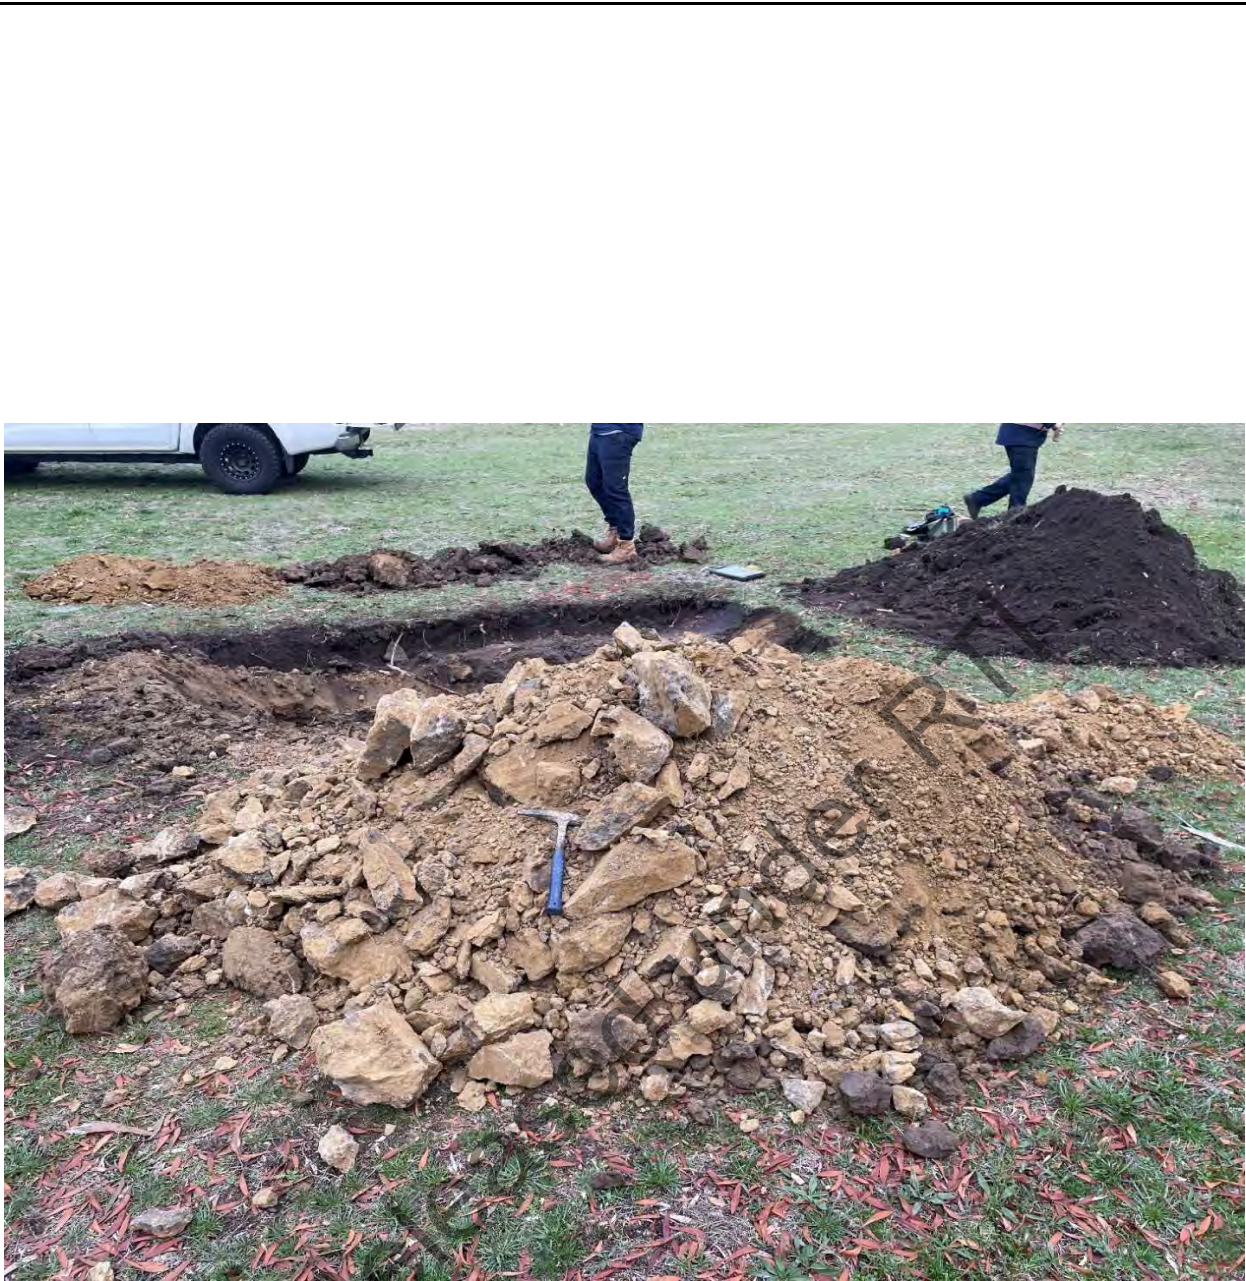
TP20

Photographic Record

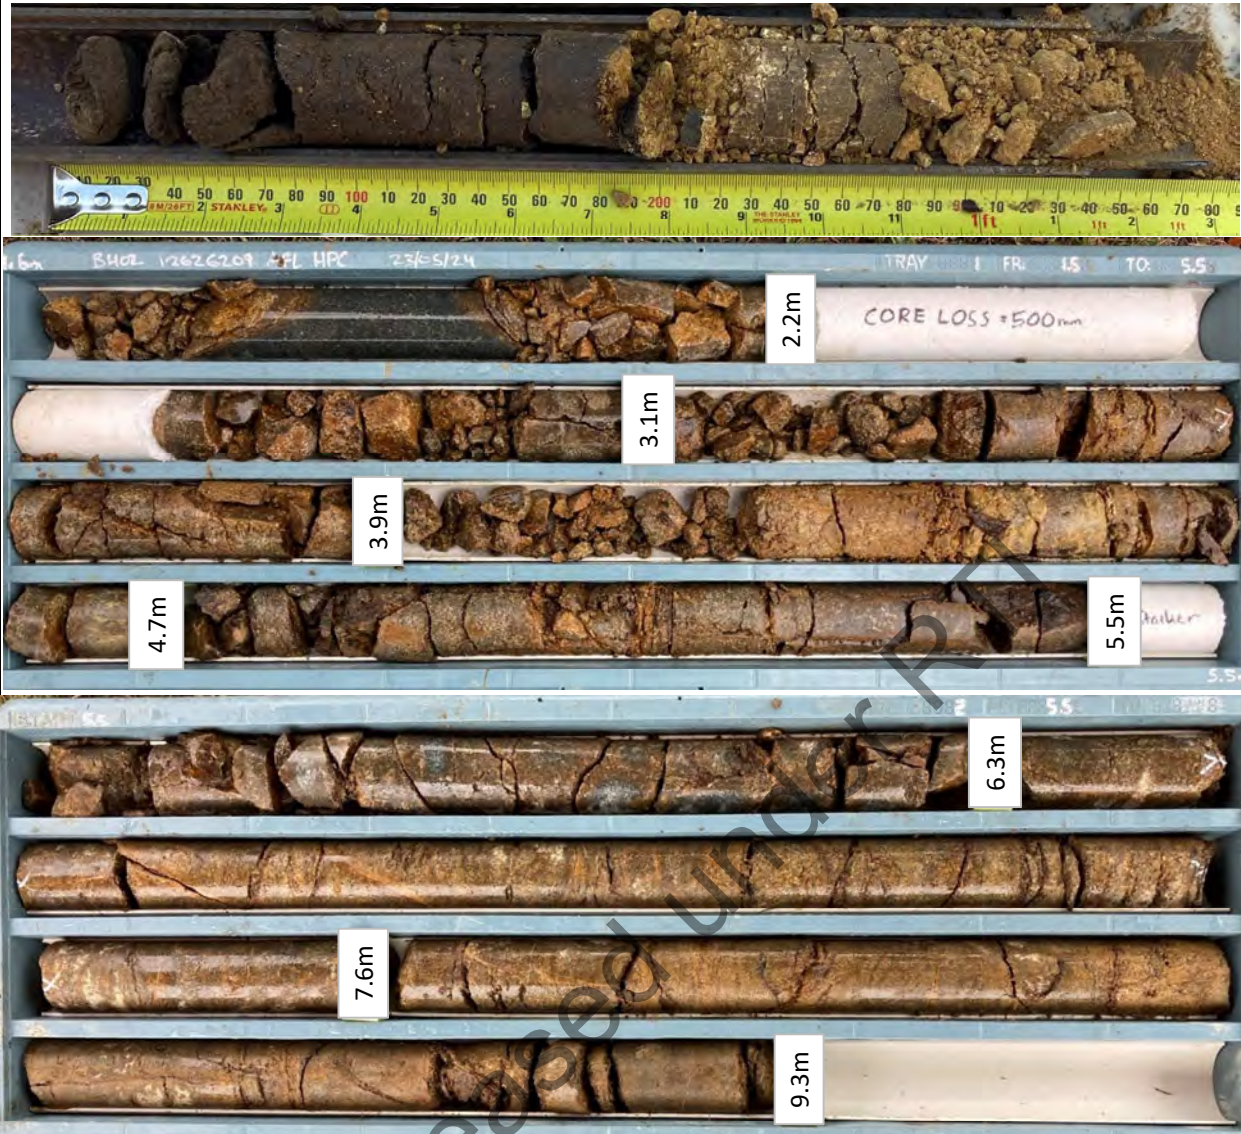
SPT1 (0.9 - 1.35), N* = 43, 350 mm recovered
