## NOTES and ACTIONS – State Roads Emergency

**Event: Rock – Paradise – Tasman Hwy****Date: 27 May 2021****Putalina Room, Salamanca Square****Building and MS Teams****Notes prepared by: s 36****CM: D21/122215****Attendees: see Appendix A****Time: 10:00am**

Item No.	Topic
1	<p>1.1 Aim: To understand and manage the risk of rock movement that has been determined may cause an issue on a section of the Tasman Hwy in the vicinity of Paradise Gorge and to minimise the impacts on people and property.</p>
	<p>1.2 Actions from previous meeting:</p> <p>Maintenance – Action - Advise Stornoway to set up traffic management Friday for a full road closure. Closure to occur at 11:55am. Set up as soon as practical. Commenced and ongoing. s 36 – Action – Alternate routes and timings. No longer required.</p> <p>s 36 – Review TMP when made available, assess Wielangta Road for sign requirements if deemed a viable alternate route. Ongoing</p> <p>s 36 – Action – Identify viable alternate routing and how many VMBs will be required. Ongoing.</p> <p>s 36 – Action – contact aboriginal heritage to see if any sensitive sites are in area. Completed</p> <p>s 36 – Action – Share SCEP. Completed</p> <p>s 36 – Act

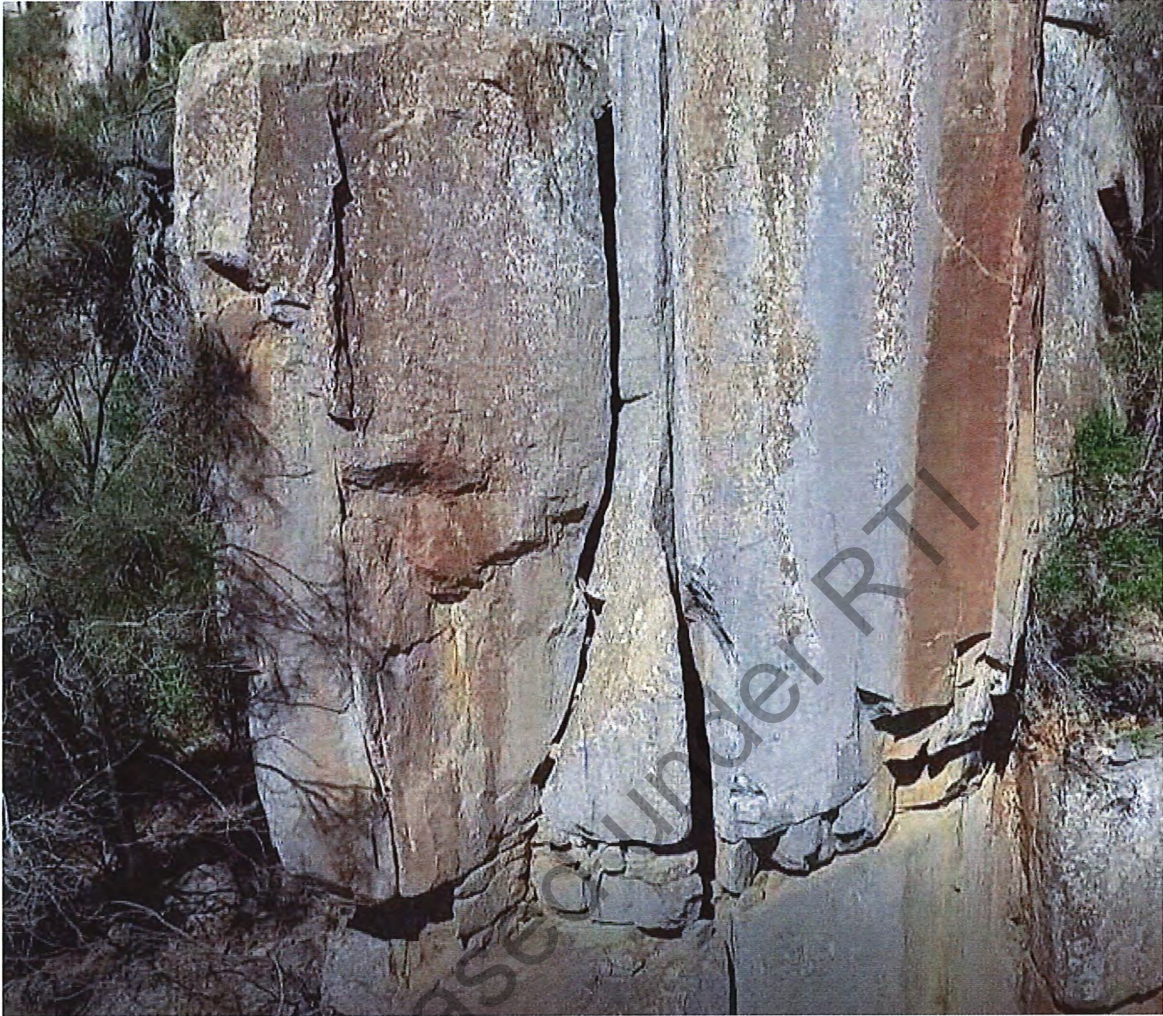
*Figure 2: Undercut column with curving defect behind and crushed rock beneath*

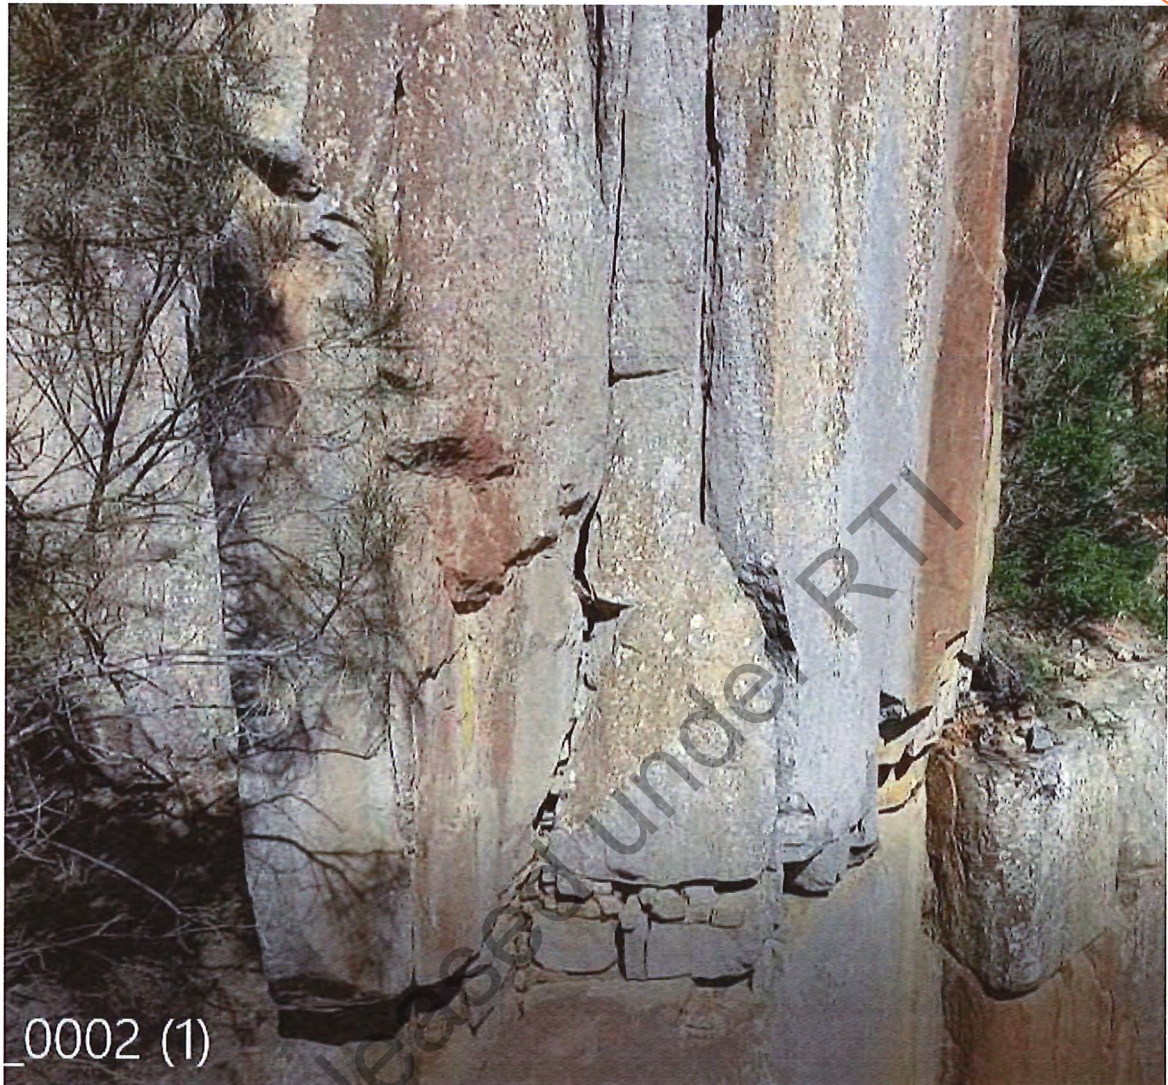
Figure 3: Undercut column pictured in Figure 2 from different angle; detail on crushed rock at base

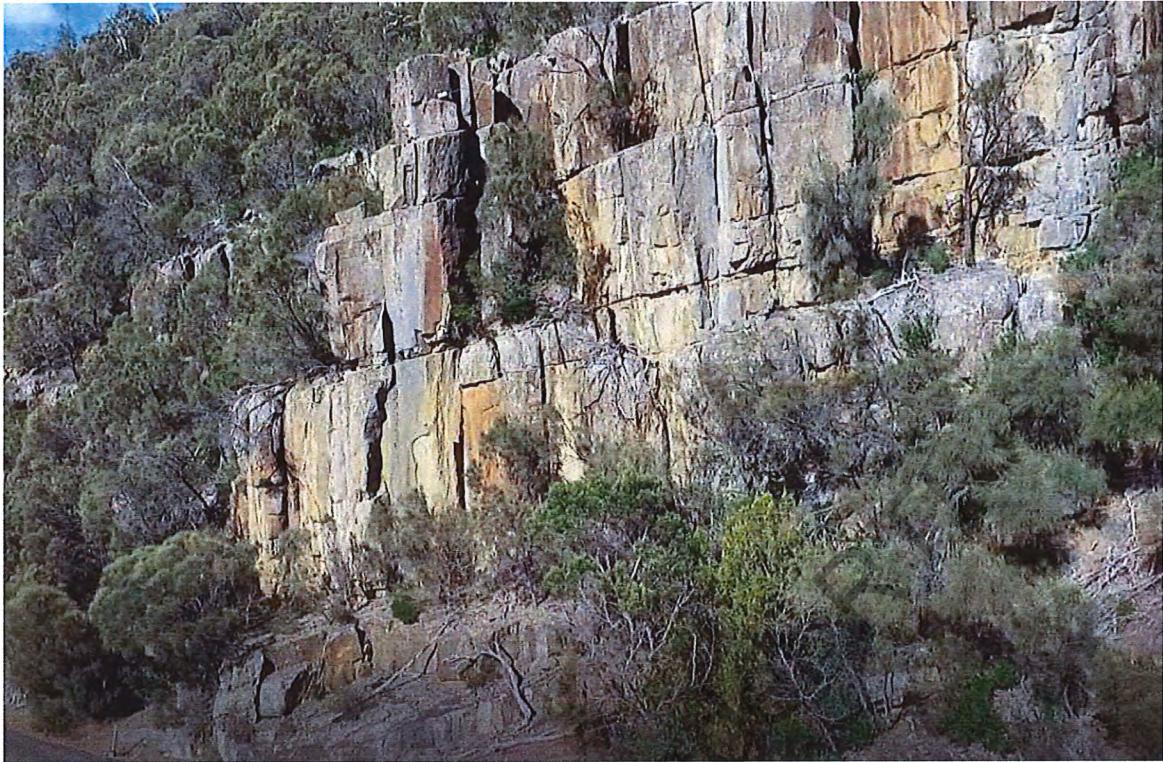
*Figure 4: Wider view of buttness*

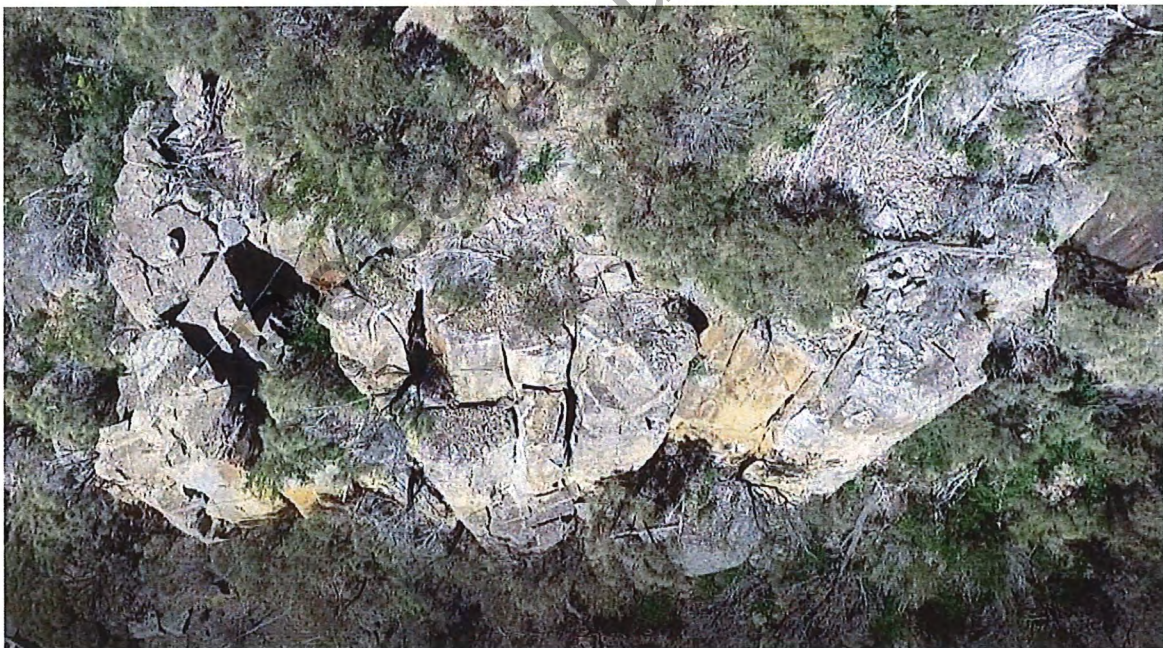
*Figure 5: Top view of buttness; note open cracking*

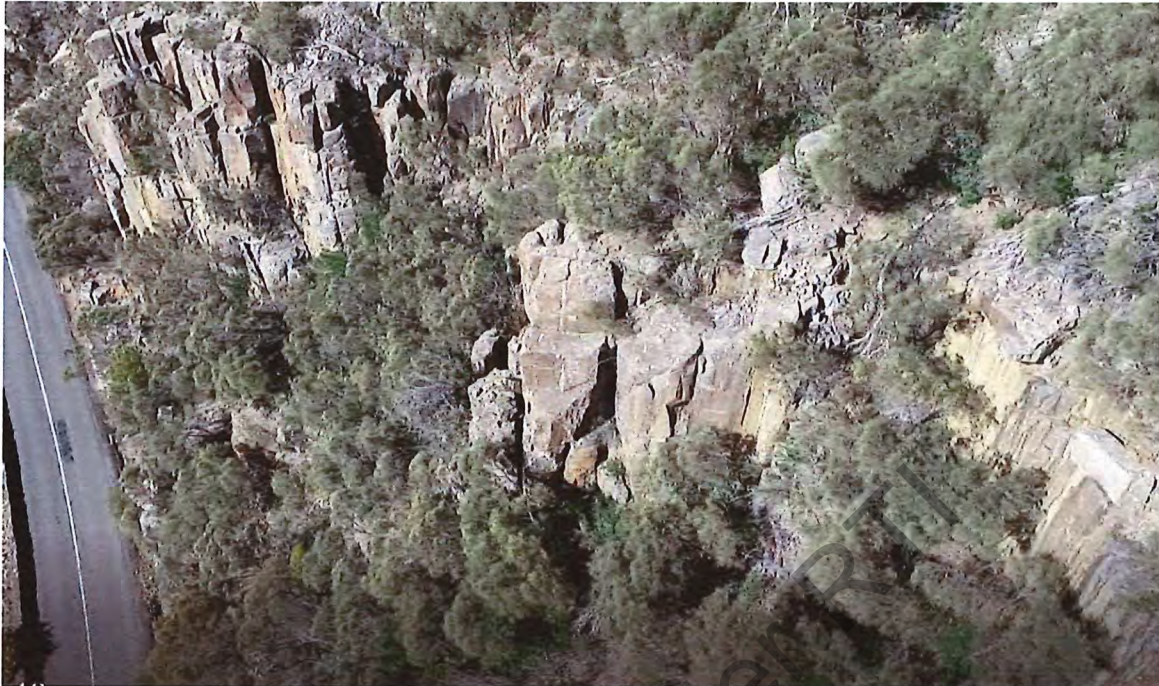
Figure 6: Buttress of interest back left; second buttress middle ground. More open cracking at top.

We recommend that urgent discussions are held with the aim of deciding on practical solutions for both the short and long term cases at the site. We anticipate that the following points will need to be discussed / considered:

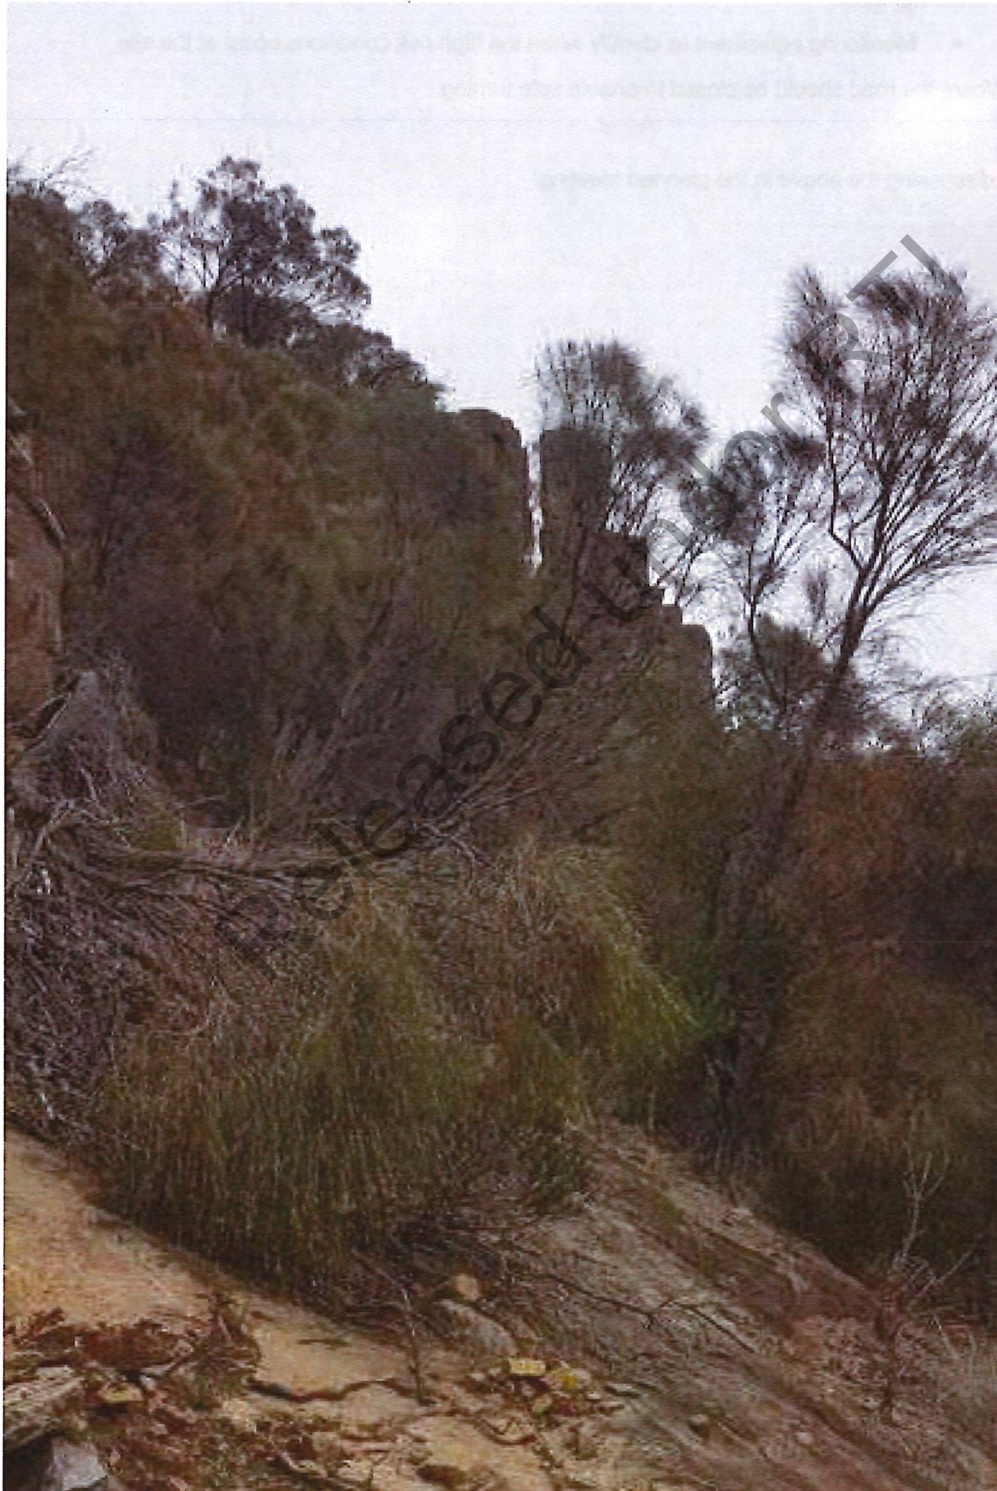
There is a substantial gap between the boulder that is restrained and the buttress behind. The crack is close to 1m wide at the top and around 0.5m wide at the base of the boulder. The crack continues down the column to lower boulders in the stack, gradually narrowing with depth.

Figure 7: View of crack behind restrained boulder

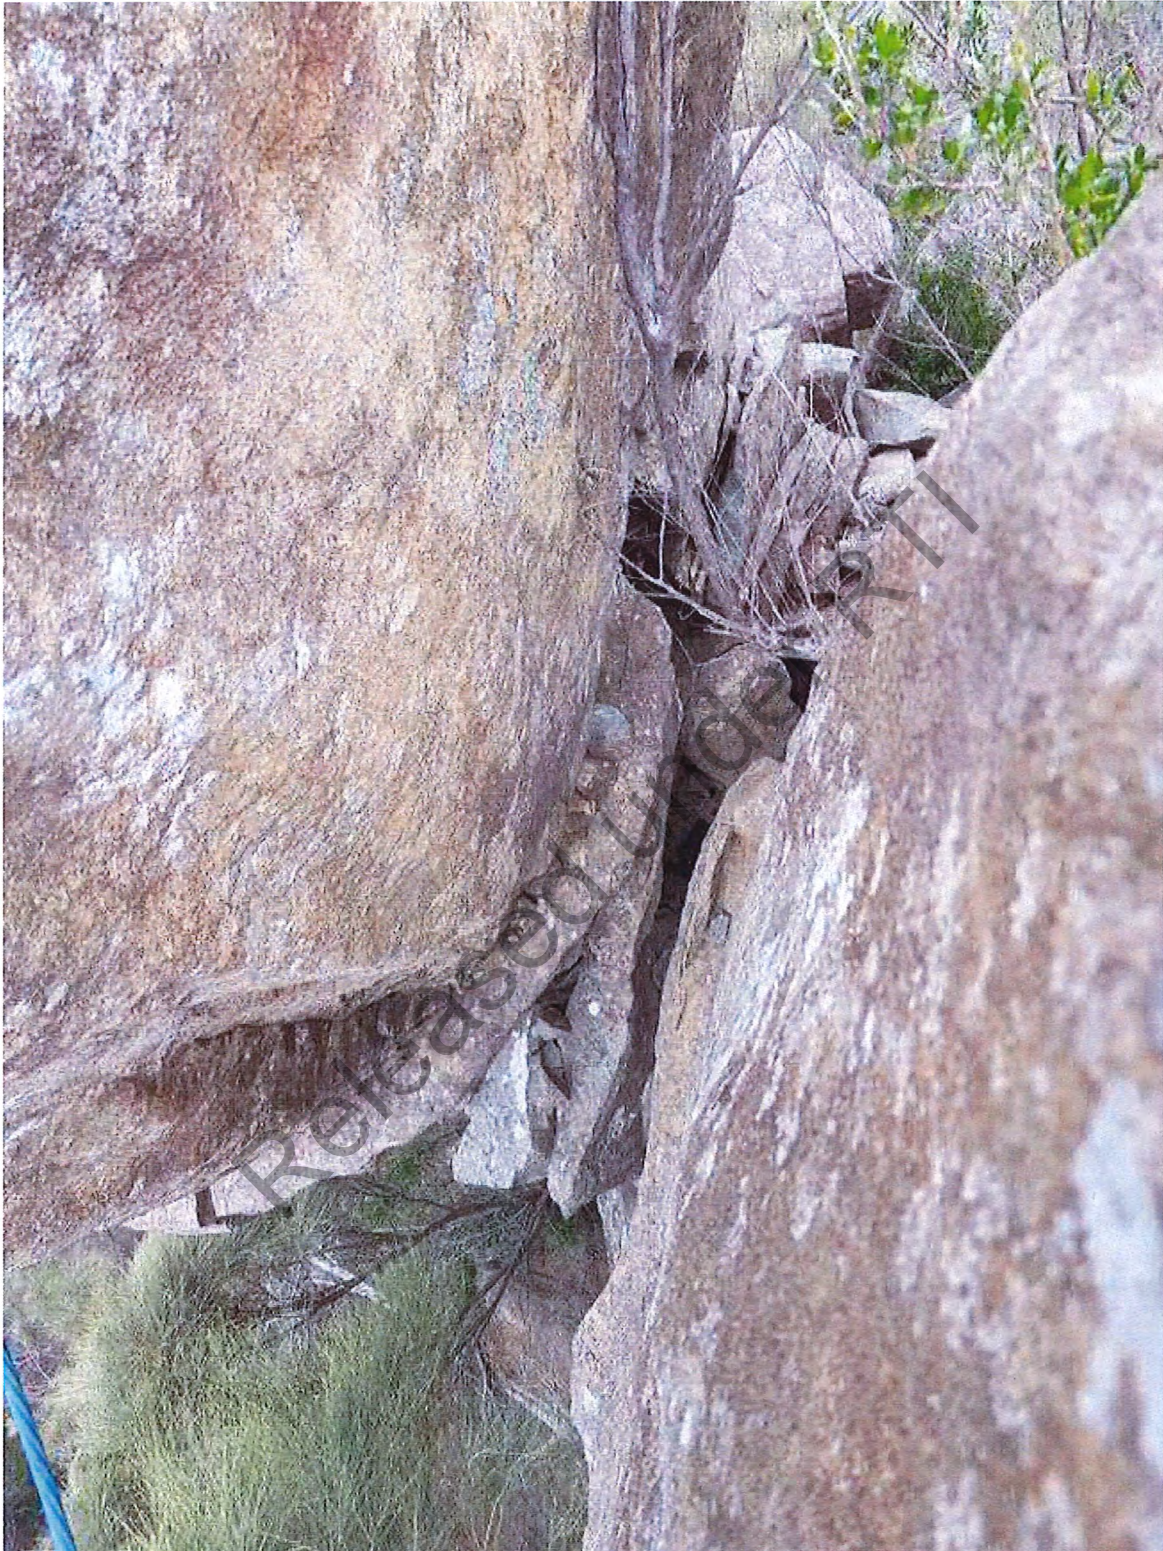
*Figure 8: View down crack at back of restrained boulder*

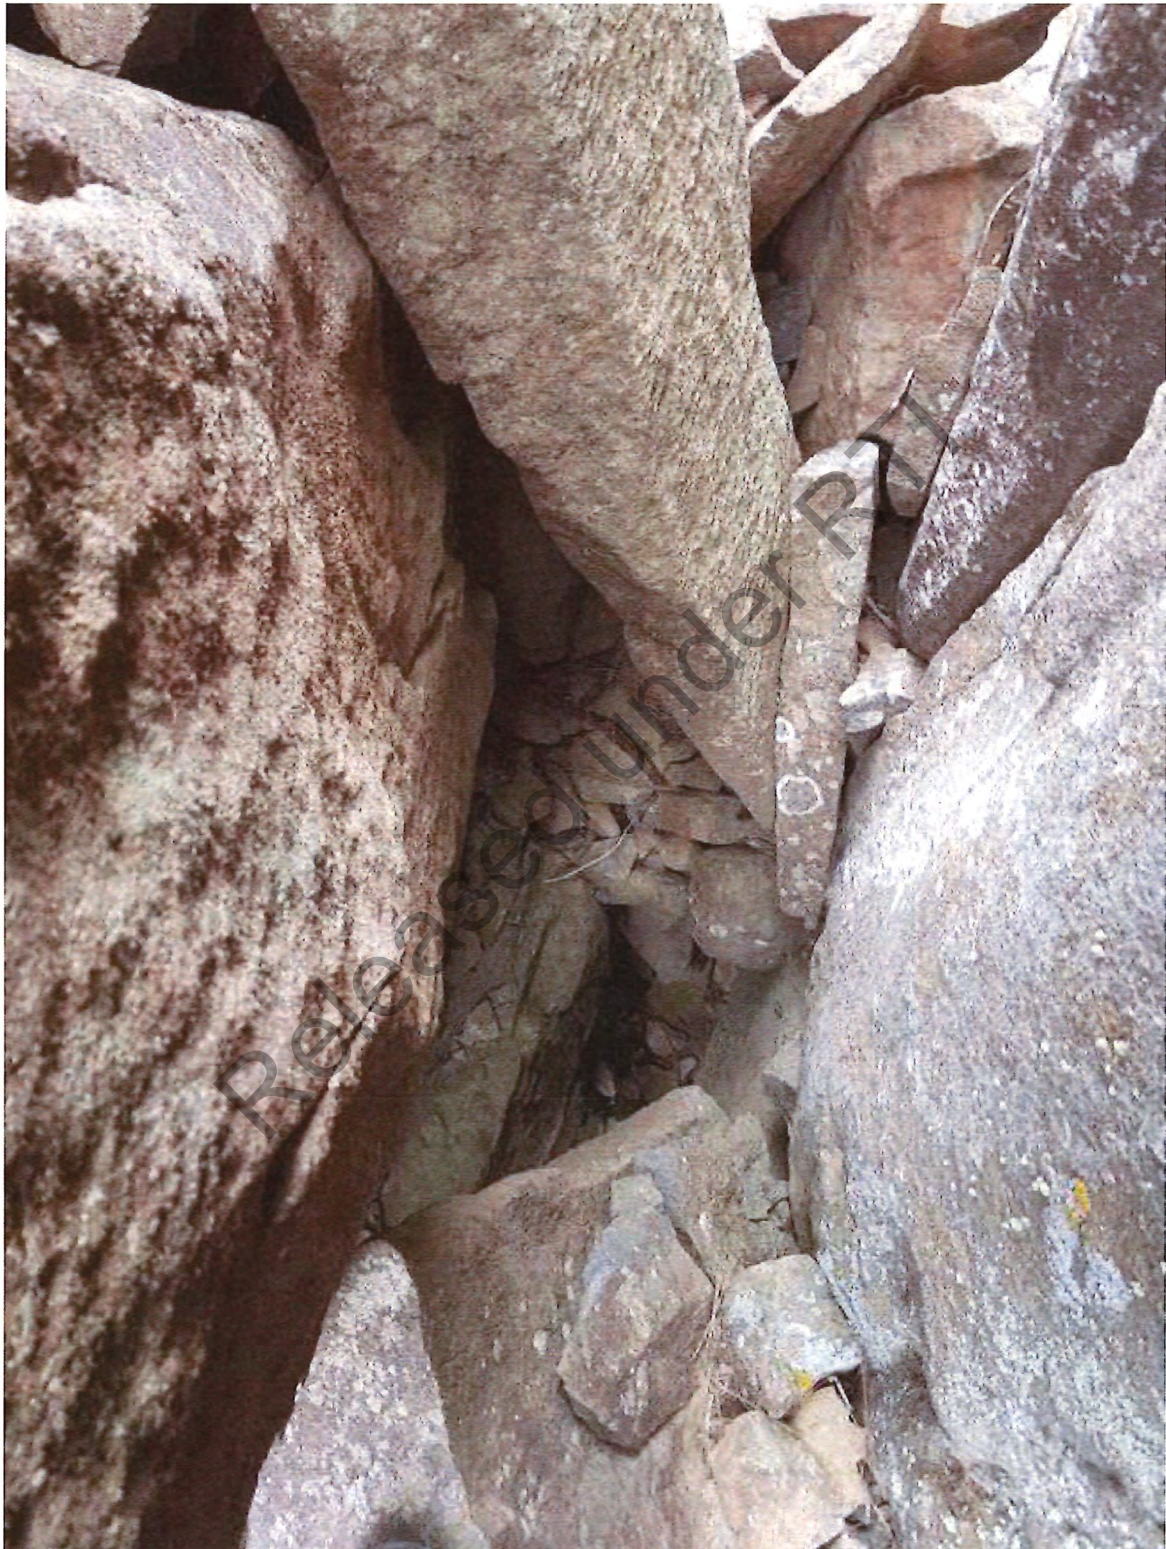
There is a substantial accumulation of rocks and other debris within the crack.

*Figure 9: View from within the crack; taken a little below the base of the restrained boulder*

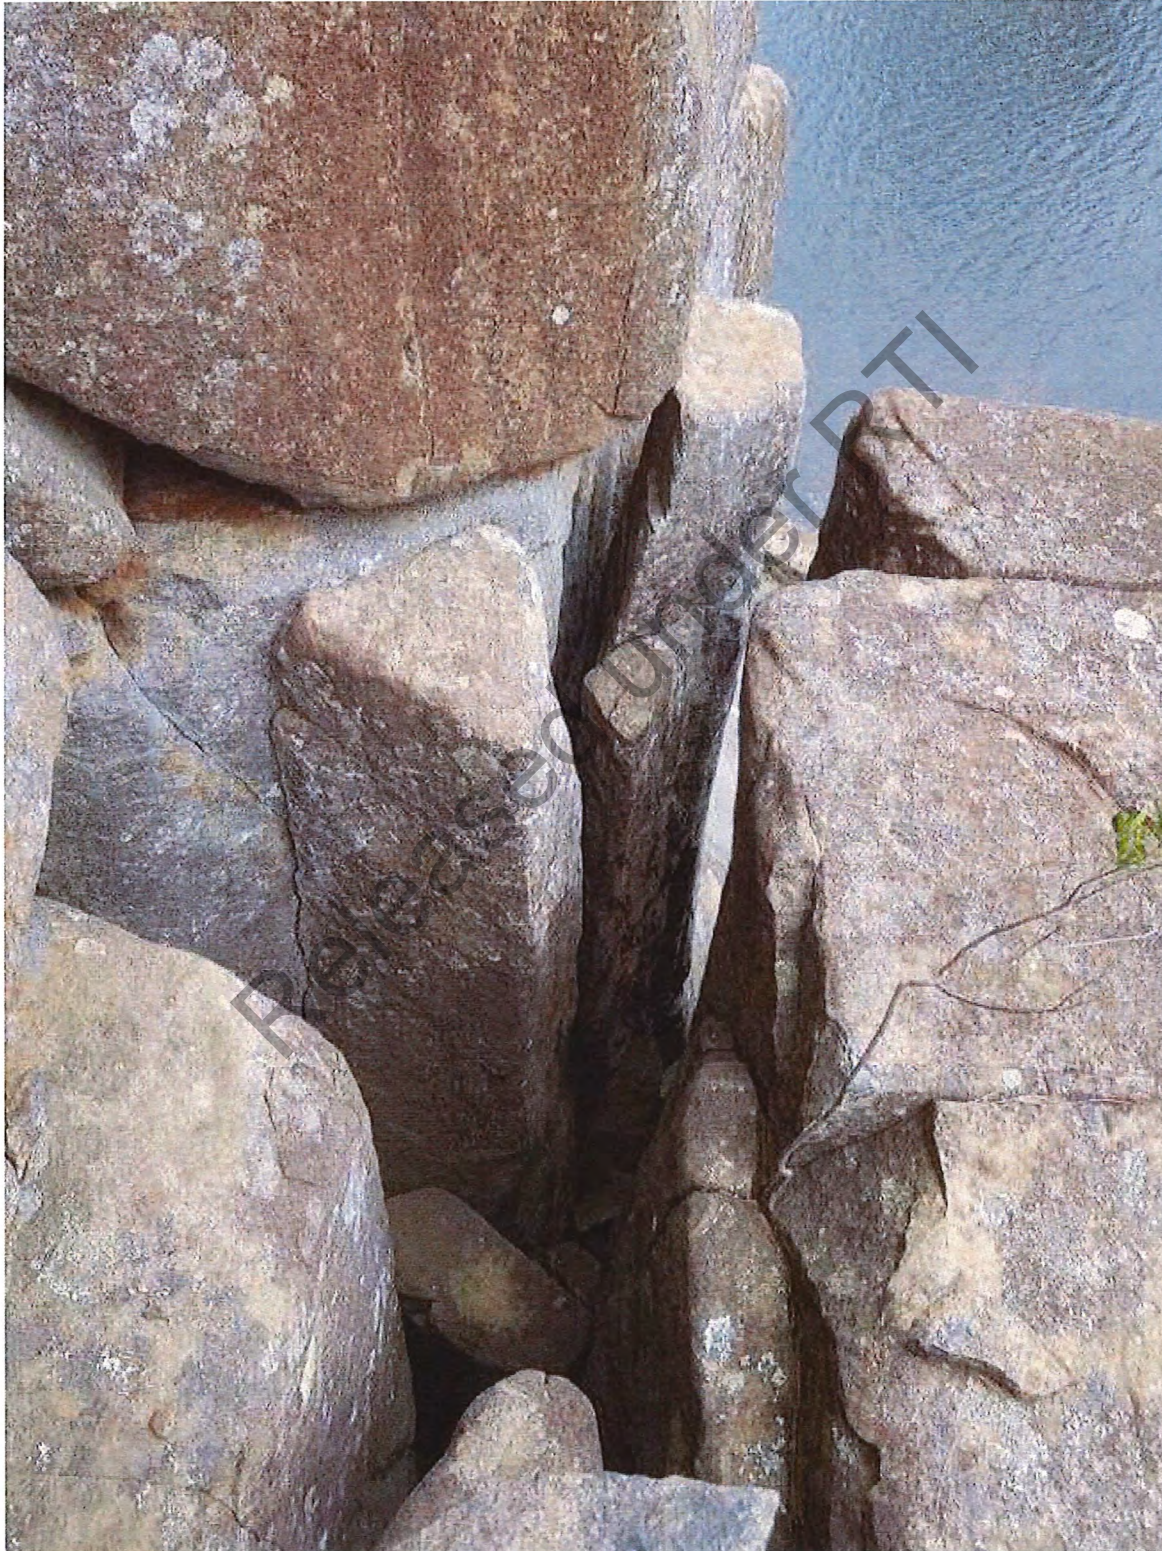
There are substantial cracks separating the columns which form the part of the buttress immediately behind the column topped by the restrained boulder. These are typically in the 200-300mm range at the top of the buttress, and also extend to depths greater than 3m and are typically filled with rock fragments and soil. Defects lower down the buttress are also very open.

Figure 10: Open defects lower down buttress (restrained boulder is above boulder in upper left of photo)

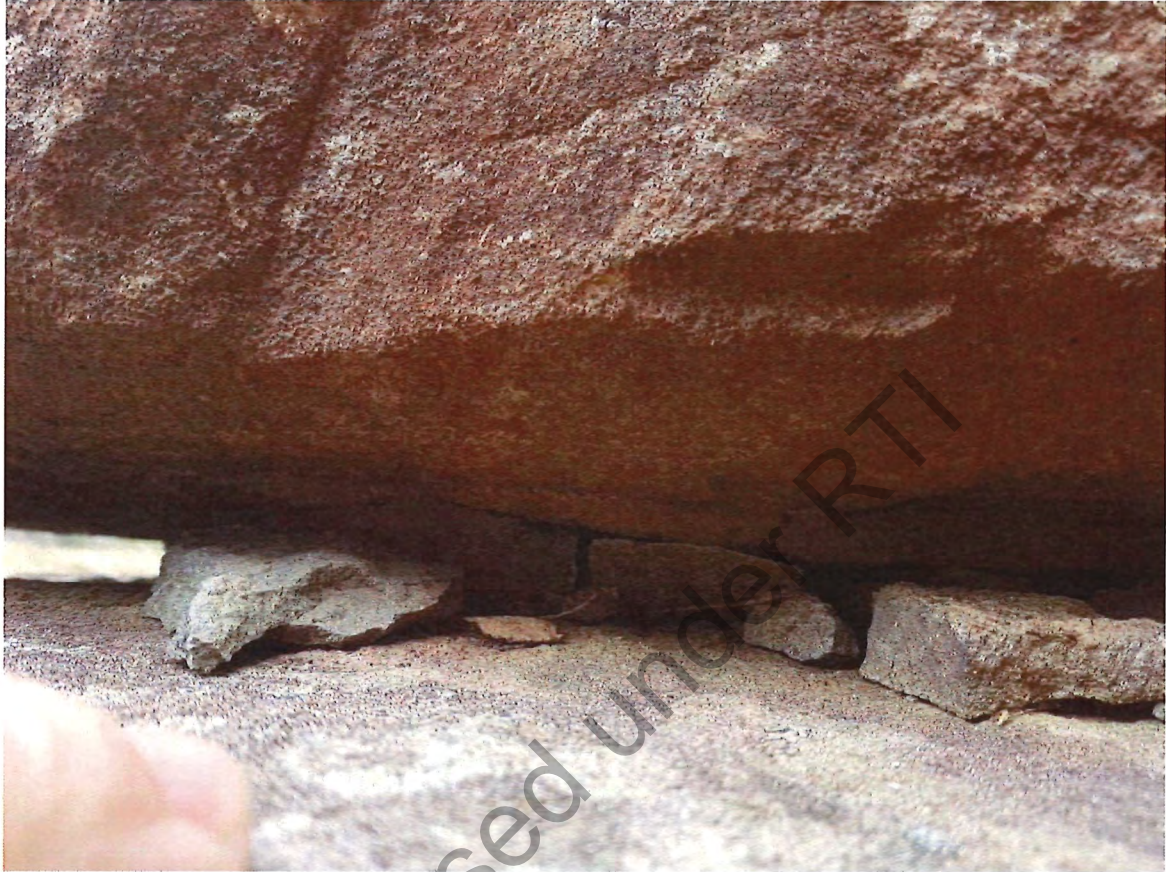
Subhorizontal defects observed on the buttress are also substantially open and typically contain many small rocks separating the larger boulders.

Figure 11: View under restrained boulder

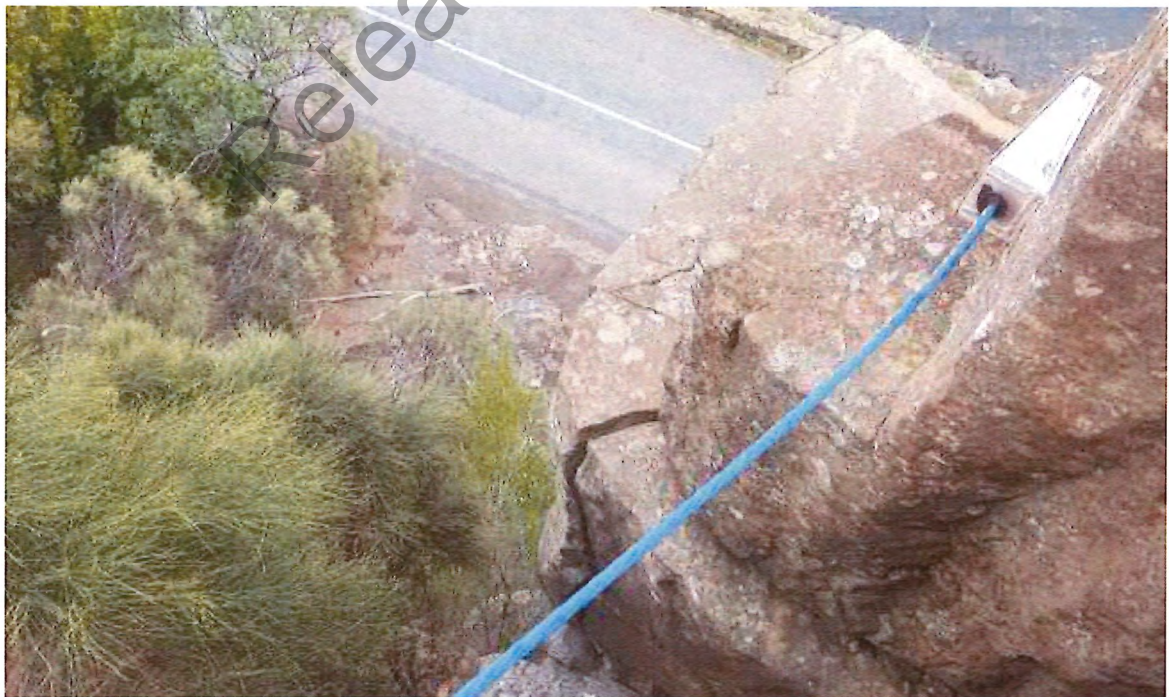
Figure 12: View of end of restraining wire on western side of boulder

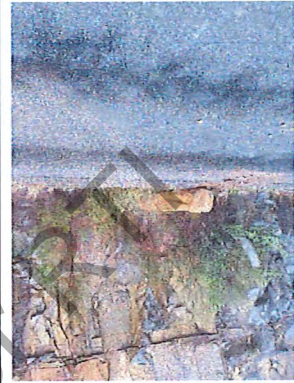
Defect Information			
Defect Number	DN92872	Date Raised	25/03/2021
Defect Type	Potential Minor Works	Response Time	0.0
Primary Location	A0113	Target Date	
Location	20	Estimated Qty	500.00
Description	Large rock fallen from rock brace storm damage march 2020		
<b>Rectification Information</b>			
Work Team	██████████	Completion Date	
Work Group	MINOR WORKS	Actual Quantity	
Activity	B05.04A	Team Leader	
Time Worked		Signed	
Comments	<MAP>		
Audit Trail			
1. Date Raised		6. Date Received	
2. Date Printed		7. Received by	
3. Date Issued		8. Input to Reflect by	
4. Issued to		9. Date Input	
5. Work Completed		10. Further Action (Y/N)	
Comments

Location of Defect

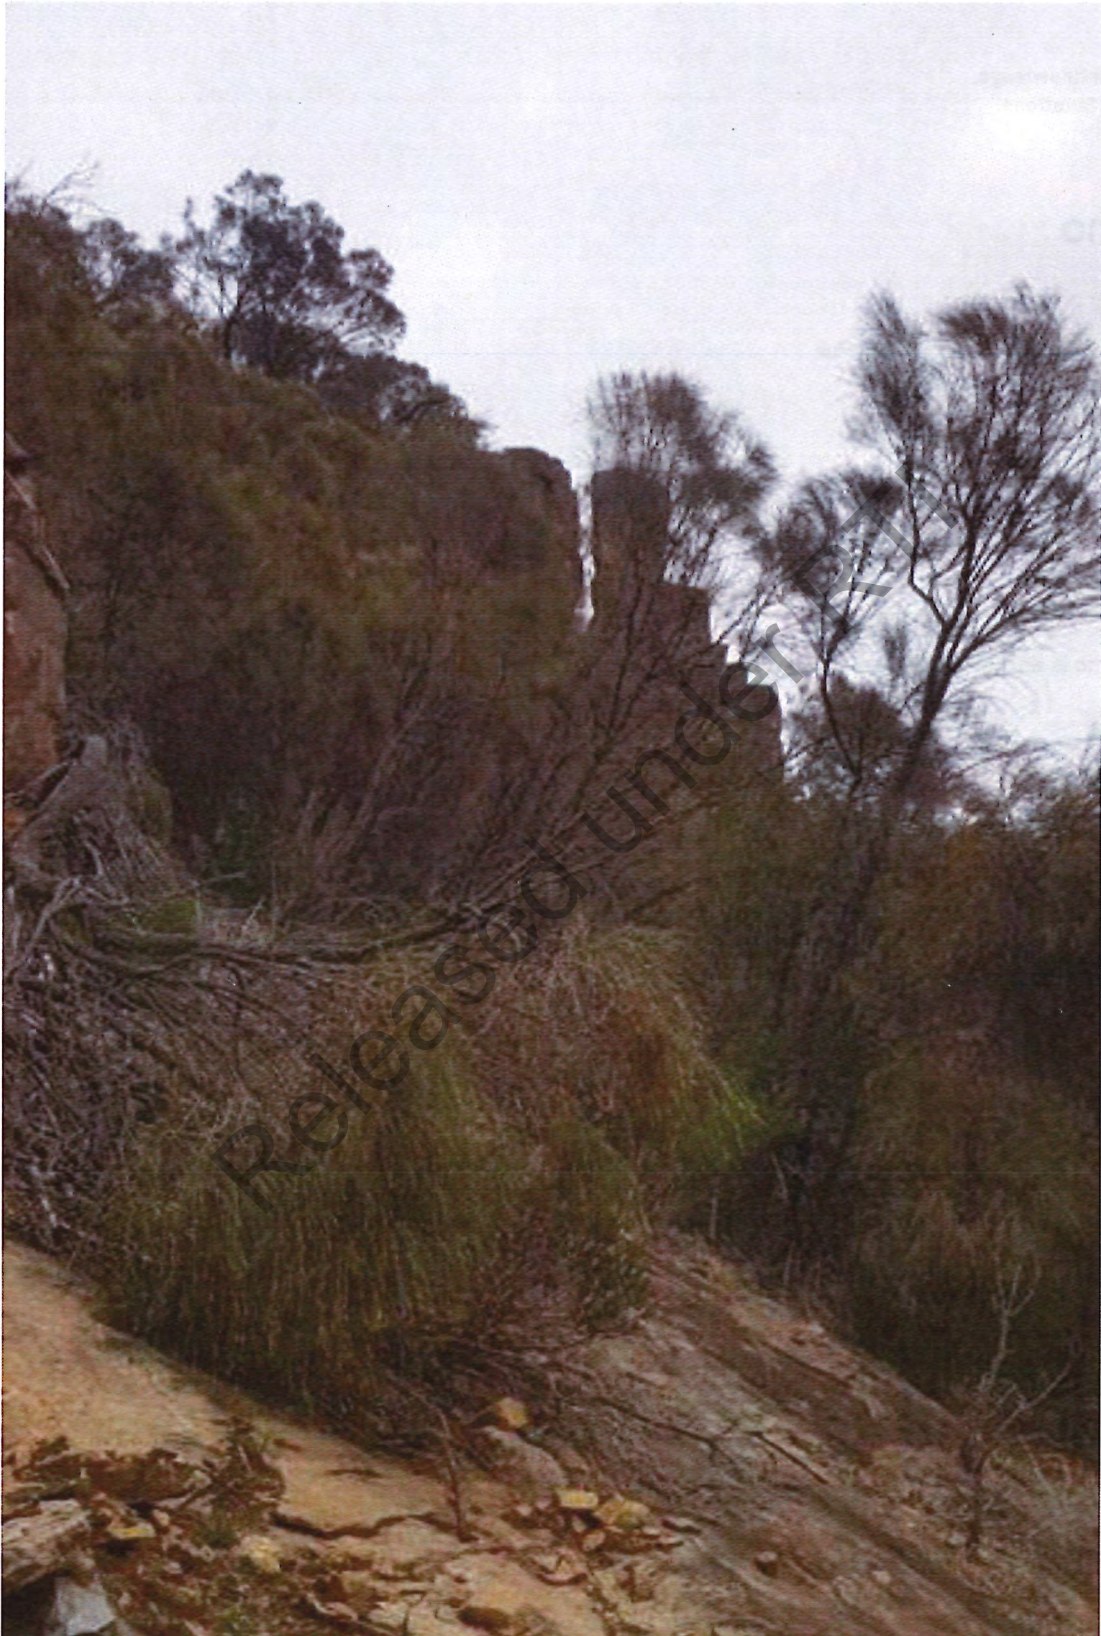
There is a substantial gap between the boulder that is restrained and the buttrass behind. The crack is close to 1m wide at the top and around 0.5m wide at the base of the boulder. The crack continues down the column to lower boulders in the stack, gradually narrowing with depth.

Figure 1: View of crack behind restrained boulder

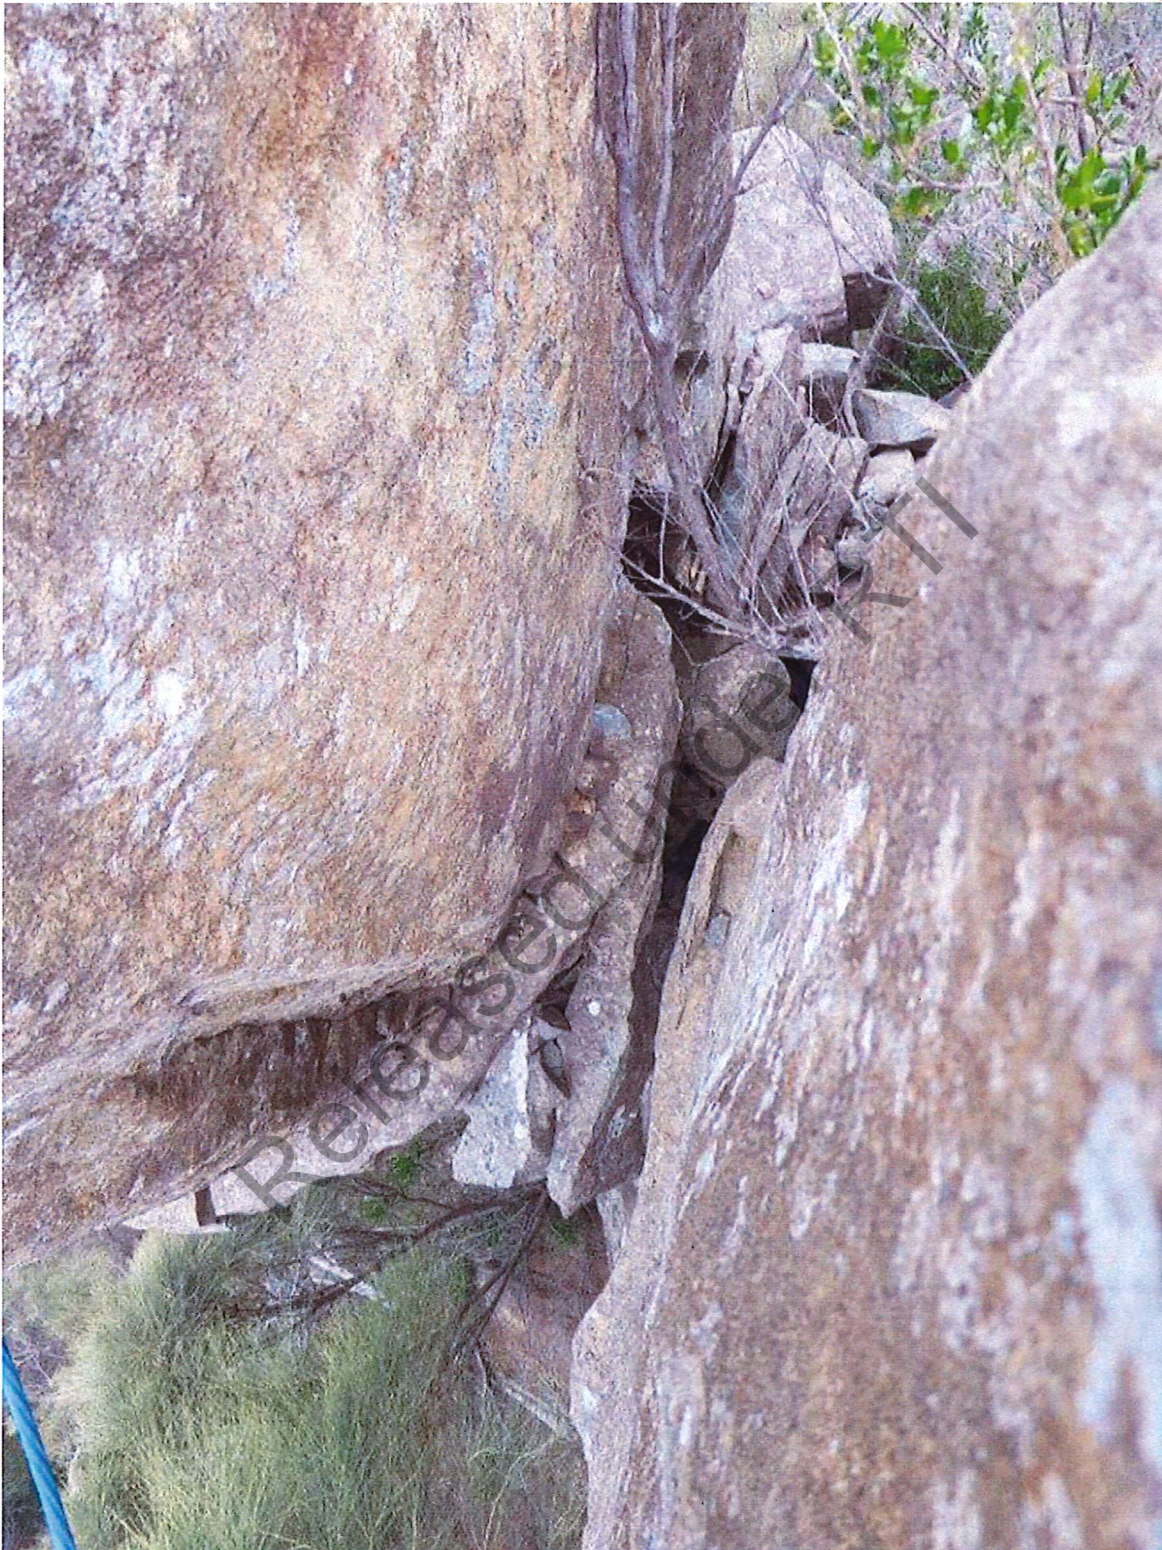
Figure 2: View down crack at back of restrained boulder

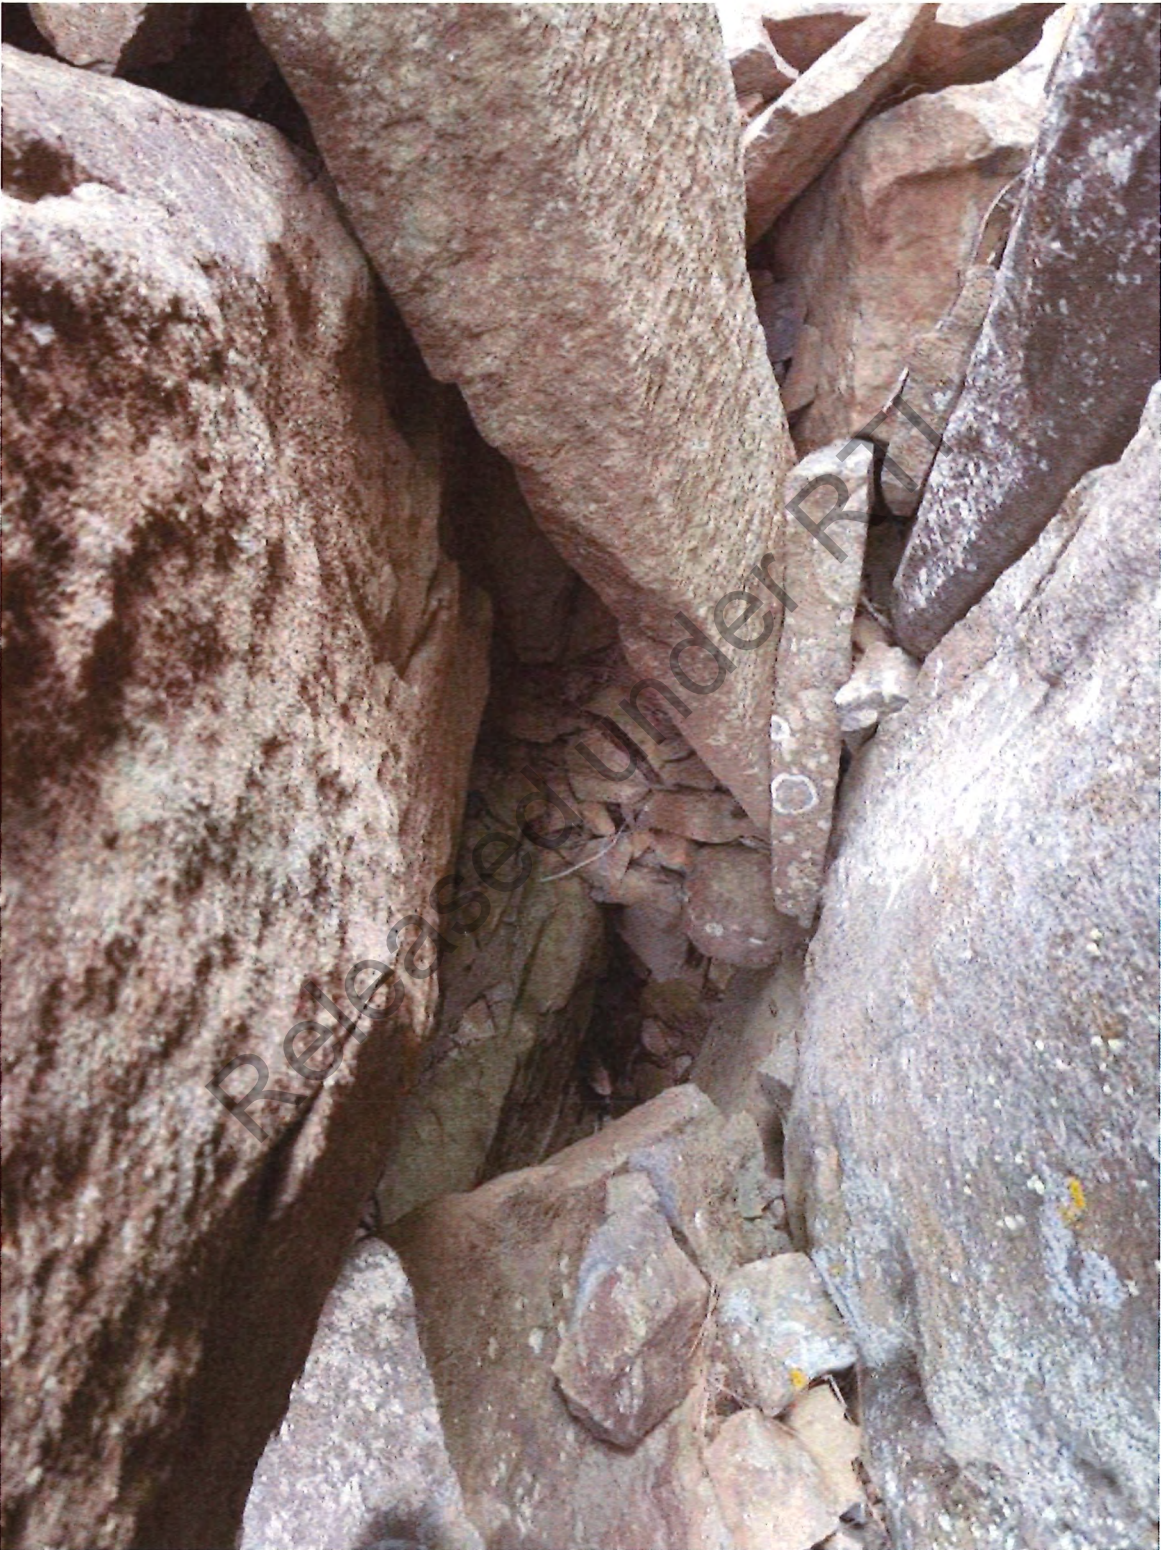
There is a substantial accumulation of rocks and other debris within the crack.

Figure 3: View from within the crack; taken a little below the base of the restrained boulder

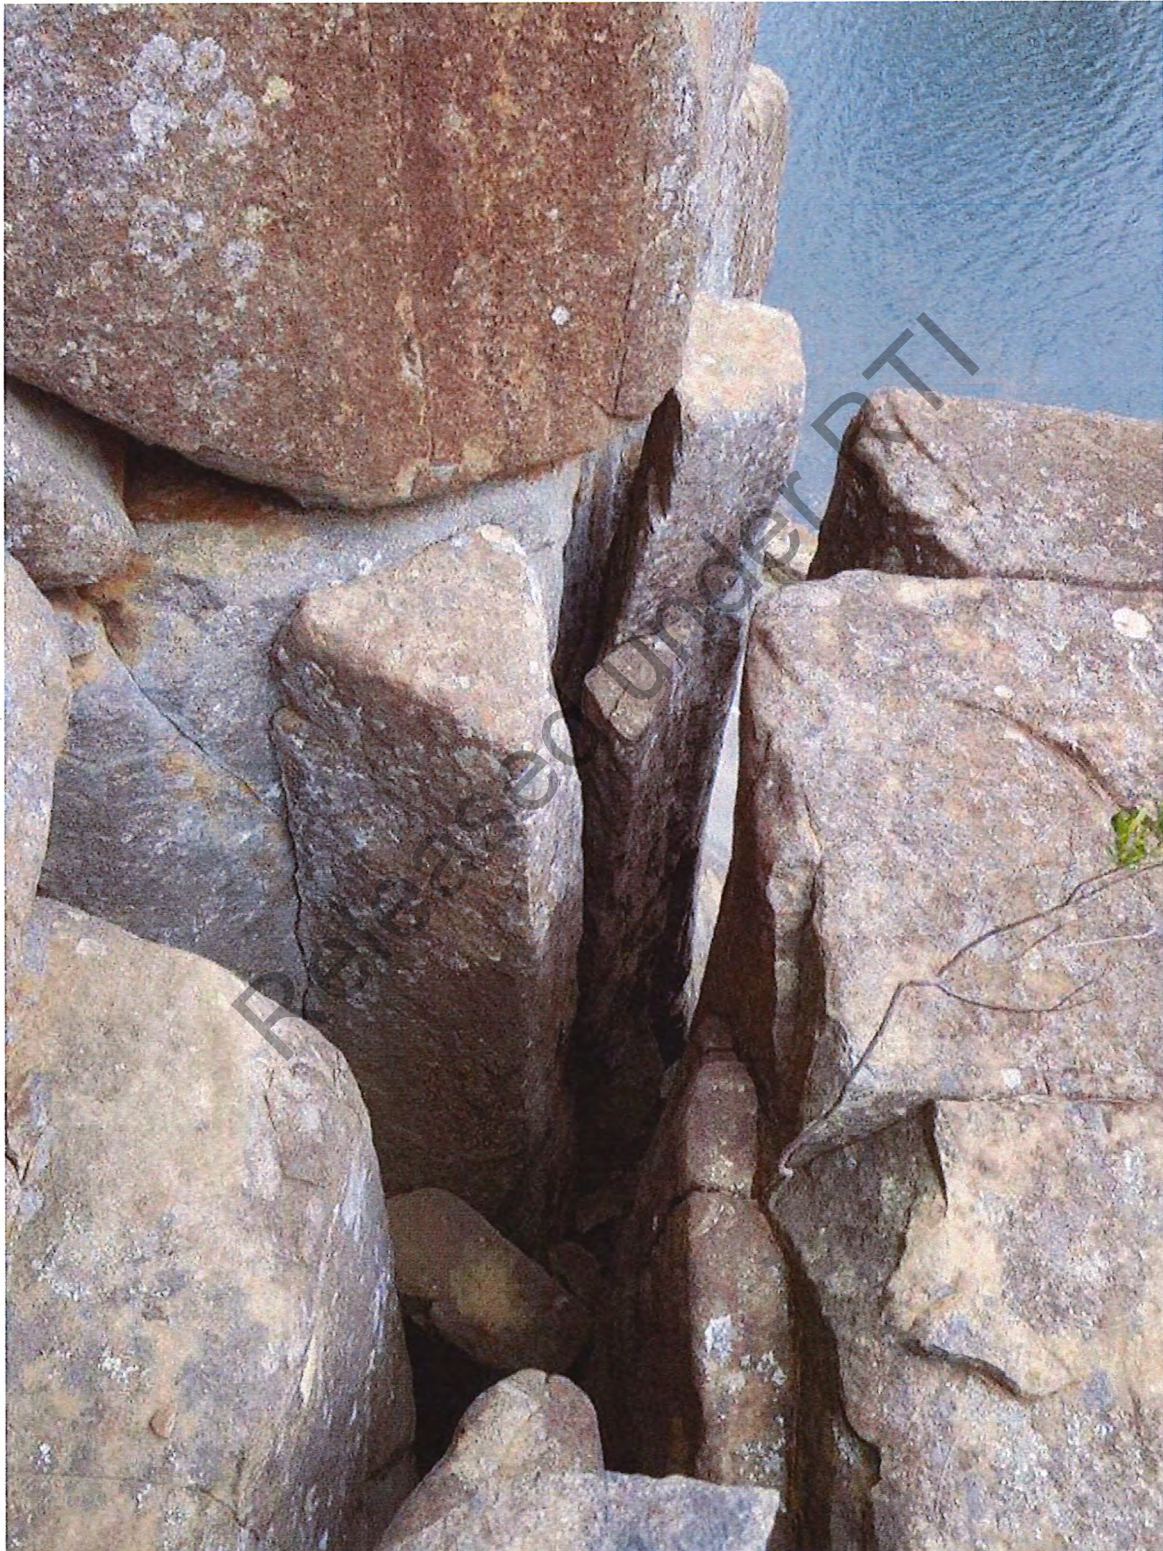
There are substantial cracks separating the columns which form the part of the buttress immediately behind the column topped by the restrained boulder. These are typically in the 200-300mm range at the top of the buttress, and also extend to depths greater than 3m and are typically filled with rock fragments and soil. Defects lower down the buttress are also very open.

Figure 4: Open defects lower down buttress (restrained boulder is above boulder in upper left of photo)
