## NOTES and ACTIONS – State Roads Emergency

**Event: Rock – Paradise – Tasman Hwy****Date: 27 May 2021****Putalina Room, Salamanca Square****Building and MS Teams****Notes prepared by: s 36****CM: D21/122215****Attendees: see Appendix A****Time: 10:00am**

Item No.	Topic
1	<p>1.1 Aim: To understand and manage the risk of rock movement that has been determined may cause an issue on a section of the Tasman Hwy in the vicinity of Paradise Gorge and to minimise the impacts on people and property.</p>
	<p>1.2 Actions from previous meeting:</p> <p>Maintenance – Action - Advise Stornoway to set up traffic management Friday for a full road closure. Closure to occur at 11:55am. Set up as soon as practical. Commenced and ongoing. s 36 – Action – Alternate routes and timings. No longer required.</p> <p>s 36 – Review TMP when made available, assess Wielangta Road for sign requirements if deemed a viable alternate route. Ongoing</p> <p>s 36 – Action – Identify viable alternate routing and how many VMBs will be required. Ongoing.</p> <p>s 36 – Action – contact aboriginal heritage to see if any sensitive sites are in area. Completed</p> <p>s 36 – Action – Share SCEP. Completed</p> <p>s 36 – Act

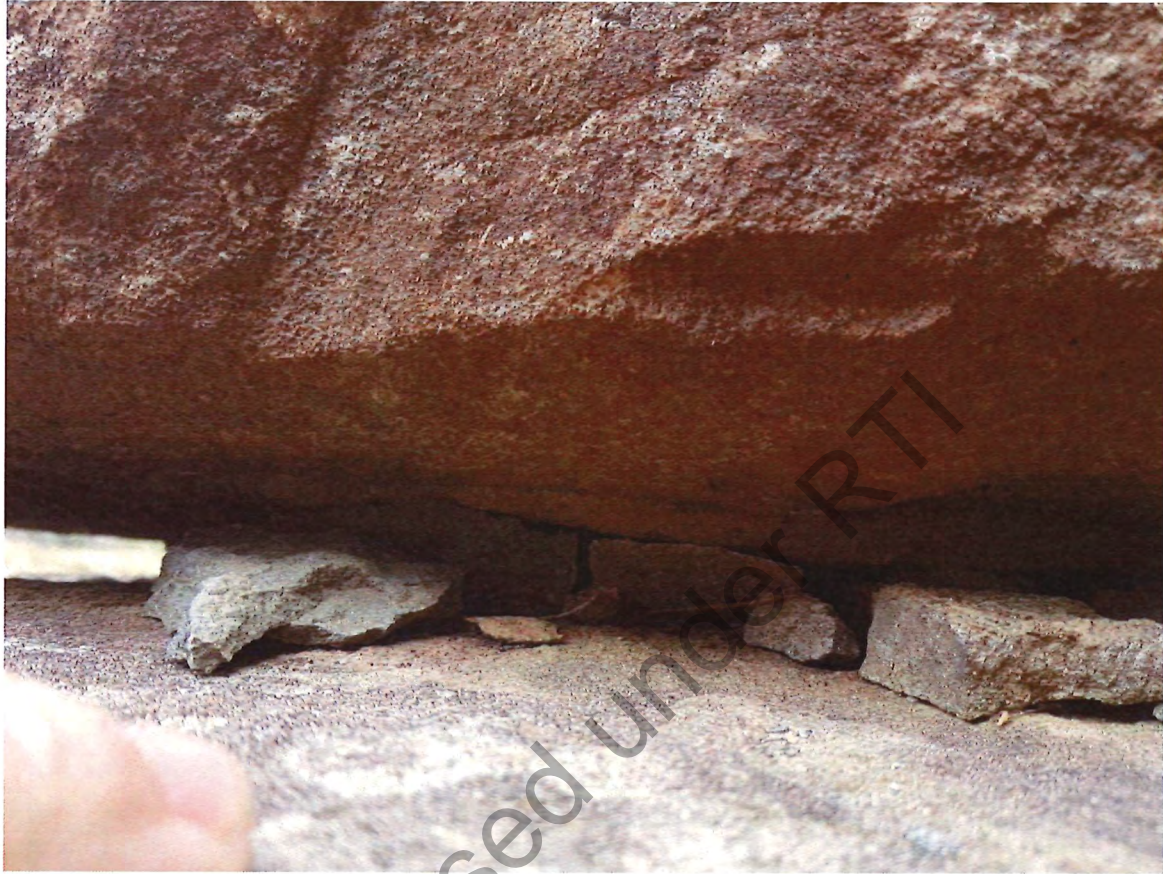
Subhorizontal defects observed on the buttress are also substantially open and typically contain many small rocks separating the larger boulders.

Figure 5: View under restrained boulder

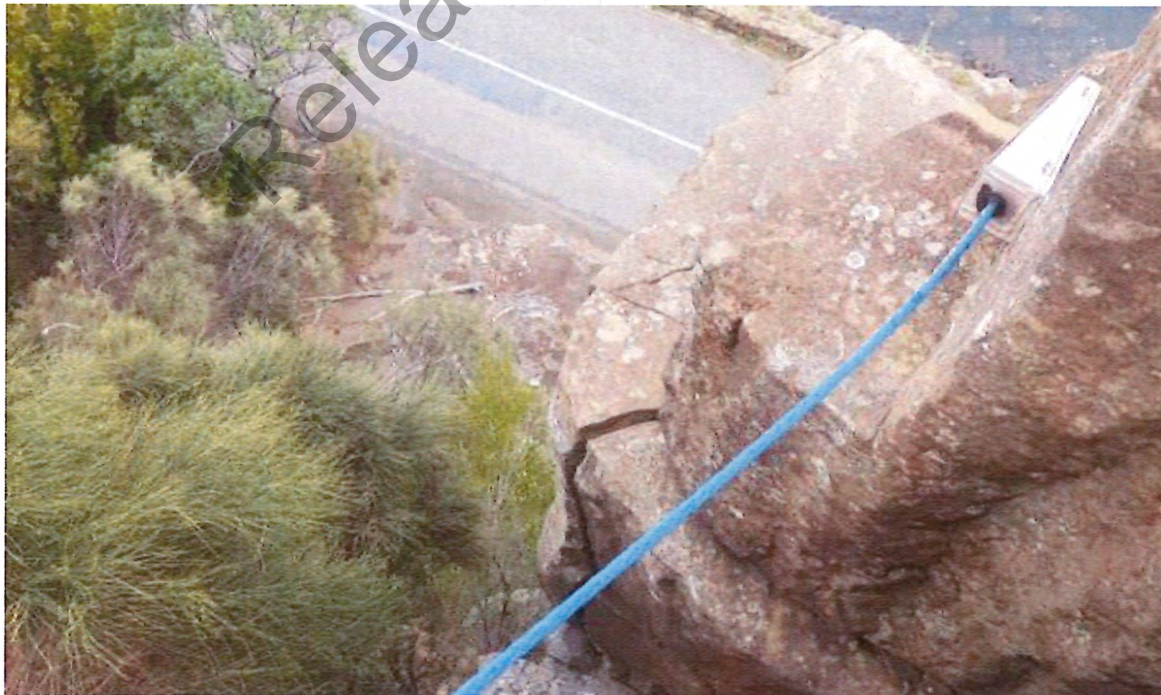
Figure 6: View of end of restraining wire on western side of boulder

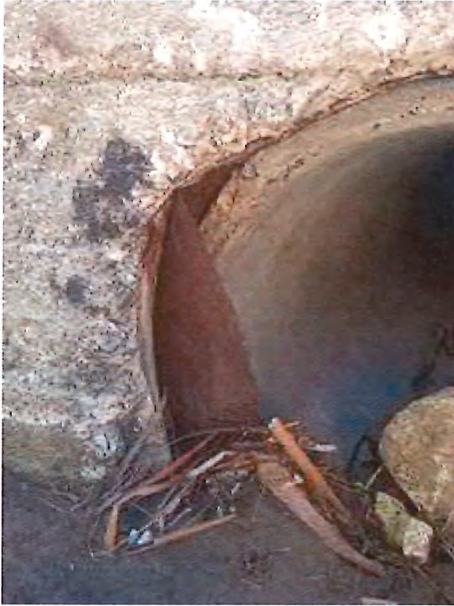
- Second culvert east of inspection start (approximate chainage 9.07km): The inlet to this culvert is partially blocked by fine sand and rocks. In addition, part of the steel liner has been bent in and will further restrict water flow in the event of another major rain event.

Both issues should be fixed, but are not considered urgent. The outlet has suffered extensive scour on each side of the headwall.

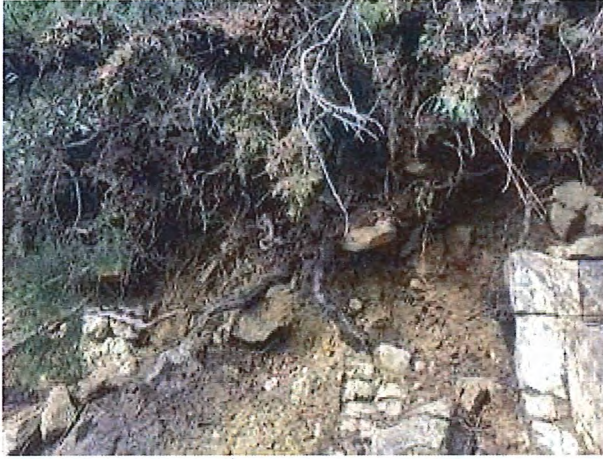
- Third culvert east of inspection start (approximate chainage 9.13km): This culvert is clear but there is an overhang that has formed in the material adjacent to the inlet of the culvert. It is recommended that this material is battered back to avoid the possibility of a collapse into the culvert and subsequent blockage.

This is not considered urgent.

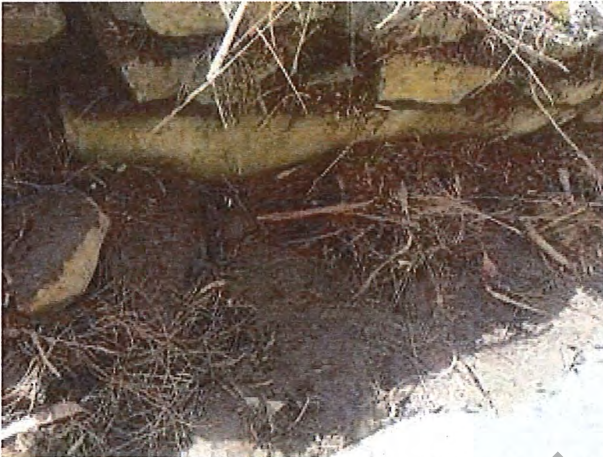
- Fourth culvert east of inspection start (approximate chainage 9.18km): This inlet to this culvert is completely blocked. It is recommended that this is cleared.

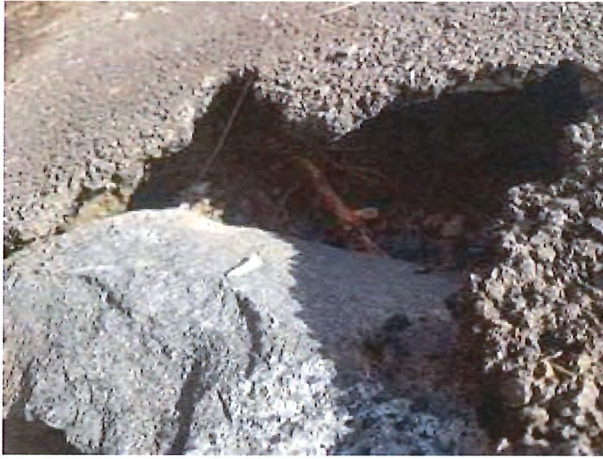
- Sixth culvert east of inspection start (chainage painted on rock wall 9.36km): The inlet to this culvert is partially blocked with rock fragments and vegetation, though the culvert is still running. The asphalt seal beside the headwall has become undermined. Clearing this culvert and repairing the seal is considered not to be urgent.

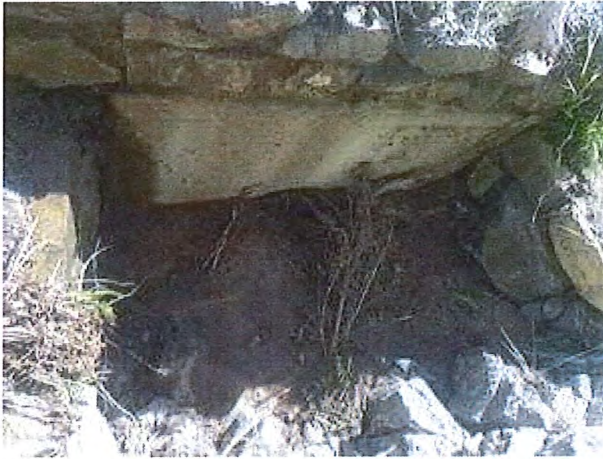
- Eighth culvert east of inspection start (estimated chainage 9.48km): This culvert is almost completely blocked by clay.

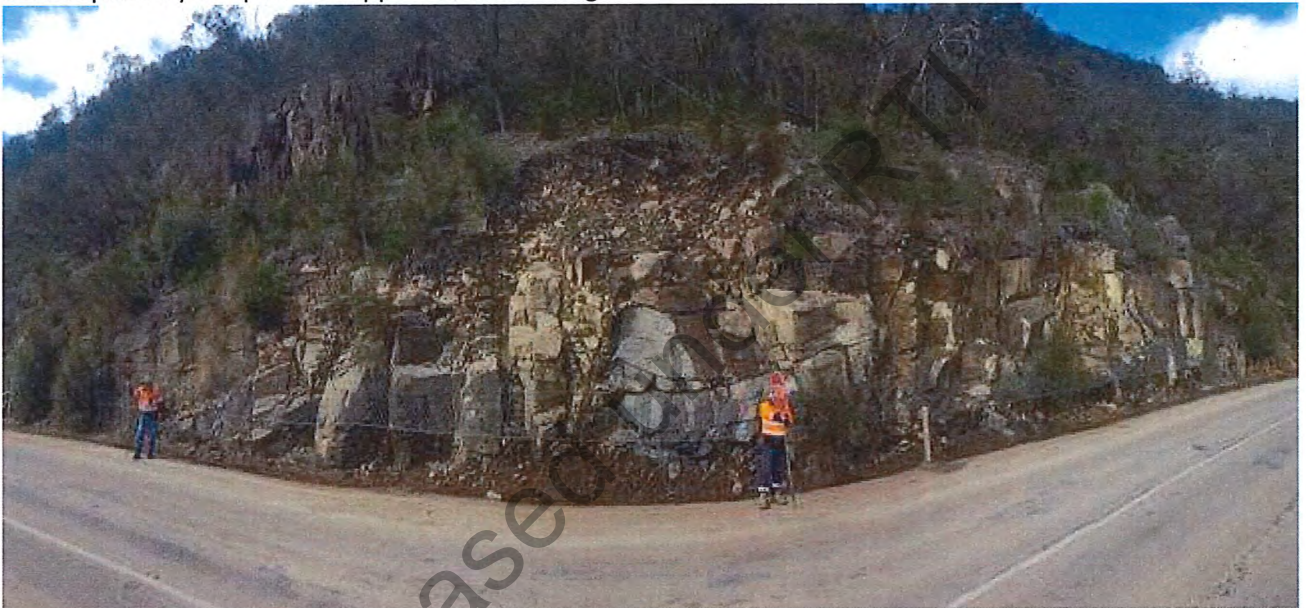
- Netting (estimated chainage 9.45km and beyond): The netting that was installed on the slope appears to be performing as intended by guiding falling material to the base of the slope at low velocity. Some regression of the headscarp of a colluvial failure appears to have occurred, but other boulders in the area appear to be held in place by the passive support of the netting.
