This folder is for the 12 and 6 Month servicing of the Tasman Bridge

12 Monthly service April
2019- Inspections and
recommendations

Tasman Bridge Gantry Structural Capacity Assessment

6137698-MEM-0002-A Durability Assessment of Tasman Bridge Beams

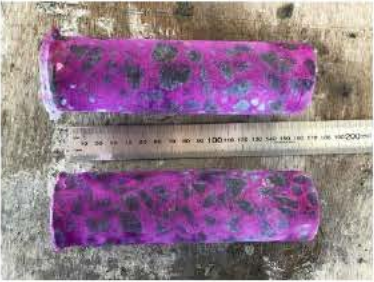
GHD obtained four 45 mm diameter concrete cores samples from the web of the deck beams slightly west of the mid-point of span 21, as shown on Figure 1, Figure 2 and Figure 3. Each core passed through the full web section. Cores were taken from the upper region of the beam webs to avoid embedded post-tensioned cables. Typical photos are shown for beam 1 in Table 1.

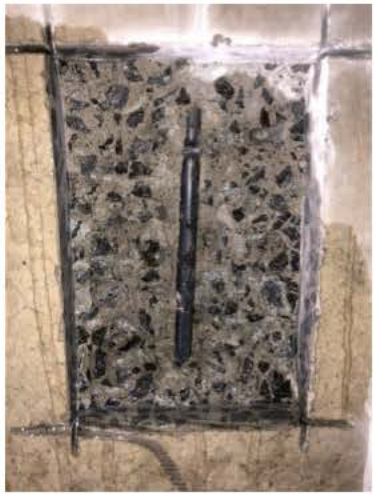
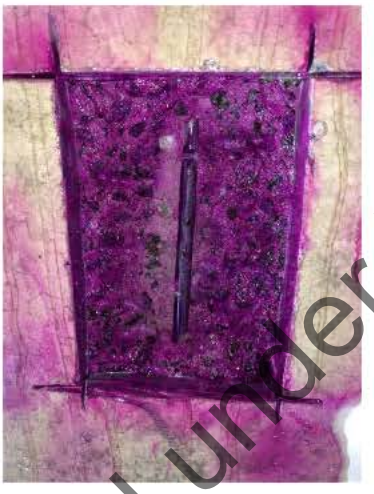
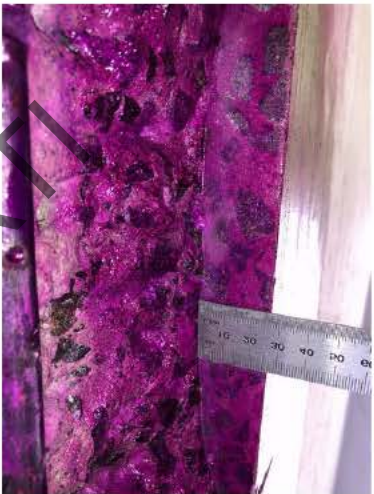
Breakout	Breakout with phenolphthalein indicator	Breakout depth

Each end of each core was marked with “N” or “S” to designate the “North” and “South” faces of the beams.

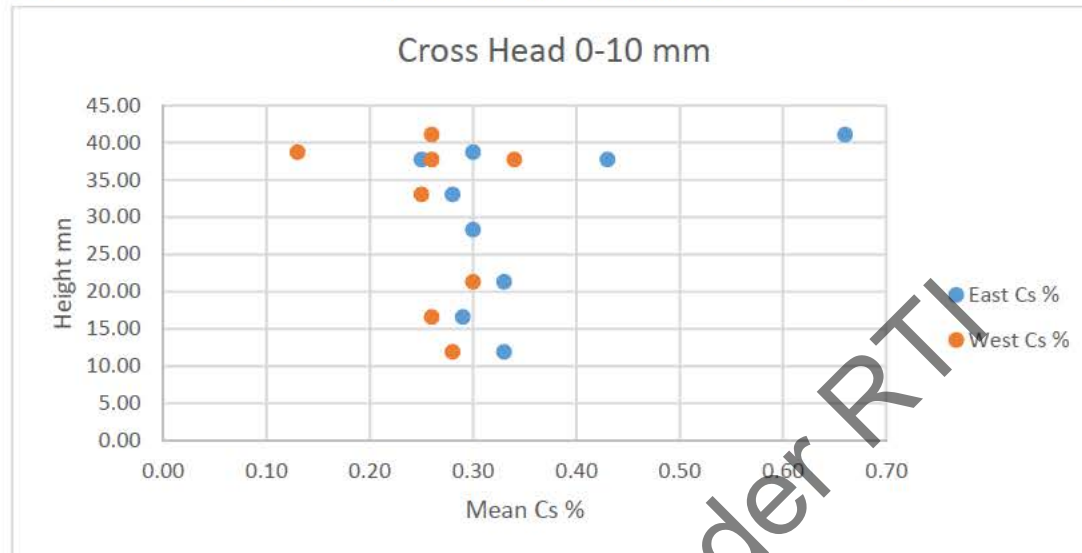
The 0-10 mm chloride levels have been plotted with height for the crossheads and top of columns in Figure 1 and Figure 2.

The maximum measured surface chloride value 0.75%/wt cement equates to 0.07 %/wt concrete.

Figure 1 Plot of surface chloride variation with height for crossheads

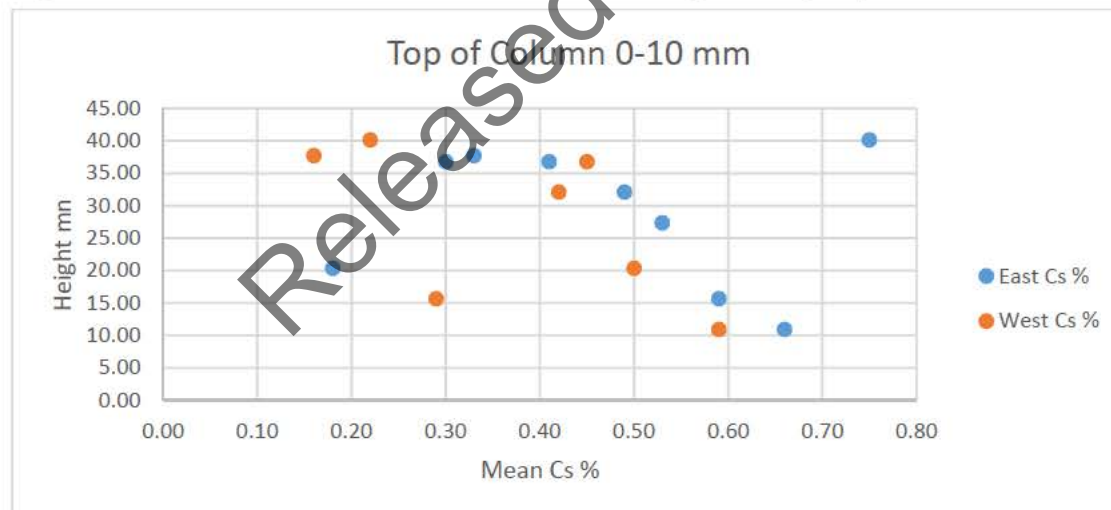
Figure 2 Plot of surface chloride variation with height for top of piers

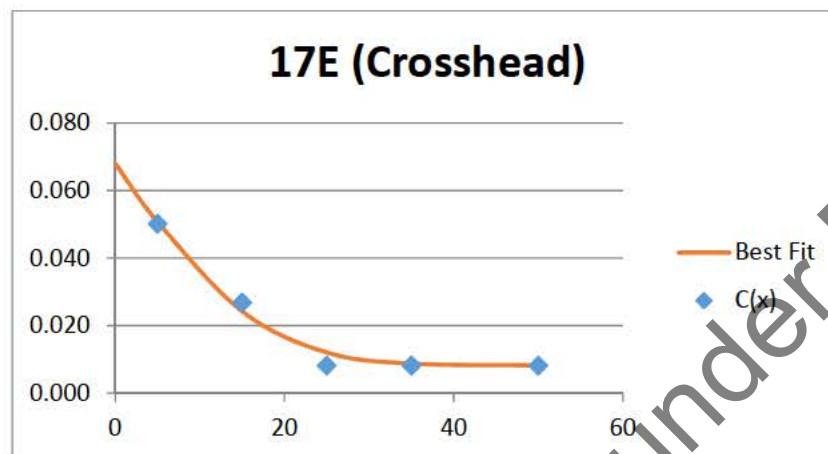
A typical plot is shown in Figure 3, confirming that although surface chloride levels are low, the ingress mechanism is consistent with a diffusion mechanism, and that chloride levels in the original concrete mix were very low around 0.01% by weight concrete. It also shows that the calculated surface chloride level is always higher than the sample increment value.

Figure 3 Typical curve fit of chloride data

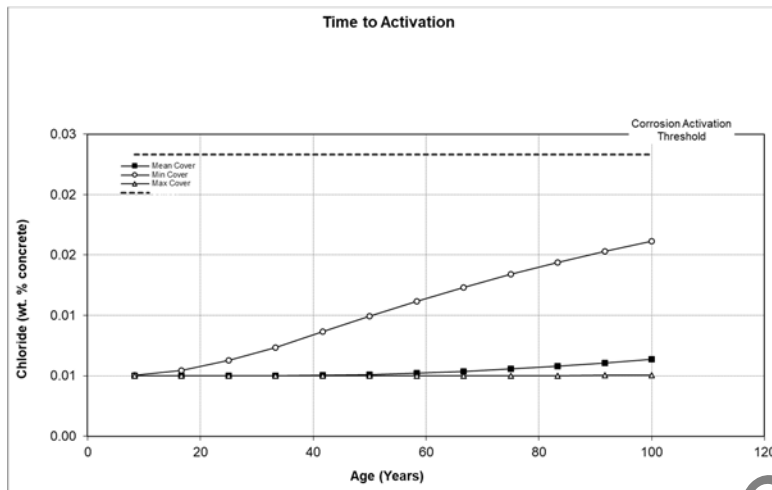
The model results shown in Figure 4 suggests that the cross head beams are at low risk of corrosion initiation or propagation over the remaining 45 year service life, in particular as the design cover is significantly higher than modelled.

Figure 4 Precast Cross Head Corrosion Prediction Model

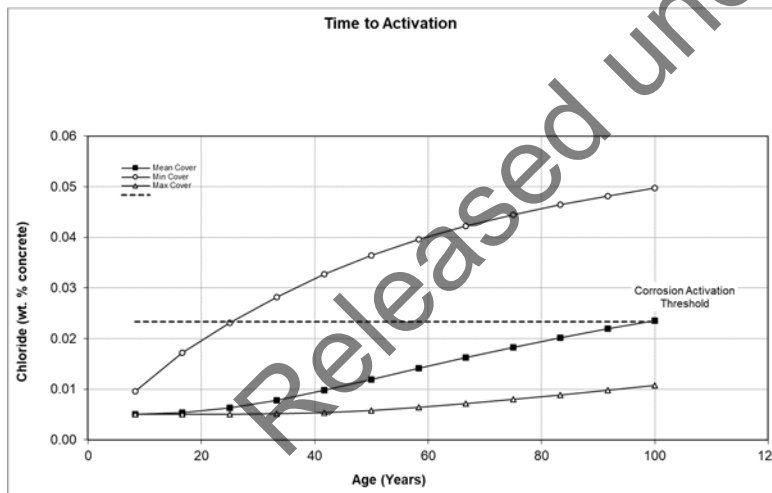
The model results shown in Figure 5 suggests corrosion might initiate in the encased strands at very low cover areas, whereas corrosion should not initiate at mean or greater cover over a 100 year life.

Figure 5 Encasement Concrete Corrosion Prediction Model

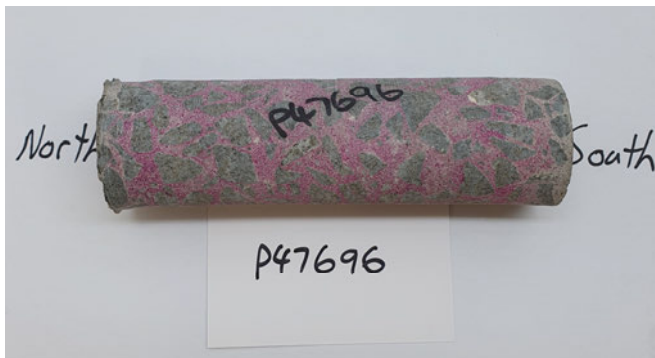
Depth of Carbonation: North end 4-20 mm; South end 4-17 mm

Comments: Length – 150 mm

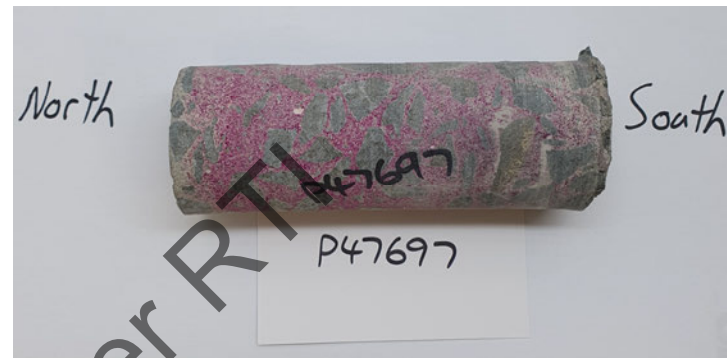
Depth of Carbonation: North end 2-8 mm; South end 3-5 mm

Comments: Length – 125 mm

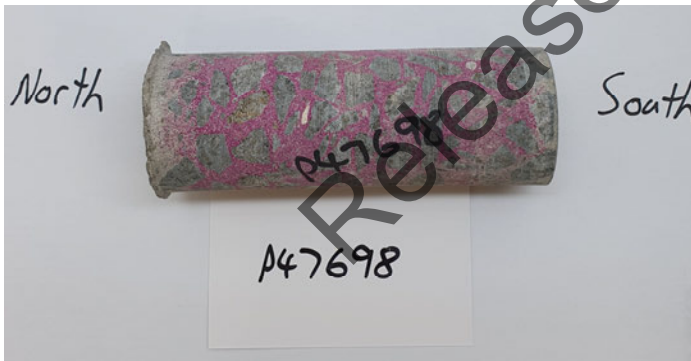
Depth of Carbonation: North end 4-8 mm; South end 3-12 mm

Comments: Length – 122 mm

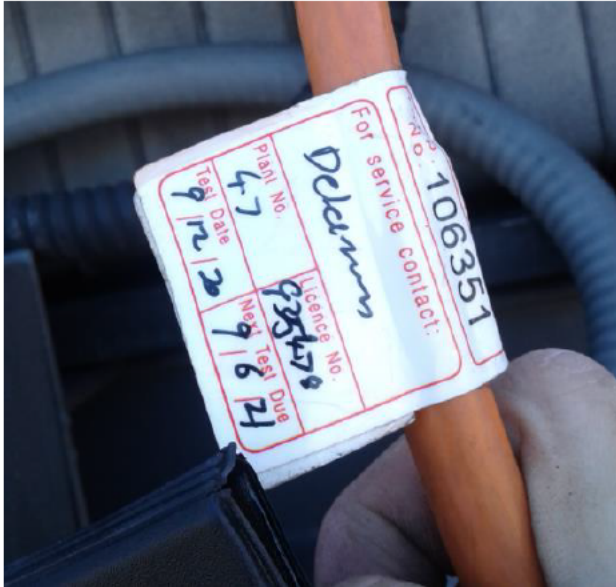
Fig. *a(i)

Description	Timeframe
*a – Trailing cables have been tested and tagged. One is in date, due for next inspection on 9/6/21. The other has been filled out incorrectly and should be retested and tagged immediately.	Immediately
*b – The outer cable sheath of both the pendant controllers has pulled free from the gland nut and been temporarily patched up with electrical tape. This will eventually lead to water ingress and failure of the pendant or electrical plug. Re-terminate and/or repair the cable/gland immediately.	Immediately

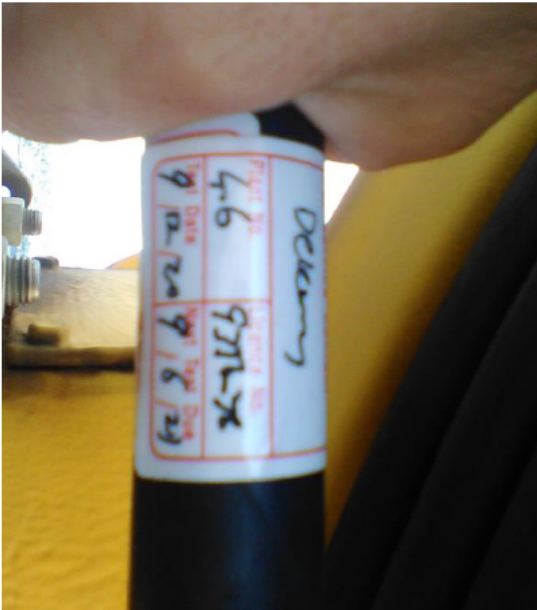
Fig. *b

Description	Timeframe
*a – The plywood covering, over the aluminium mesh floor of the gantry, is weathered and starting to break up. Consider replacing or removing the plywood now that the major bridge maintenance works have been completed.	12 months
*b – Trailing cables are tested, tagged and in date, due for next inspection on 9/6/21	12 months
*c – Long travel chain anchor shackles are tested, tagged and in date, due for next inspection in April 2021 – The rusty hammerlock links between the long travel chains and the swivels have been replaced.	3 months
*d – The guide rollers that run against the handrail were previously rubber lined. These rollers have been replaced with hard plastic rollers. These rollers damage the paint on the handrail which will lead to future corrosion issues. Monitor and replace the hard plastic rollers with rubber (or polyurethane) tyred alternatives as per the original design if paint damage becomes excessive.	24 months

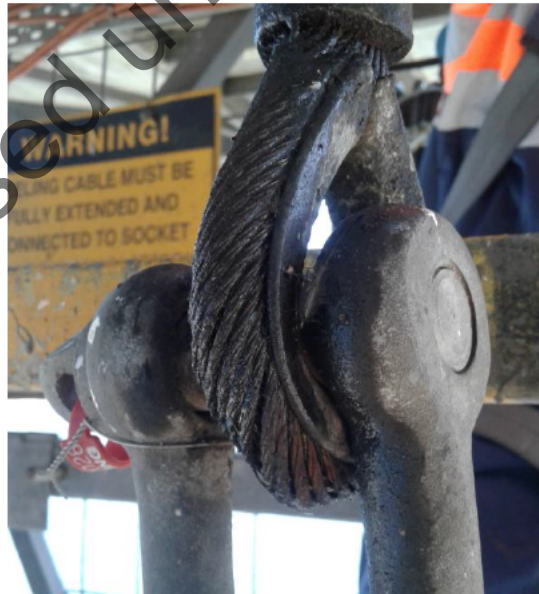
Fig. *f

*e – The leveling cylinder bypass valves on the upriver gantry were very stiff to operate (nearly seized). Lubricant spray was worked into the taps, but future disassembly and service may be required.	12 months
*f – There was some surface corrosion noted on the wire rope loop around the thimble. Recommend clean and relubricate	<u>Immediately</u>
*g – Deterioration of the outer jacket of some hydraulic hoses was noted on both towers. Continue to monitor hoses and replace worn/deteriorated hoses before leaks occur.	12 months
*h – The large NHP limit switches for the gantry hoist working and final limits are inoperable. Recommend immediate repair or replacement. Care must be taken to setup and recommission switches if they are moved or adjusted in any way.	<u>Immediately</u>
*i – Some of the electrical wiring runs through PVC pipe sleeves under metal 'P' clips. Recommend tidying up electrical wiring to prevent damage	12 months

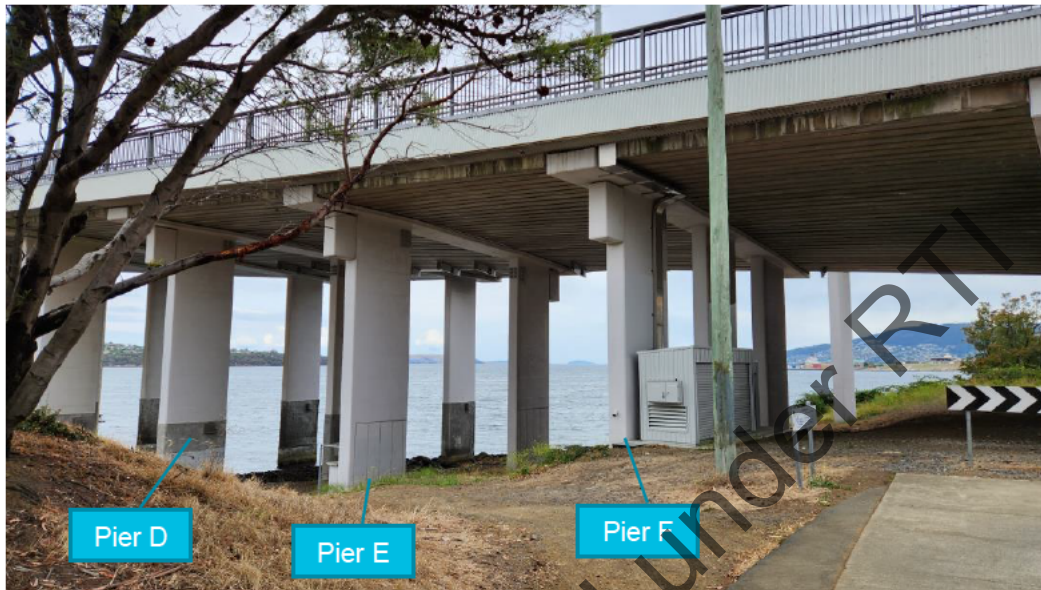
Figure 1 General view of the bridge between Piers D, E and F
