DEPARTMENT OF STATE GROWTH

JUNE 2020

HOBART CITY DEAL SOUTHERN PROJECTS SUB-PROJECT 2: MACQUARIE STREET AND DAVEY STREET BUS PRIORITY
CONCEPT STAGE - ROAD SAFETY AUDIT

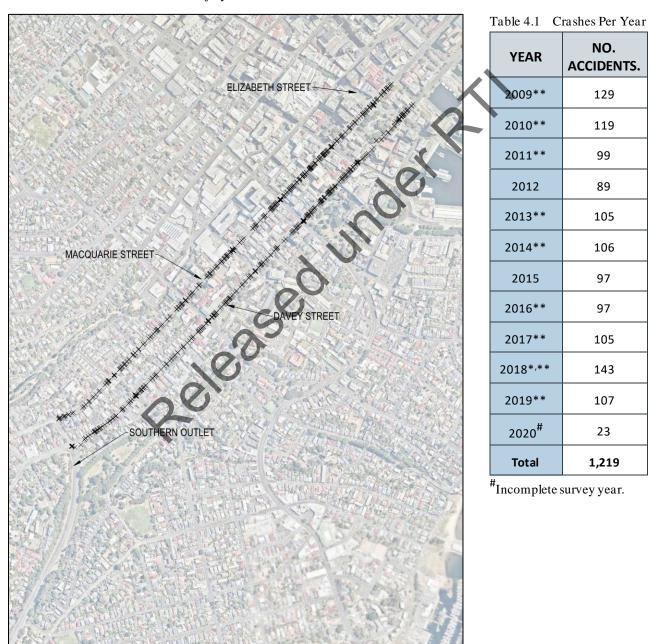
Figure 4.1 Southern Outlet Crash Locations 2009-2020

With regards to the preceding output crash locations, it appears that whilst in general there appears to be a fairly even distribution of crashes along the investigation area, there does appear to be some minor increase in crash numbers between Harrington Street to Elizabeth Street (35% of crashes occurring within 30% of the surveyed road length). Some minor clustering of crashes also occurs around intersections which is in line with expectations as these areas typically result in increased likelihood in vehicle speed variations, movement between lanes, or the opportunities for opposing vehicle conflicts, thereby creating greater opportunity for conflicts to occur.
